**Chilliwack Bell Slough
Improvements Feasibility
Study [Draft]**

Feasibility Study

Prepared for:
City of Chilliwack

Prepared by:
Stantec Consulting Ltd.
500 – 4515 Central Boulevard
Burnaby, BC, V5H 0C6

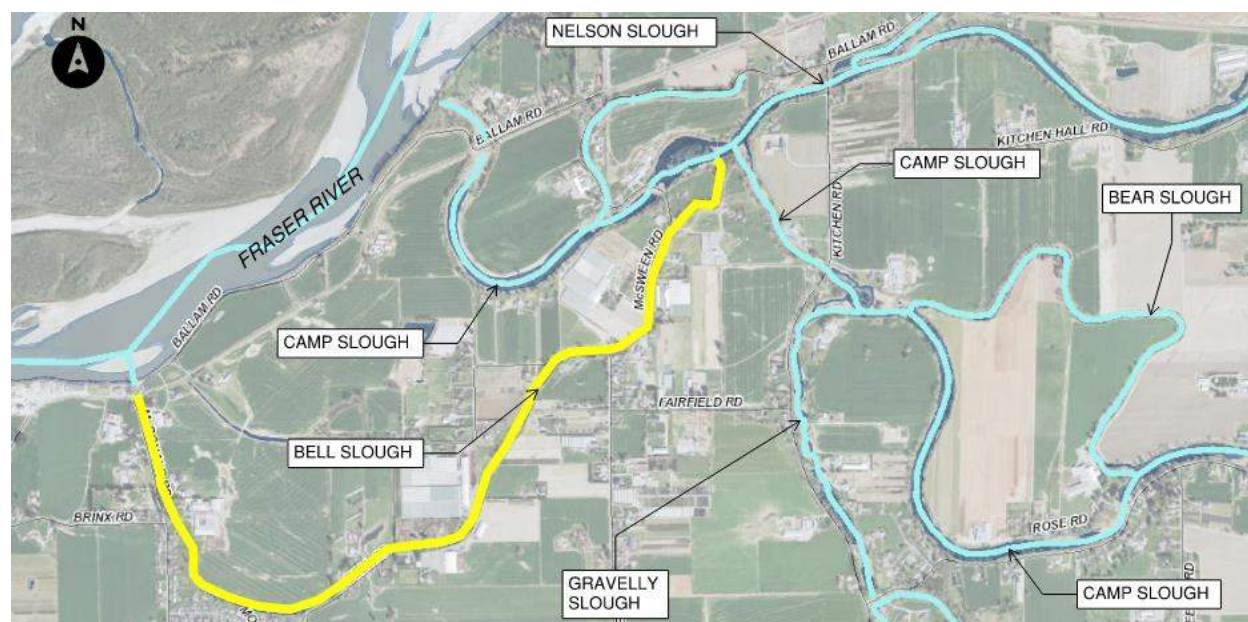
Figure 1-1: Bell Slough Physical Limitations

As a result of the limited connectivity of the Bell Slough and lack of water entering and flowing through the slough, there have been several negative impacts to the water quality and ecological performance of the slough. In addition, nutrient loading and stormwater runoff from adjacent properties may also have contributed to the declining environmental and habitat health of the slough. Stantec Consulting Ltd. (Stantec) has been retained by the City of Chilliwack (City) to complete this *Chilliwack Bell Slough Feasibility Study*, which will identify and evaluate potential hydraulic infrastructure, environmental and habitat rehabilitation, and operational measures that could be implemented to improve the hydraulic and ecological performance of the Bell Slough System. Subsequently, hydraulic modeling, environmental samplings and detailed analysis have been conducted to support this study, which is further explained in the following sections of this report.

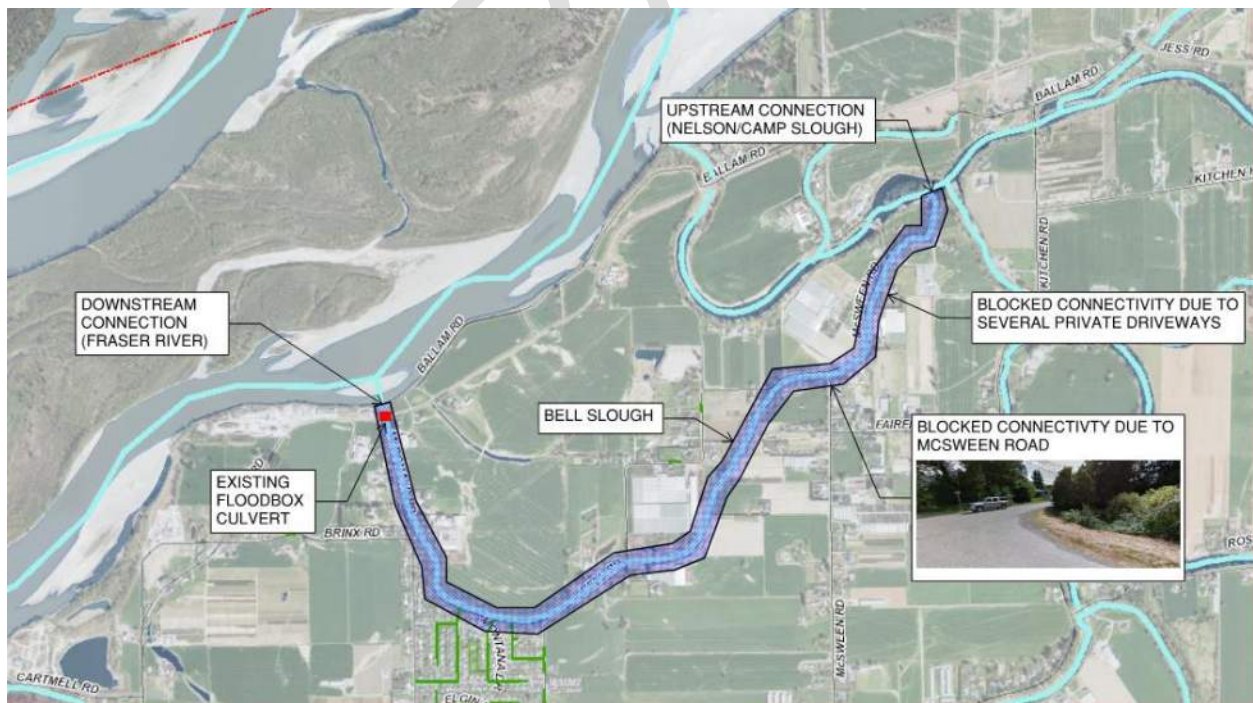
Figure 2-1: Bell Slough Physical Limitations

The Fraser River Levee system along the south bank of the Fraser protects the lands from high water levels overtopping. The levee top elevation in the vicinity of the Bell Slough floodbox is approximately 13.5m. According to the Bell Slough Study 1989, the lowest basement elevation around the Bell Slough is at 10760 McDonald Road which is 9.42m (fixed to CGVD28 datum, $9.30+0.12 = 9.42\text{m}$).

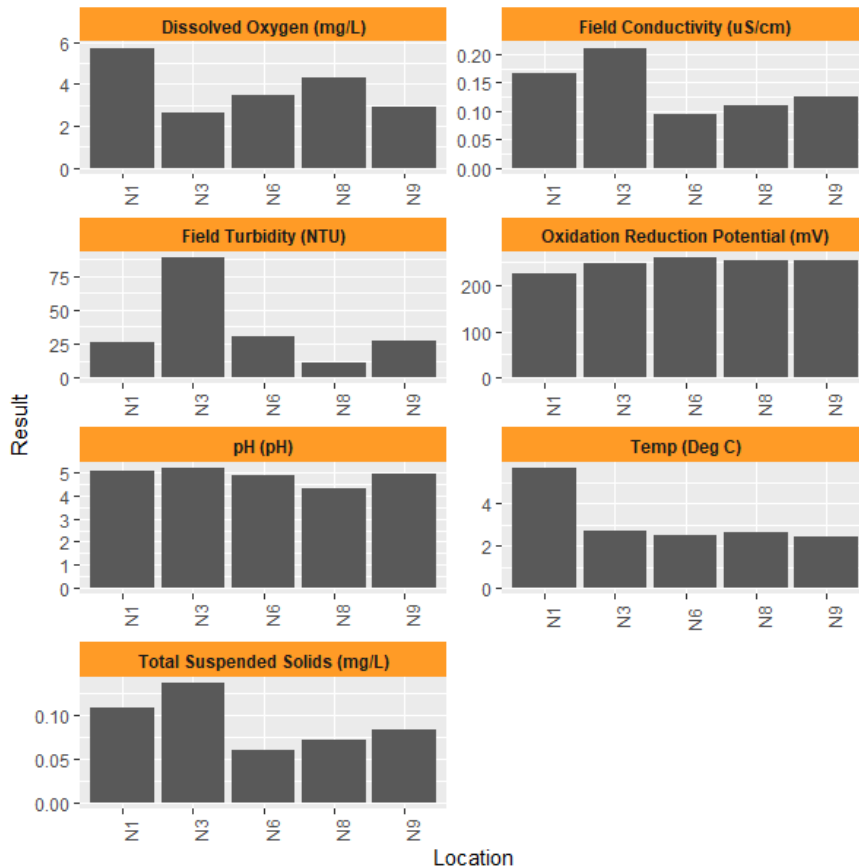
Figure 2-5: In-Situ Field Measurements from November 3, 2022

Results from in situ water quality parameters measurements in November were overall not supportive of aquatic life, which is consistent with the findings of the September visit. Dissolved oxygen was below the BC-WQG (8mg/L) across all stations, with the lowest values at N3 and N9 (2.61 and 2.88mg/L respectively). The pH was also lower than guidelines across the slough (pH <6.5). Temperature levels were, as expected, cooler across the slough than during the September visit, with a spike in temperature at the downstream extent of the slough. Total suspended solids, conductivity and turbidity were elevated at the N3 station compared with the rest of the stations. Oxidative reduction potential (ORP) was consistent across stations with all values above 200mV, suggesting suitable water characteristics to facilitate chemical reactions. In an environmental context, ORP is a measurement of the ability of a freshwater system to break down waste products¹⁹. Plots of the field parameters measure in November are available in **Figure 2-5**. Aquatic habitat where dissolved oxygen levels are below 2mg/L are known as hypoxic zones²⁰. Anthropogenic nutrient pollution is one of the most common causes of aquatic hypoxia²¹. Imbalances in nutrients cause blooms in aquatic plant biomass. Initially, increases in plant density result in high levels of dissolved oxygen produced from photosynthesis; however, as the bloom progresses and plants die off the biological oxygen demand (BOD) increases as microbes break down the decaying plant matter. This causes oxygen depletion and if the amount of oxygen dissolving at the surface is exceeded by BOD, the aquatic environment will become hypoxic or anoxic. This overall process is called eutrophication.

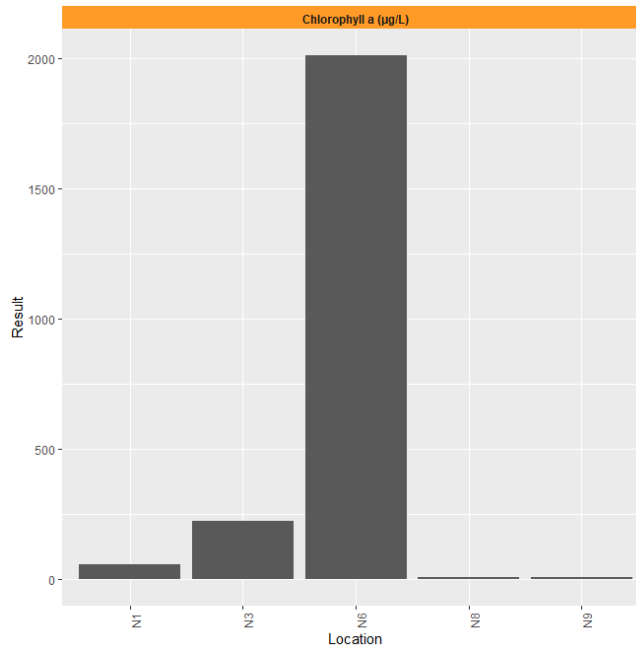
Figure 2-6: Chlorophyll A Concentrations (ug/L) from November 3, 2022

The results from the laboratory analysis showed that plant pigments (as measured as chlorophyll a) were elevated at N6, and slightly higher at N3 than other locations within the slough (**Figure 2-6**). Plant pigment concentration is a proxy for plant biomass. Therefore, the analysis quantitatively supported the qualitative observations of plant biomass seen during the September field visit. There is no WQG or CCME guideline aquatic life for chlorophyll a concentration. However, values below 3 ug/L are considered oligotrophic (low productivity) and above 15 ug/L are considered eutrophic²². Stations 1, 3, 6 and 8 were all well above this level.

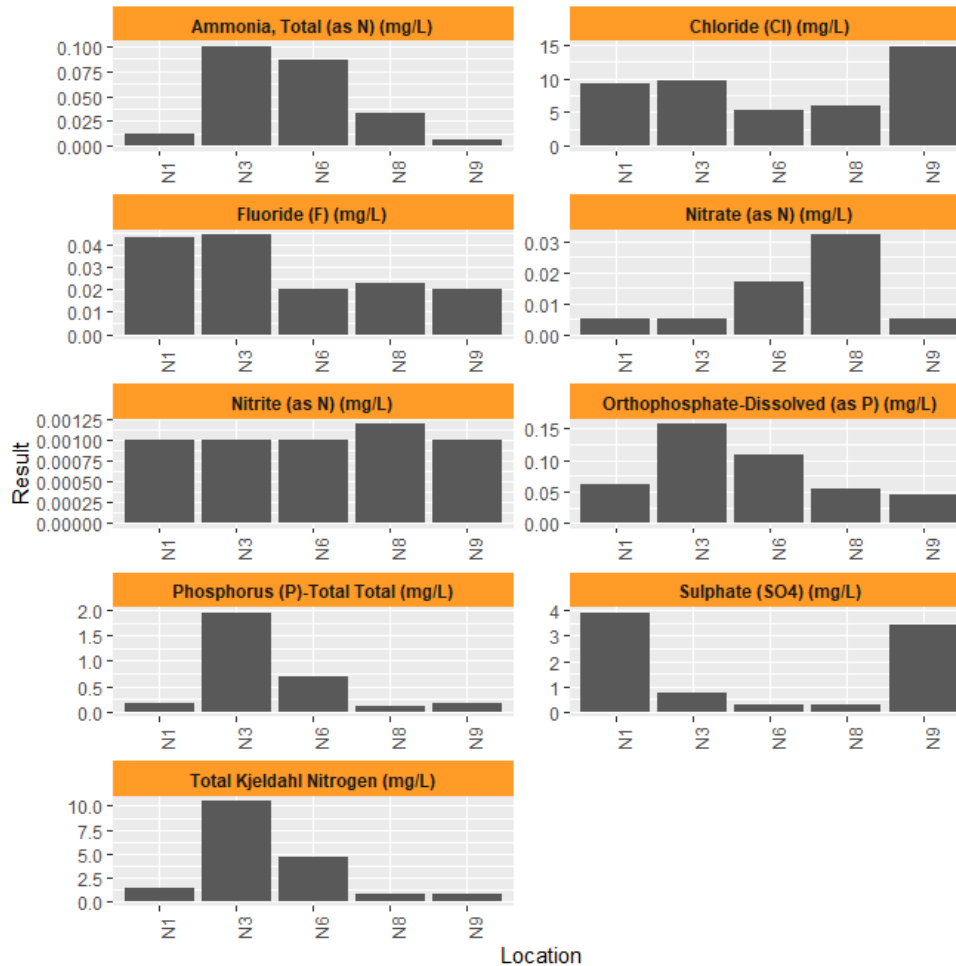
Figure 2-7: Nutrient and Anion Concentrations (mg/L) from November 3, 2022.

An array of nutrients and anions were measured to screen for potential point sources and identify the nutrient type causing eutrophication within the slough (**Figure 2-7**). Organic nitrogen, as Total Kjeldahl nitrogen, and ammonia, showed spikes at N3 and N6, whereas inorganic nitrogen species (nitrate and nitrite) were less concentrated and more localized to the N6 and N8 locations. Phosphorus and Orthophosphate levels peaked at both N3 and N6. Chloride is highest at the upstream end; however, Fluoride is highest at the downstream end of the slough. Bromide levels were below the laboratory detection limits of 0.05 mg/L and therefore was not plotted. Sulphate levels were elevated at the upstream and downstream ends of the slough. Based on these trends it appears that organic nitrogen and phosphate inputs are causing eutrophication in the center of the slough. While trends showed relative differences in nutrients, none of the nutrients exceeded the CCME or BC-WQG for aquatic life. For ease of viewing trends, the guidelines were not included in **Figure 2-7**. Despite not exceeding the toxic benchmarks for any nutrients, nutrient pollution can be deadly when it leads to hypoxic conditions. For example, there is not a BC-WQG benchmark for phosphorus; however, at values greater than 0.025 mg/L is considered eutrophic in lakes²³. Every station across the slough was at least 6-fold greater than this value, with N3 being 78 times greater.

Note: There were no exceedances of BC-WQG or CCME guidelines; for ease of viewing trends guidelines were not plotted.

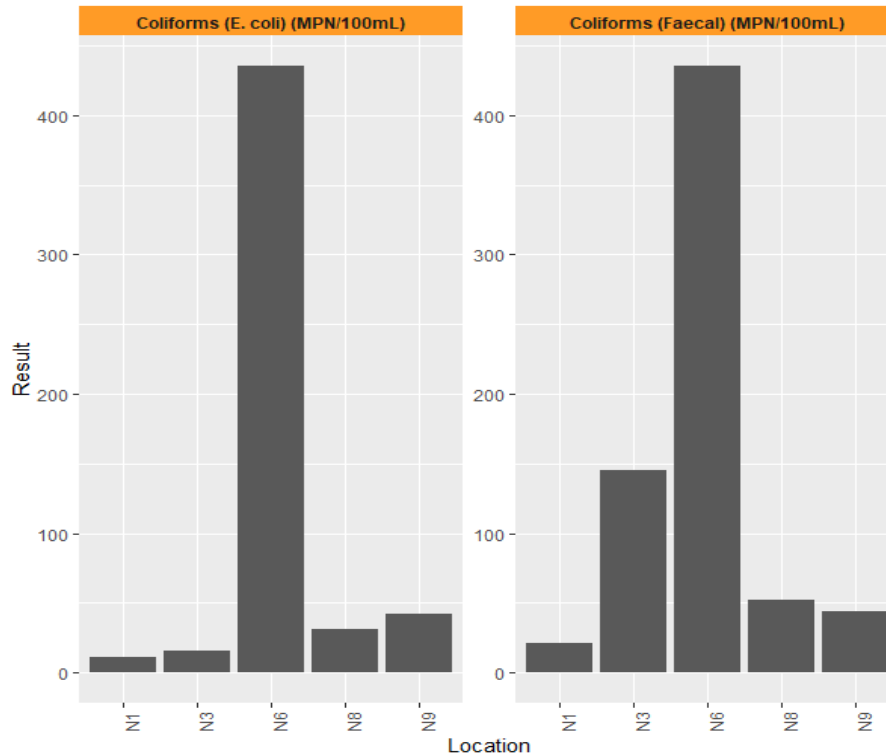
Figure 2-8: Coliforms (E.coli) and Faecal Coliforms Concentration (MPN/100mL) from November 3, 2022

Faecal coliforms and coliforms (as *E. coli*), were assessed to determine if nutrient inputs were as a result of manure and/or septic contamination. The results for microbiology analysis suggests that there may be a point source of sewage or manure effluent which is introducing nutrients to the slough in proximity to stations 3 and 6 (Figure 2-8). There is no guideline for *E. coli* counts for aquatic life; however, there are drinking water and recreational guidelines. While water withdrawal for drinking water from the slough is not a probable goal for restoration, homeowners have mentioned that they would like the Bell Slough to be added to the Chilliwack Blue Way program. BC recreational guidelines for water quality are set for when a primary contact with the water is made frequently, via the trunk of the body and mouth contact to the water²⁴. There was mention from one landowner that people have historically swam within the Bell Slough. The BC recreational guideline is 200 MPN/100mL *E. coli*; station N6 exceeded this value. Identification and subsequent inhibition of the bacterial inputs would be required in order for the slough to be safe for swimming.

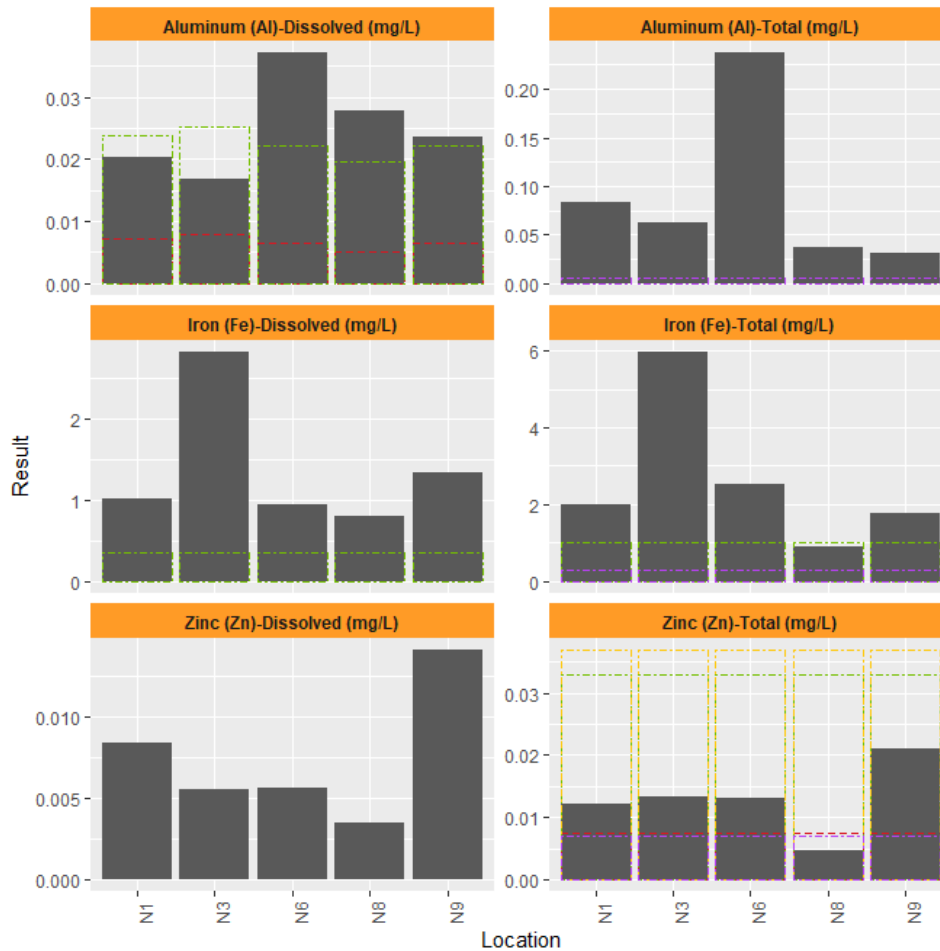
Figure 2-9: Metals with CCME or BC-WQG Exceedances November 3, 2022

Both total and dissolved iron had exceedances across the Bell Slough for long-term BC-WQG and CCME guidelines. Iron levels were highest at N3. Dissolved iron is generally low in freshwater environments; however, storm water run off and soil erosion can result in deposition in streams²⁷. Hypoxic aquatic environments can also cause iron to unbind from the sediment. Iron is also common in fertilizers, animal

Total zinc exceeded the short-term BC-WQG and the long term CCME guideline at all stations but N8. There is no guideline for dissolved zinc. Station N9 showed the highest levels of both dissolved and total zinc. Aquatic zinc concentrations in non-contaminated waters usually sit below the laboratory detection limit. It is estimated that 96% of zinc discharged into the global environment is the result of human activities²⁸. Road surface runoff, domestic waste, and agricultural land erosion are the most likely pathways that this metal entered the Bell Slough.

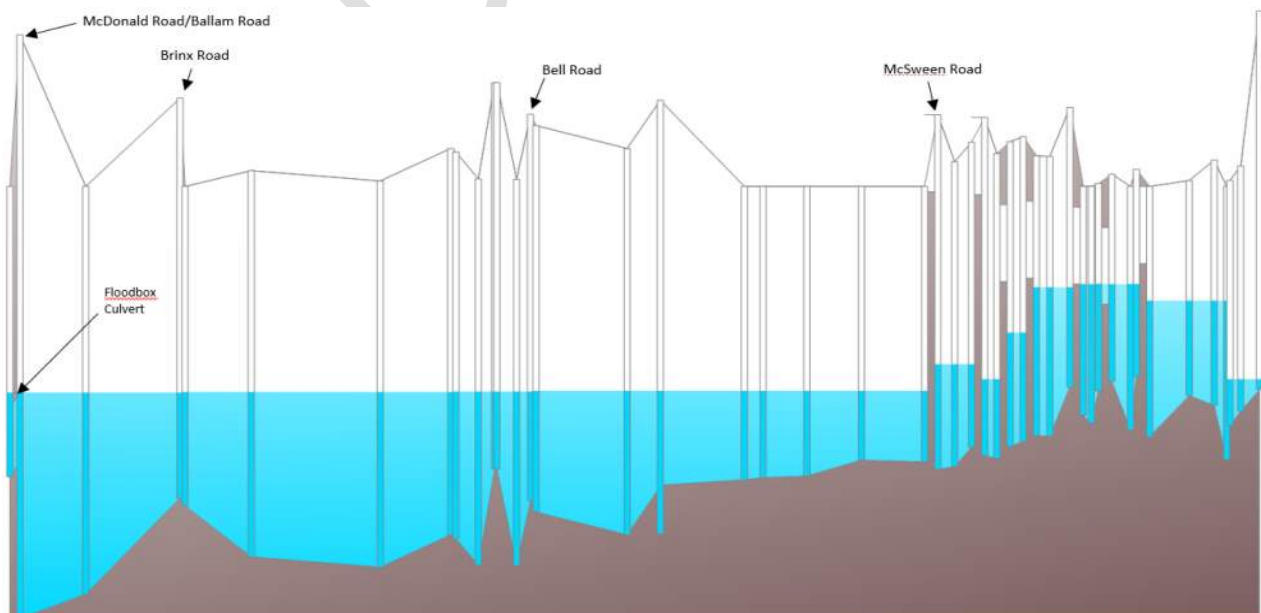
Figure 3-1: Profile of the Bell Slough

For the purpose of this feasibility study, the Bell Slough channel was considered from the inlet of the existing floodbox culvert discharging to the Fraser River to the confluence point of Nelson Slough, Camp Slough and Bell Slough, accounting to an approximate length of 3.7km. As seen in **Figure 3-1**, which illustrates the profile of the Bell Slough, the channel slope appears to be inconsistent leading to entrapment of water and reduction in flow velocity throughout.

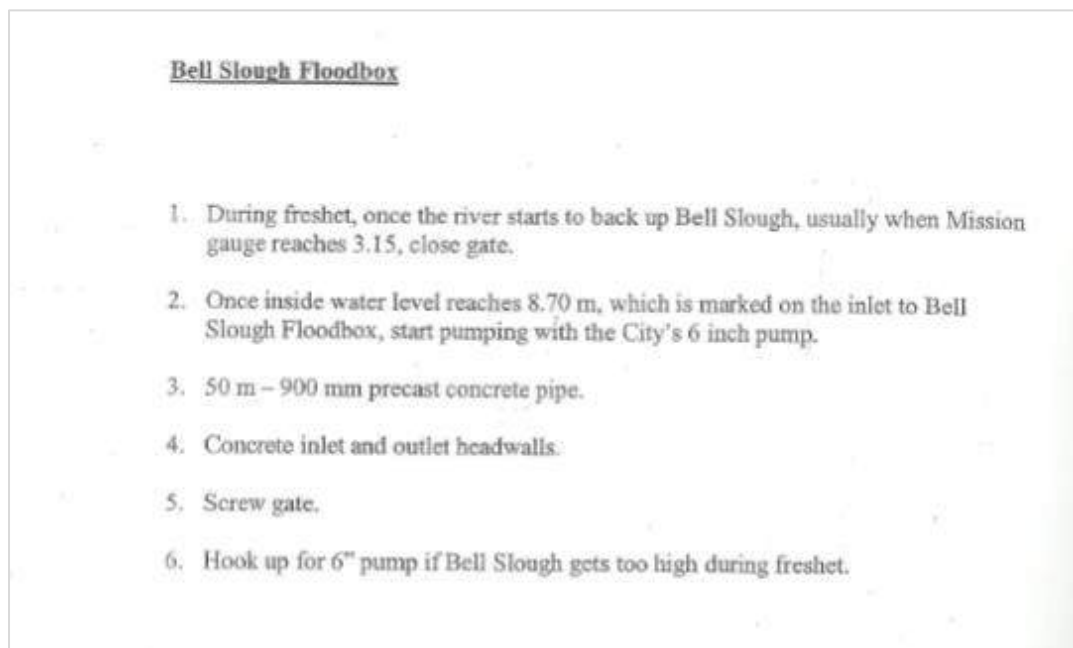
Figure 3-3: Floodbox Culvert Pumping Operations²⁹

Currently, it is understood that the existing floodbox culvert is closed during larger Fraser River freshets. Historically, water has been manually pumped with a portable 6" 6TS Thompson utility trash/sewage pump to draw down the water in the Bell Slough in efforts to control the water levels and prevent flooding. This pump is turned on when water levels reach 8.70m (CGVD28) at the inlet of the floodbox culvert. These operations are described in **Figure 3-3**. This operational procedure has been implemented and in practice ever since the floodbox culvert was installed.

Regarding the pump stop operations and closure of the floodbox culvert, it is understood that there are currently no procedures in place to control these processes. The City communicated that historically the pumps were stopped and the floodbox culvert was opened once the operator observed that the slough water levels had dropped to a visually suitable low level. There is no documentation of what these water levels could have been.

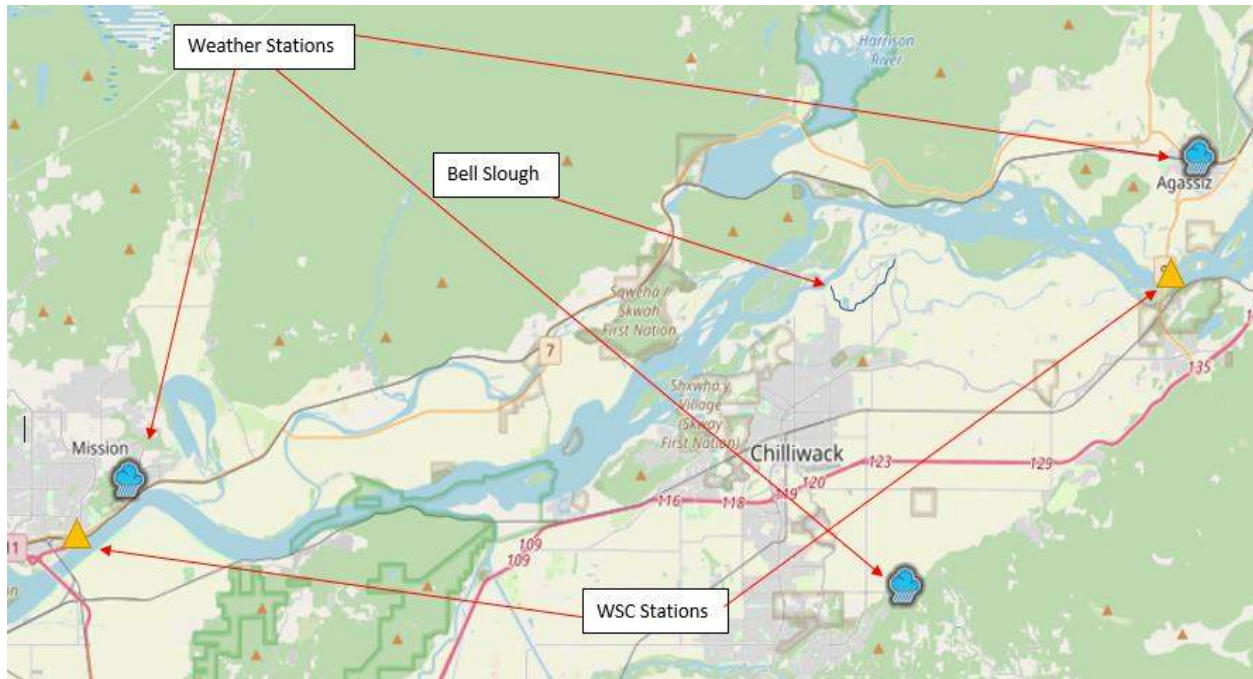
Figure 3-4: Environment Canada Station Locations (Agassiz and Mission)³⁰

The water level of the Fraser River just downstream from the Bell Slough was determined based on interpreting the historically monitored data of Water Survey Canada (WSC) stations available from Environment Canada³⁰. The water level data was taken from upstream and downstream locations (upstream station – Agassiz and downstream station – Mission). **Figure 3-4** illustrates the approximate locations of the weather stations (cloud shape) and WSC stations (triangle shaped) which were used to gather data for the analysis.

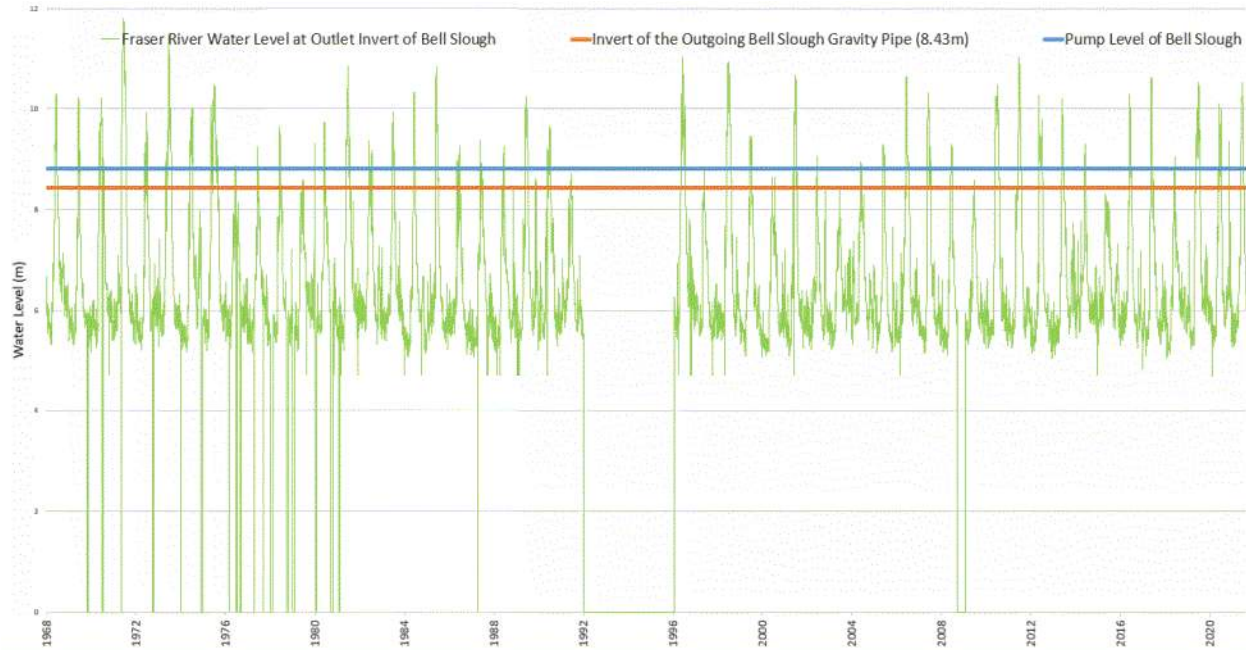
Figure 3-5: Fraser River Water Level Comparison with the Bell Slough

Based on the data referenced from 1968-2022, and as inferred from **Figure 3-5**, the water levels for the Fraser River have been below the invert elevation (8.43m) of the outgoing floodbox culvert (90% of the time) located at the downstream end of the Bell Slough. Refer to **Figure 3-6** for the percentages.

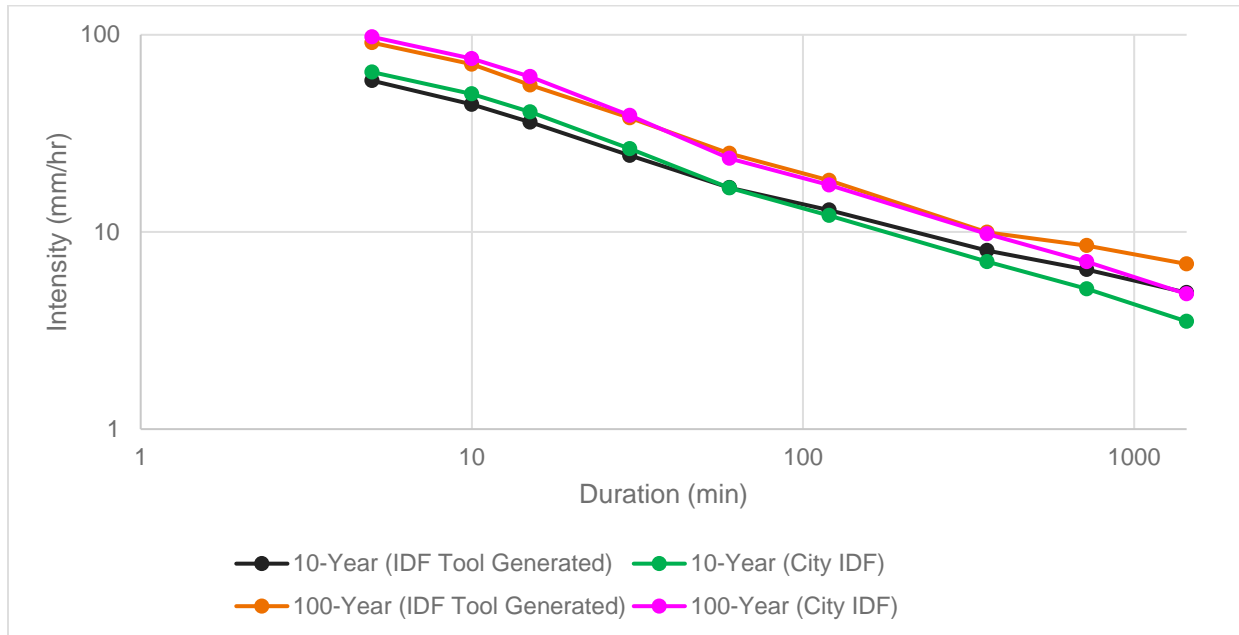
Figure 3-7: Comparison of City IDF curves and IDF Tool generated curves

the PCSWMM models using the IDF Tool generated intensities. The new generated IDF curves can be found in **Appendix D**.

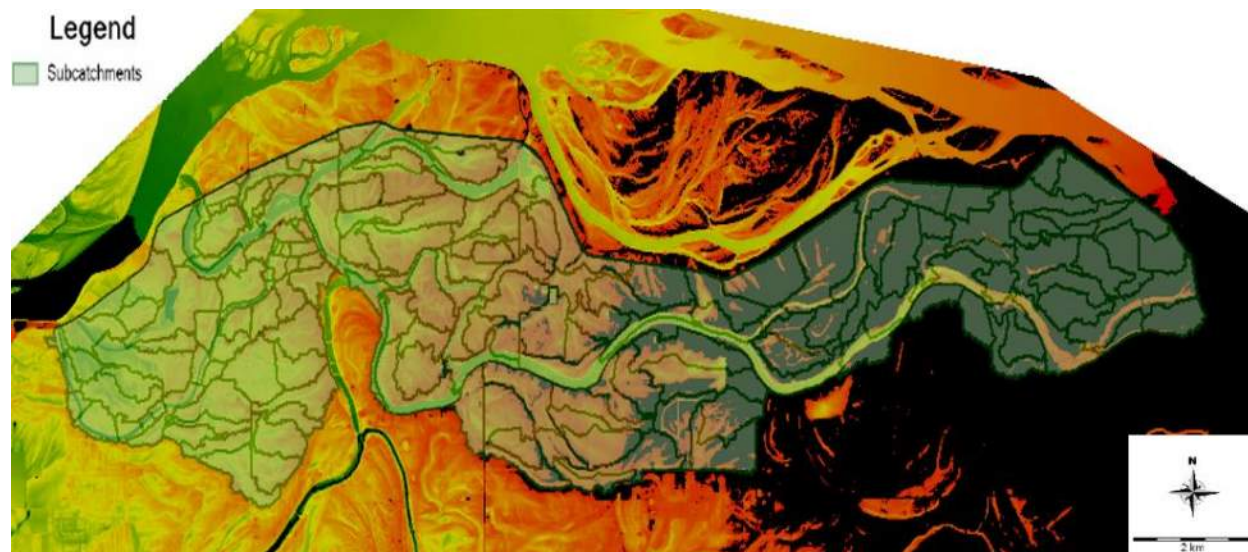
Figure 3-8: Delineated PCSWMM Model

A DEM was created using LiDAR data. The GIS tool in PCSWMM was utilized to delineate the overall areas into sub-catchments and to create cross-sections of the existing ditches using this DEM. The pre-development stage model is shown in **Figure 3-8**.

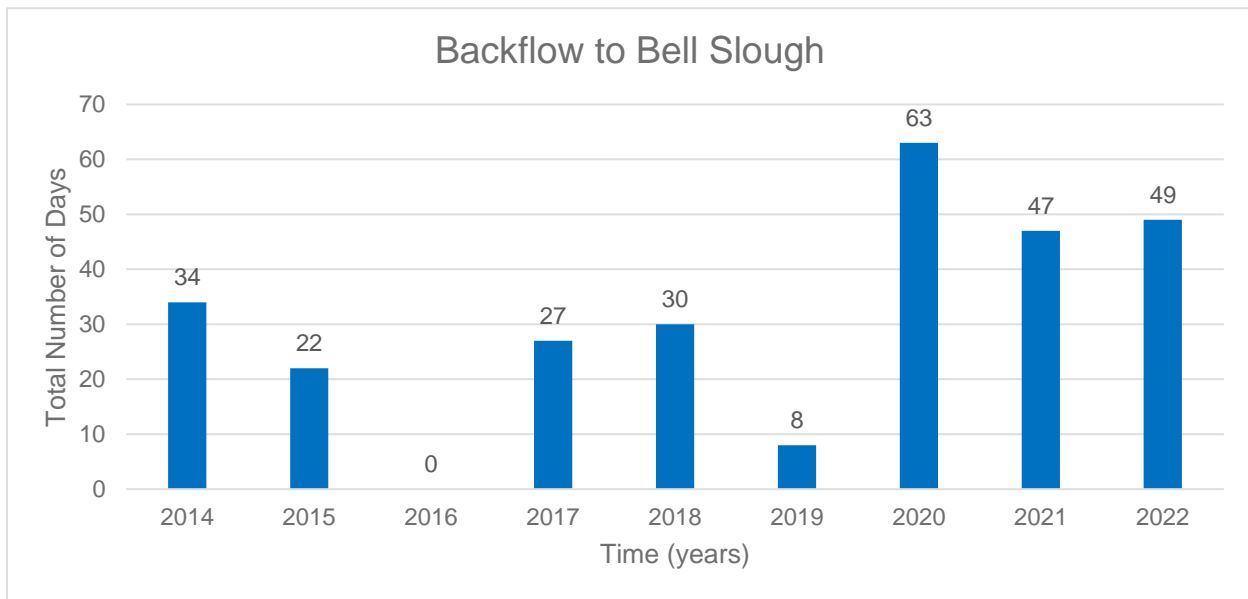
Figure 3-9: Backflow to the Bell Slough

The PCSWMM model was calibrated using the 2014-2022 historical water levels data within the Bell Slough provided by the City and comparing the data with the simulated water levels. According to the water level data, over the last few years there has been an increase in backflow frequencies from the Fraser River. 2016 was determined to be the year with no backflow whereas 2020 was the year with the highest number of backflows from Fraser River to the Bell Slough. Thus, the water level data for these two years were used to calibrate model. **Figure 3-9** illustrates the number of days with a backflow on a yearly basis from Fraser River to the Bell Slough.

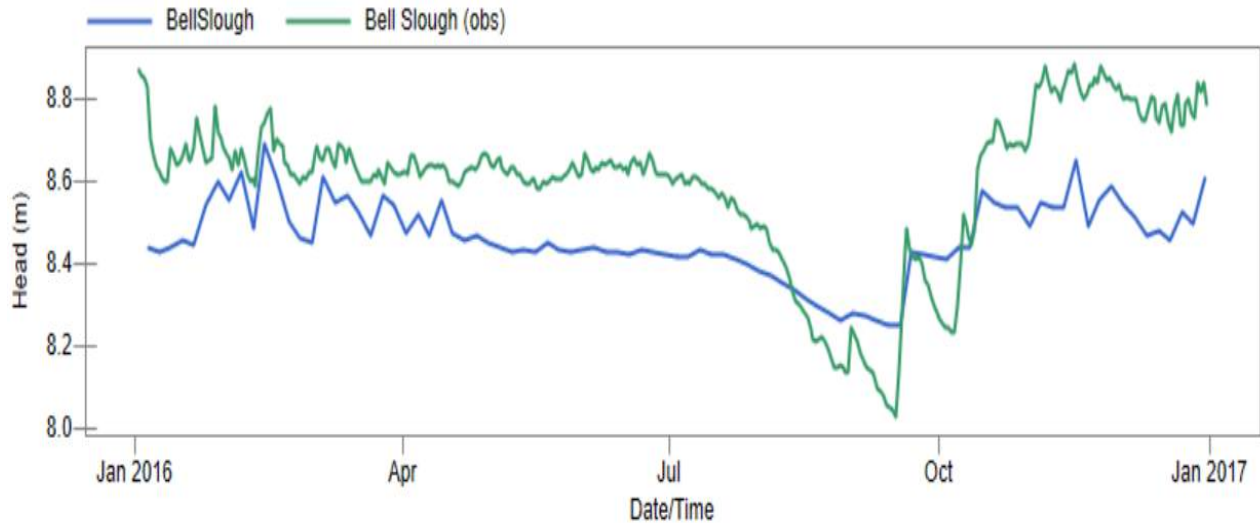
Figure 3-10: Model vs. Observed Data Comparison for the 2016 Water Levels at the Bell Slough Floodbox Culvert

During calibration of the water levels within the Bell Slough, the PCSWMM model was run with the simulated flows and the 2016 water level data was added as an observed timeseries as seen in **Figure 3-10**. The comparison of simulated versus observed data indicate a close match in pattern. The highest water level event observed during 2016 was in November and the model shows similar peak in that time frame. This is a good measure for checking the model's usefulness in predicting the depth levels in response to the simulated inflows.

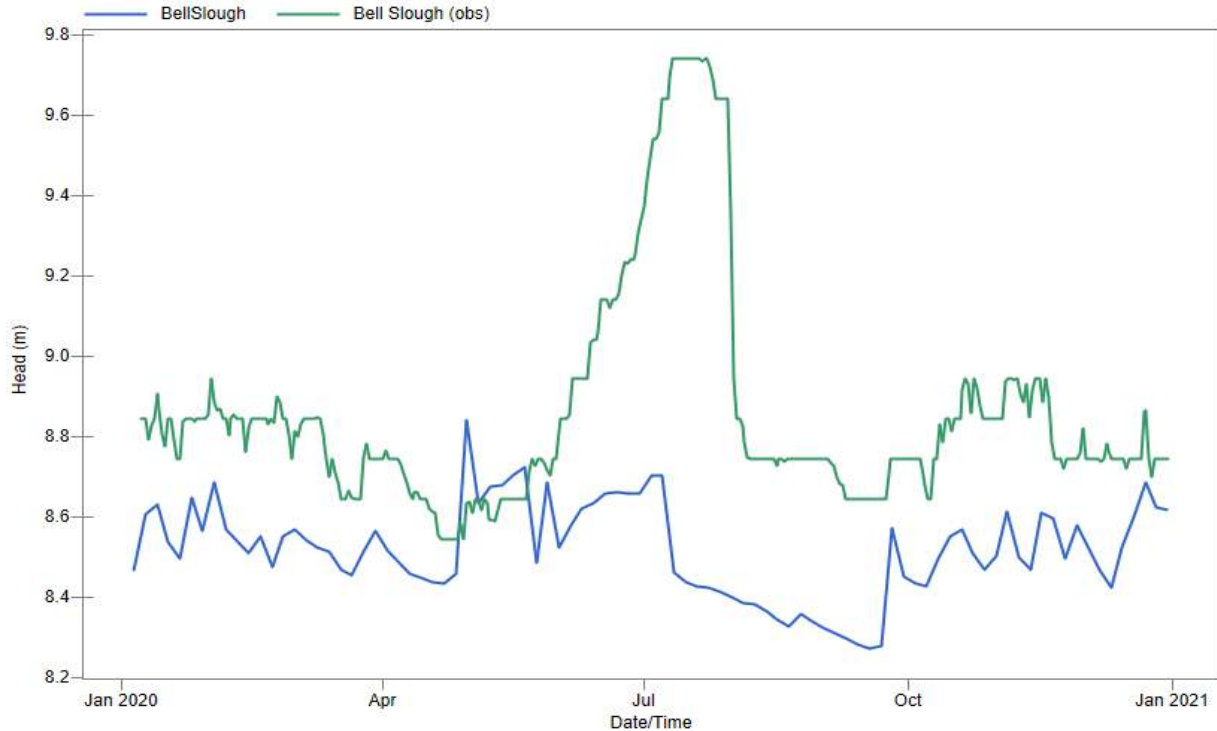
Figure 3-11: Model vs. Observed Data Comparison for the 2020 Water Levels at the Bell Slough Floodbox Culvert

The PCSWMM model was run for 2020 rainfall data, and the resulting simulated flow level was compared with the 2020 observed water level data as seen in **Figure 3-11**. The modeled depth pattern appears to be comparable in most cases. For 2020, the highest water level was observed in July.

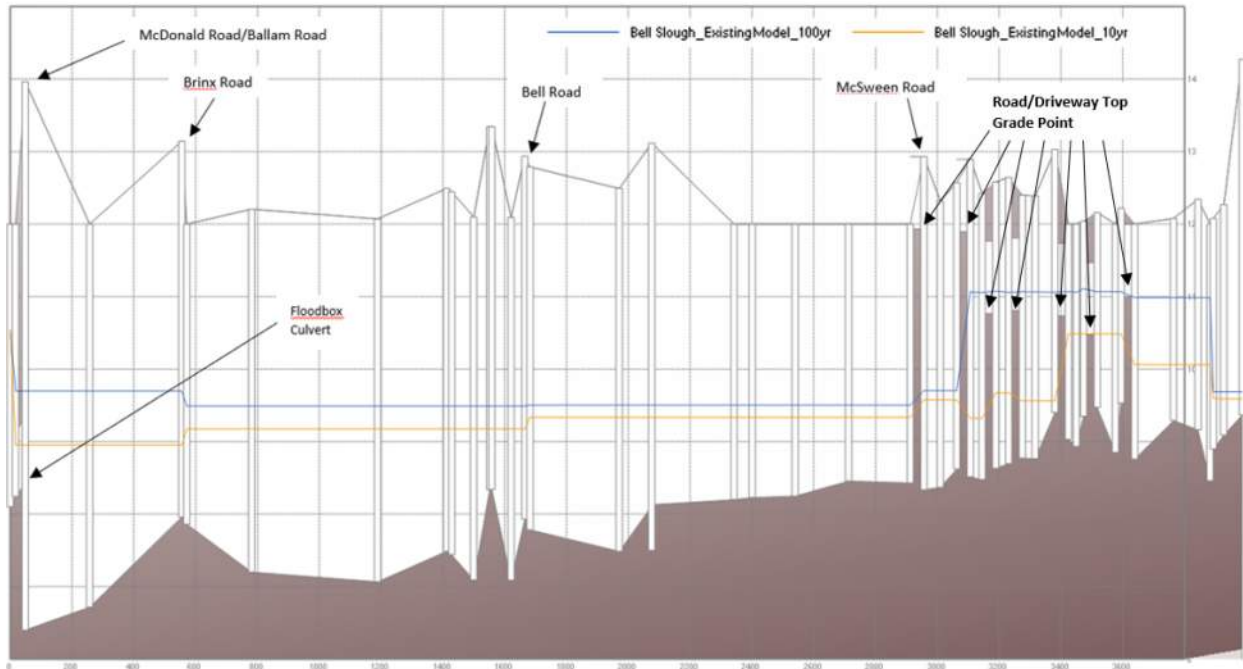
Figure 3-12: HGL Levels for 10-year (Orange HGL) and 100-year (Blue HGL) SCS Design Storm Event

Note the ground surface elevations shown in the model figures throughout this report do not represent the actual ground surface elevation of the roadway/driveway. These ground elevations have been increased in the model to simulate overtopping of flows across roadways/driveways crossing the Bell Slough. The brown coloured land at the top of the profiles represent sections where overtopping of roadways can occur within the Bell Slough.

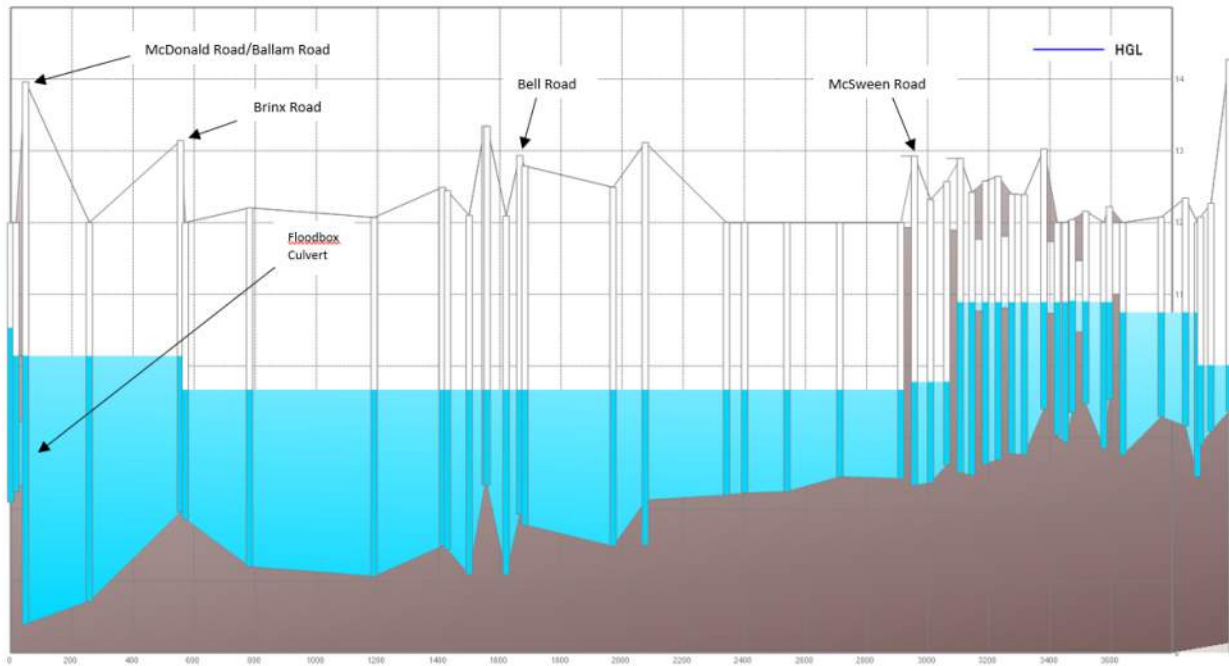
Figure 3-13: Bell Slough Hydraulic Profile for 100-Year Climate Change Scenario

According to LiDAR data, the developed lands surrounding the lower reach of Bell Slough have a minimum elevation of 10.00m. Since the HGL reaches only 9.74m here, modeled surface water does not appear to flow from the Slough to buildings and is unlikely to ingress into basements from an event of this magnitude. Additionally, during the public-open house conducted on September 22, 2022, and the subsequent public feedback collected from the City of Chilliwack residences (refer to **Appendix B**) there have been no reports of basement flooding recorded to-date since the late 1990's.

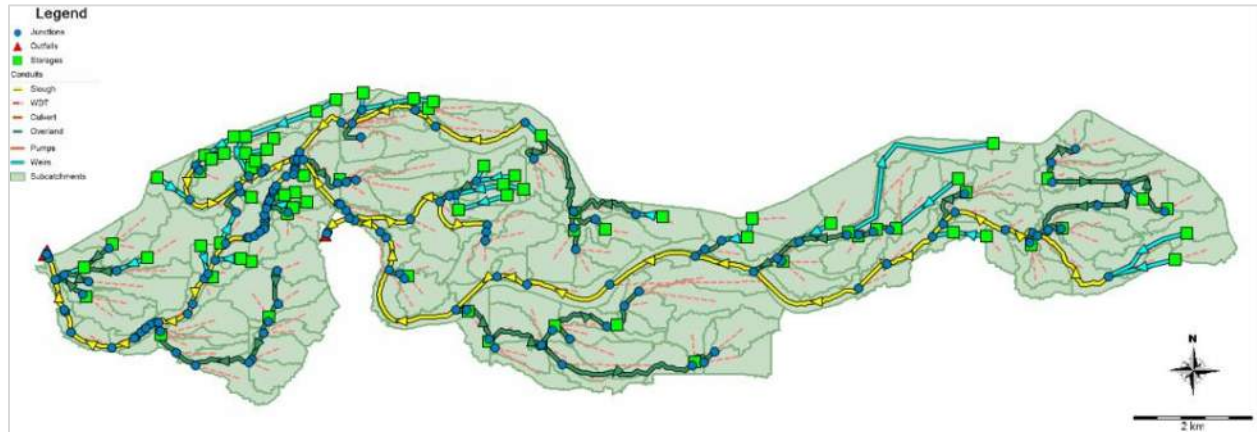
Figure 3-14: Post Conditions Base Model

The proposed conditions model (refer to **Figure 3-14**) was built on top of the existing conditions model. Different modeling scenarios were run to determine the possible options for improving the hydraulics within the Bell Slough.

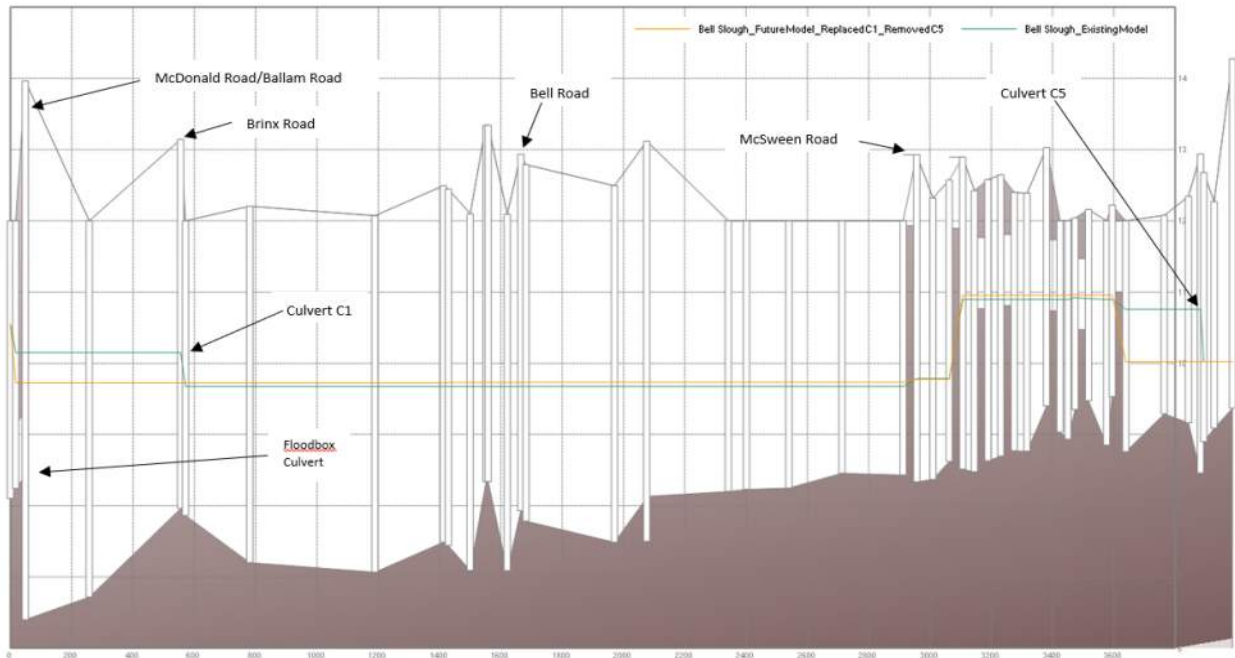
Figure 5-1: HGL Level Comparison for the 100-year Climate Change Design Storm Event of the Replaced C1 & Removed C5 Culvert Scenario (Yellow HGL) with the Existing Conditions (Green HGL)

The modelling analysis was done with 400mm diameter culverts as well but due to better hydraulic conductivity and more flow conveyance, 900mm diameter culverts were selected. **Figure 5-1** illustrates that replacing the damaged culvert C1 and removing the damaged culvert C5 would support in reducing the HGL levels over the Bell Slough.

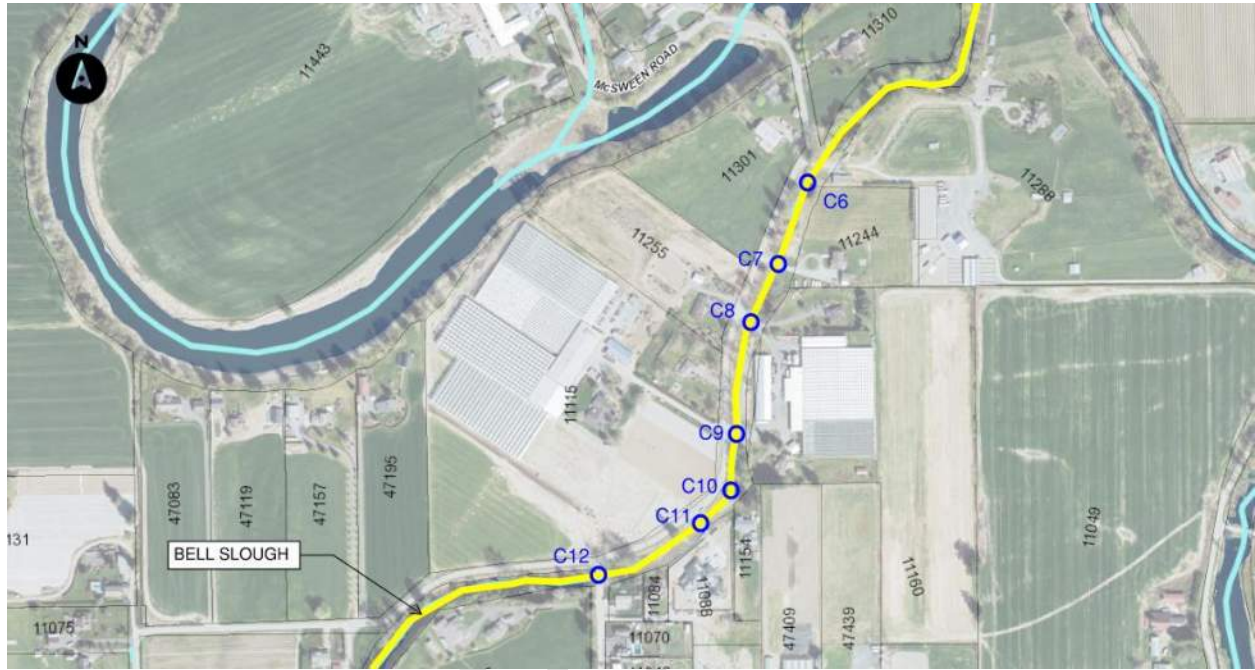
Figure 5-2: Proposed Culvert Locations within the Bell Slough

During the public consultation (refer to **Appendix B**) and meetings with the City, it was communicated that there have been instances of flooding across the upstream extent of the Bell Slough due to overtopping during major storm events. Throughout the Bell Slough it is apparent that there are road crossings and private driveways with no culvert to allow for flow conveyance. The culvert data from the City¹³, in conjunction with the topographic survey completed on September 27, 2022, confirmed that a total of seven crossings would require a culvert installation – this is illustrated in the following **Figure 5-2** and detailed in **Table 5.1**. These culverts can be 900mm (except Culvert C7 – 525mm) high-density polyethylene (HDPE) dual-walled culverts complete with riprap armoring on the banks or log drops.

based on the existing slough grading. As per the technical note by ADS for the corrugated HDPE pipe (see **Appendix D**), the minimum cover required for 100-1200mm diameter HDPE pipe is 300mm.

Culvert C7 can be maximum 525mm in size because of insufficient depth at the Property Parcel #11244 driveway from McSween Road. The driveway elevation is 10.3m and Bell Slough bottom invert is 9.43m resulting in a depth 0.87m. For a 900mm culvert with minimum cover a minimum required depth is 1.2m.

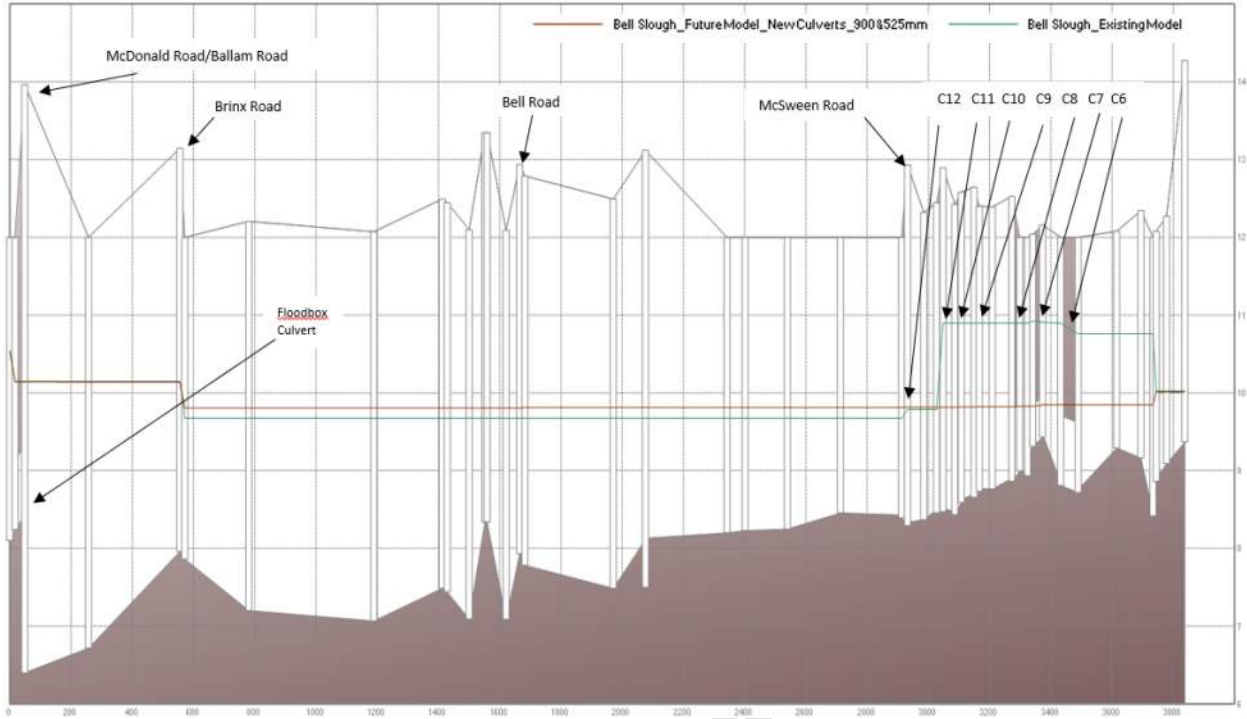
Figure 5-3: HGL Level Comparison for the 100-year Climate Change Design Storm Event of the Proposed Culverts (Green HGL) with the Existing Conditions Model (Brown HGL)

Figure 5-3 depicts the scenario with the proposed culverts installed within the Bell Slough. It can be observed that water levels would be significantly reduced at the upstream end, reducing the risks of flooding to properties north of McSween Road. Additionally, the HGL is relatively increased on the downstream end, allowing for better hydraulic connectivity throughout the Bell Slough.

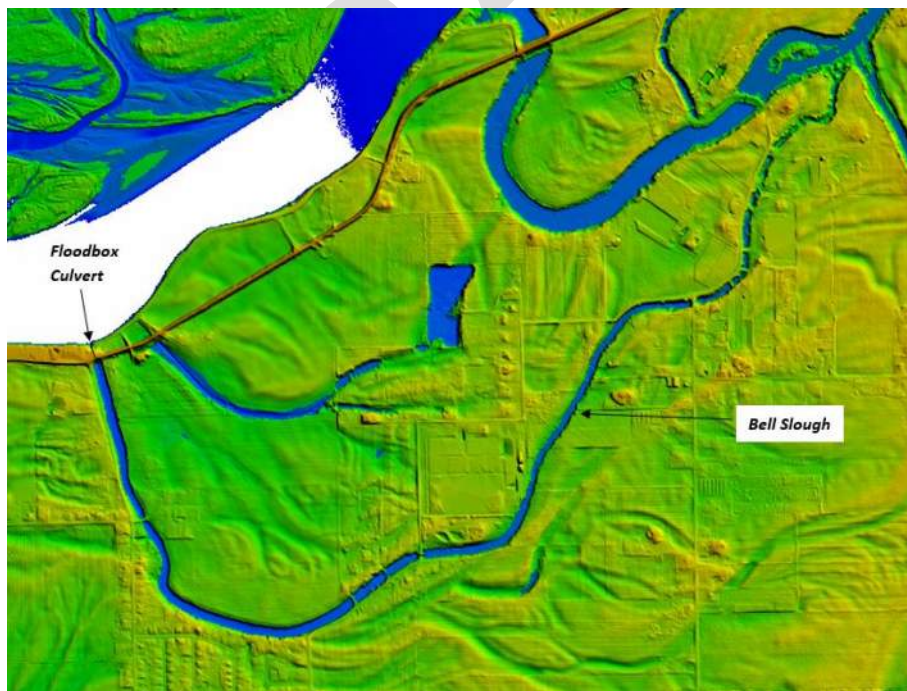
Figure 5-4: Water Level in The Bell Slough and Surrounding Area at 9.50m Elevation

As described previously in **Section 3.1.4.2**, historically the pump start level for the Bell Slough has been 8.82m. Based on the existing model analysis, the HGL levels within the slough for the 100-year plus (inclusive of climate change) are still within the slough in most instances. Based on the LiDAR data, it is apparent that the lowest elevation at the downstream vicinity of the Bell Slough is 10.15m. **Figure 5-4**, **Figure 5-5**, and **Figure 5-6**, illustrate some different elevation gradients. For flooding to become induced in the downstream surrounding areas, the water level within the slough would need to surpass this 10.15m level. described previously, historically the water level within the slough reached a maximum elevation of 9.74 m from 2014-2022. Therefore, it was calculated and hydraulically modelled that the pumping start level could be increased to 9.40m.
