**Chilliwack Bell Slough
Improvements Feasibility
Study [Draft]**

Feasibility Study

Prepared for:
City of Chilliwack

Prepared by:
Stantec Consulting Ltd.
500 – 4515 Central Boulevard
Burnaby, BC, V5H 0C6

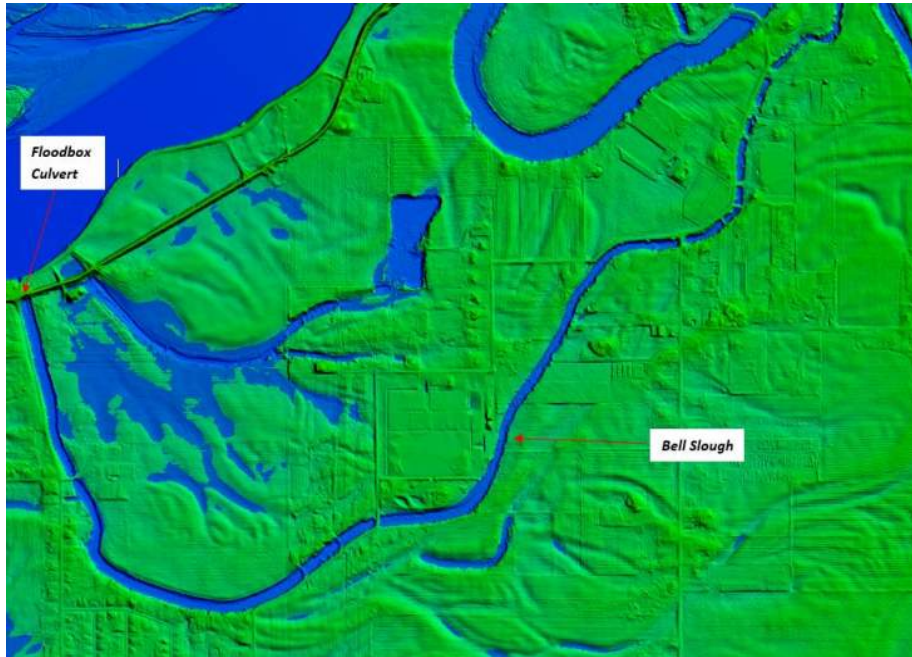
Figure 5-5: Water Level in the Bell Slough and surrounding area at 10.15m Elevation

As described previously in **Section 3.1.4.2**, historically the pump start level for the Bell Slough has been 8.82m. Based on the existing model analysis, the HGL levels within the slough for the 100-year plus (inclusive of climate change) are still within the slough in most instances. Based on the LiDAR data, it is apparent that the lowest elevation at the downstream vicinity of the Bell Slough is 10.15m. **Figure 5-4**, **Figure 5-5**, and **Figure 5-6**, illustrate some different elevation gradients. For flooding to become induced in the downstream surrounding areas, the water level within the slough would need to surpass this 10.15m level. described previously, historically the water level within the slough reached a maximum elevation of 9.74 m from 2014-2022. Therefore, it was calculated and hydraulically modelled that the pumping start level could be increased to 9.40m.

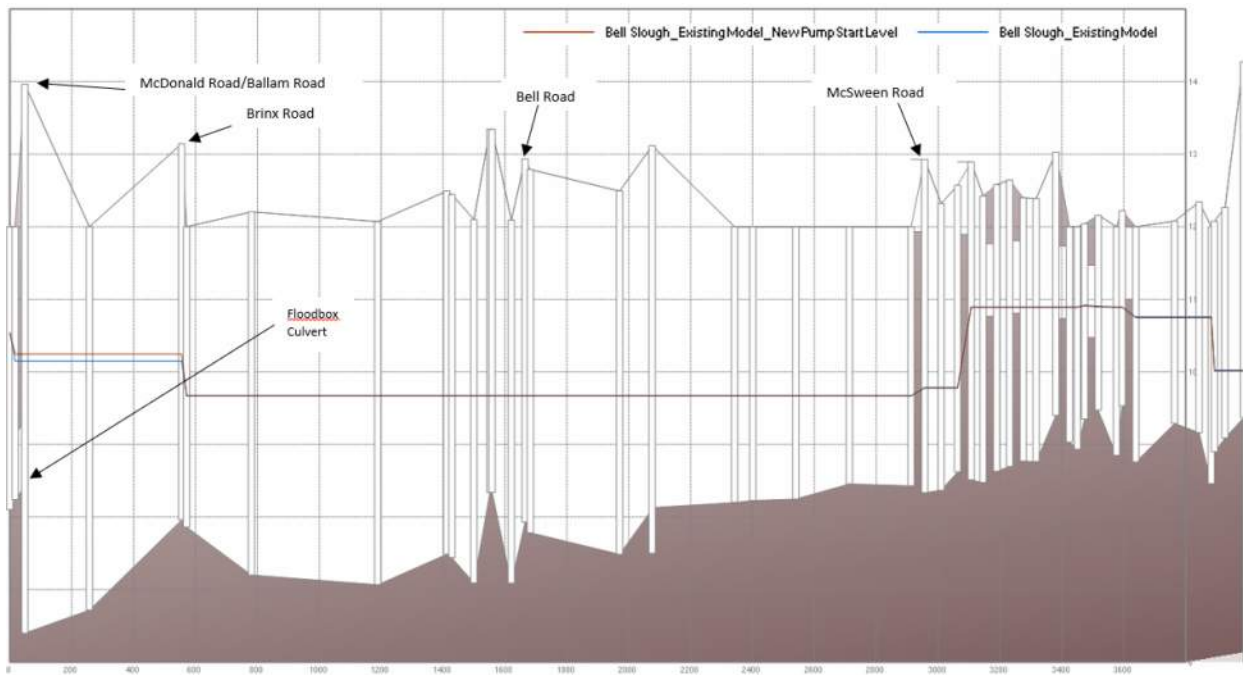
Figure 5-7: HGL Levels Comparison for the 100-year Climate Change Design Storm Event of the Existing Conditions Model with Existing (Blue HGL) and Proposed Pump Start Levels (Brown HGL)

However, while the highest water level in the slough was 9.74m and there have been no reports of basement flooding recorded to-date during these years, it is recommended that changing the pumping start level to the proposed 9.40m should be considered with caution. After the change to the start level operations have been made, especially at the downstream portion of the Bell Slough, water levels and the surrounding areas should be carefully monitored for any signs of flooding, at least for the first year to determine the suitability. If there are occurrences of any flooding, then a new pump start elevation would need to be investigated and implemented.

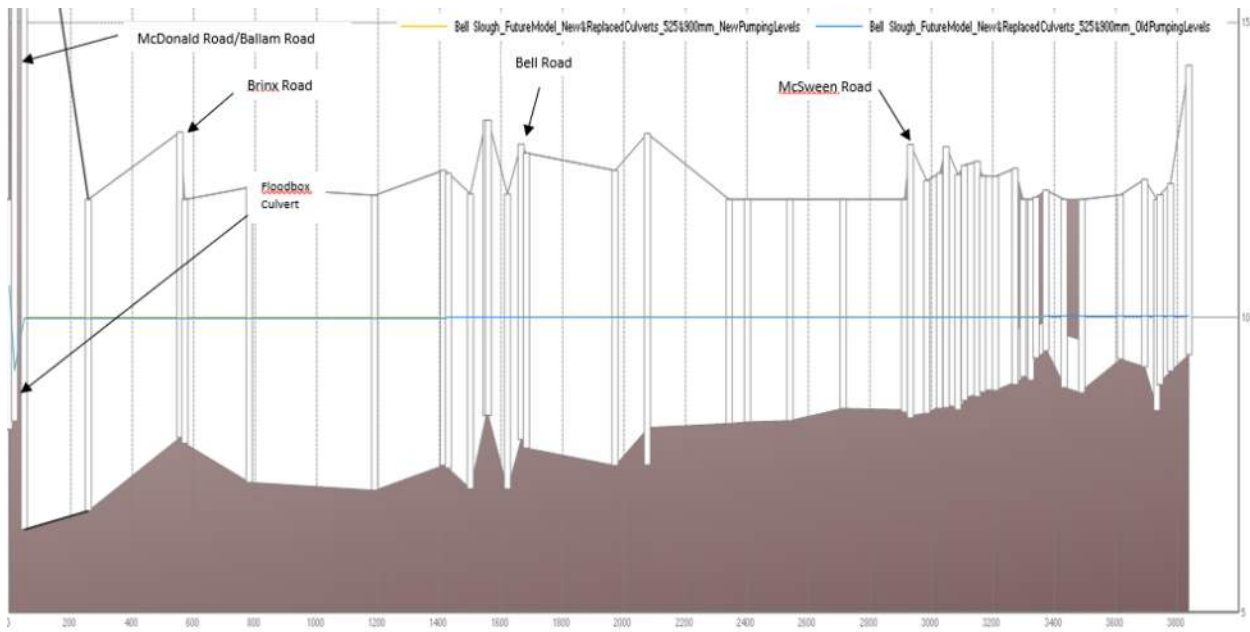
Figure 5-8: HGL Levels Comparison for the 100-year Climate Change Design Storm Event of the Proposed Culverts Model with Existing (Blue HGL) and Proposed Pump Start Levels (Yellow HGL)

Figure 5-8 illustrates the HGL levels of the existing against the proposed pump start levels if there were no physical conveyance barriers throughout the slough (i.e., no damaged culverts, culverts installed at blocked private driveways, etc.). It was noted that the pump start stop levels have a minimal impact on the slough water levels.

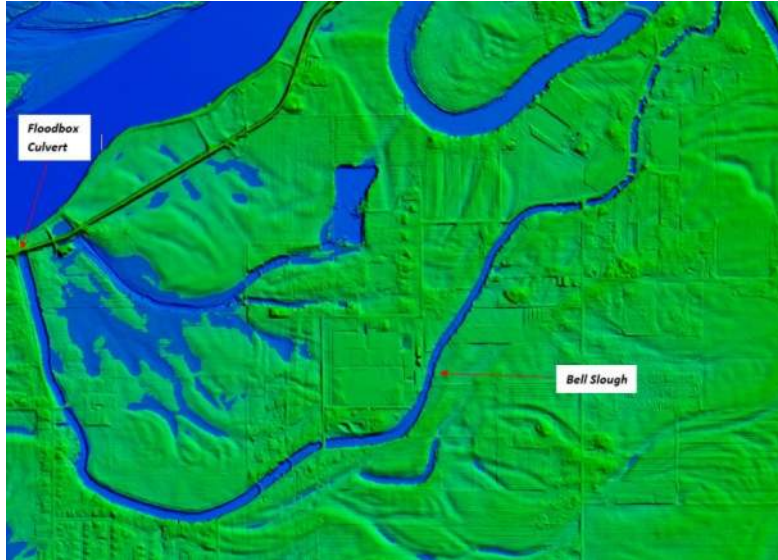
Figure 5-9: Water Level in the Bell Slough and Surrounding area at 10.15 m Elevation

If Floodbox Closure Trigger Elevation (m)...	Then Bell Slough Maximum Water Level (m) =
8.70	9.87
8.80	9.89
8.90	9.93
9.00	9.98
9.10*	10.04
9.20	10.09
9.30	10.17
9.40	10.24
9.50	10.32
*Recommended floodbox open-close water level.	
Note: Pumping from the slough occurs during the modelling analysis

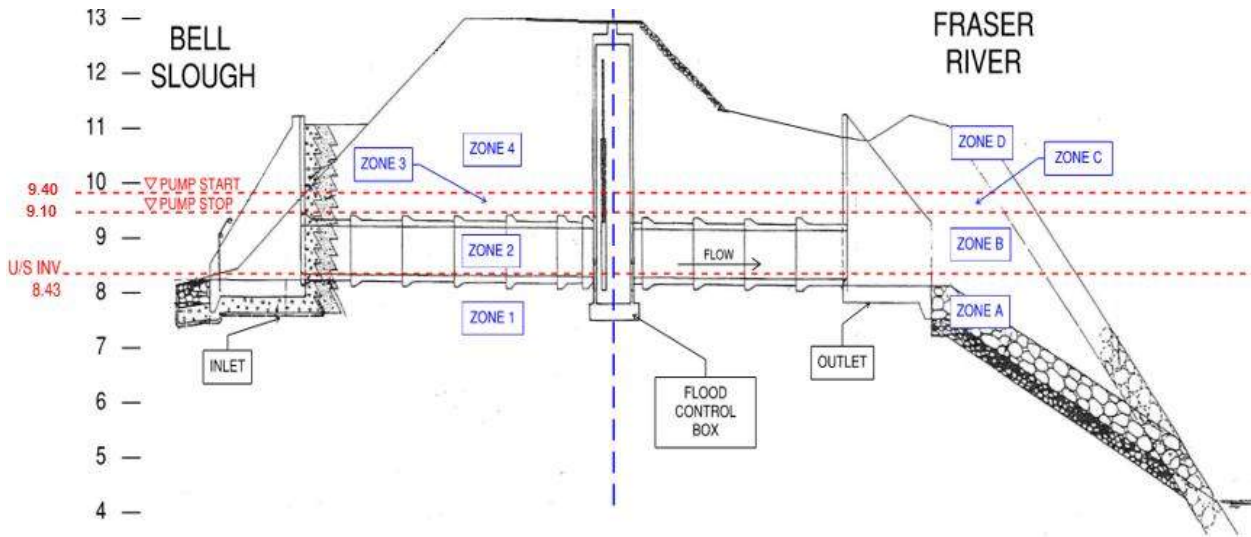
Figure 5-10: Pump and Floodbox Gate Operational Zones

Table 5.3 uses the zones in that figure to indicate the recommended operation of the gate and pump for various combinations of water levels.

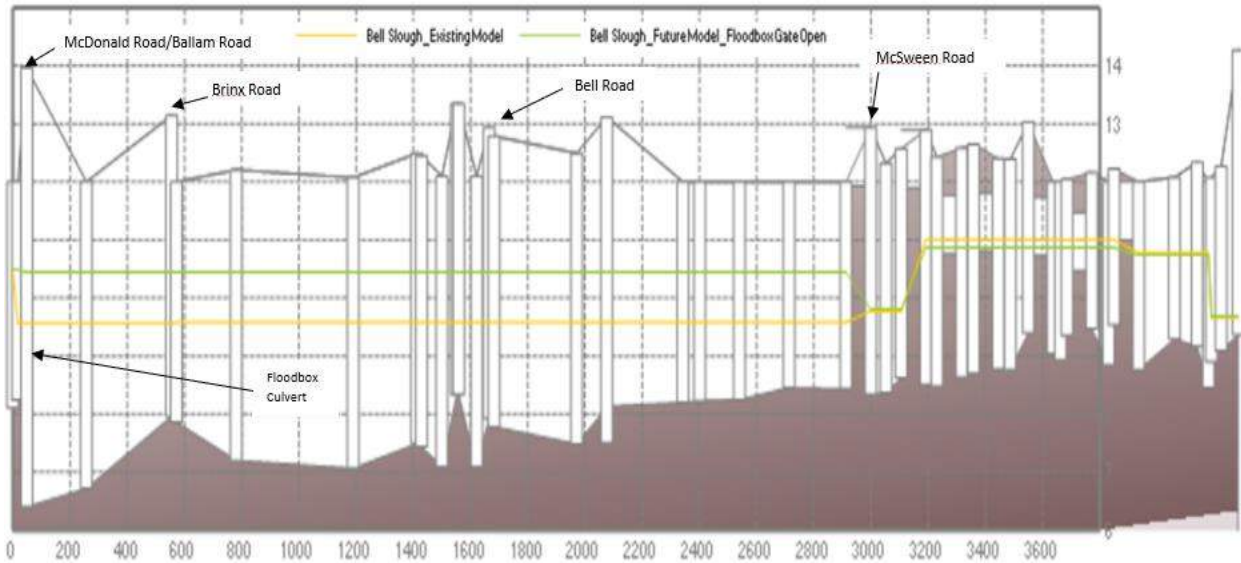
Figure 5-11: HGL Level Comparison for the 100-year Climate Change Design Storm Event of the Floodbox Remaining Open During the 100-year+20% (Green HGL) with the Existing Conditions Model (Yellow HGL)

However, with this scenario, the model indicated occurrences of potential flooding around the downstream end of the slough due to the backflow of water from the Fraser River. Therefore, to move forward with this option, a levee would be needed along the slough to hold the water during the major storm events, however this would create complications with land drainage, perhaps requiring additional flap gates. During the modelling analysis, to determine the maximum water levels within the slough while keeping the floodbox gate open, the maximum witnessed water level (9.743m between 2014-2022) within the Fraser River was chosen as the downstream water level for the Bell Slough to account for the maximum backflow possible.

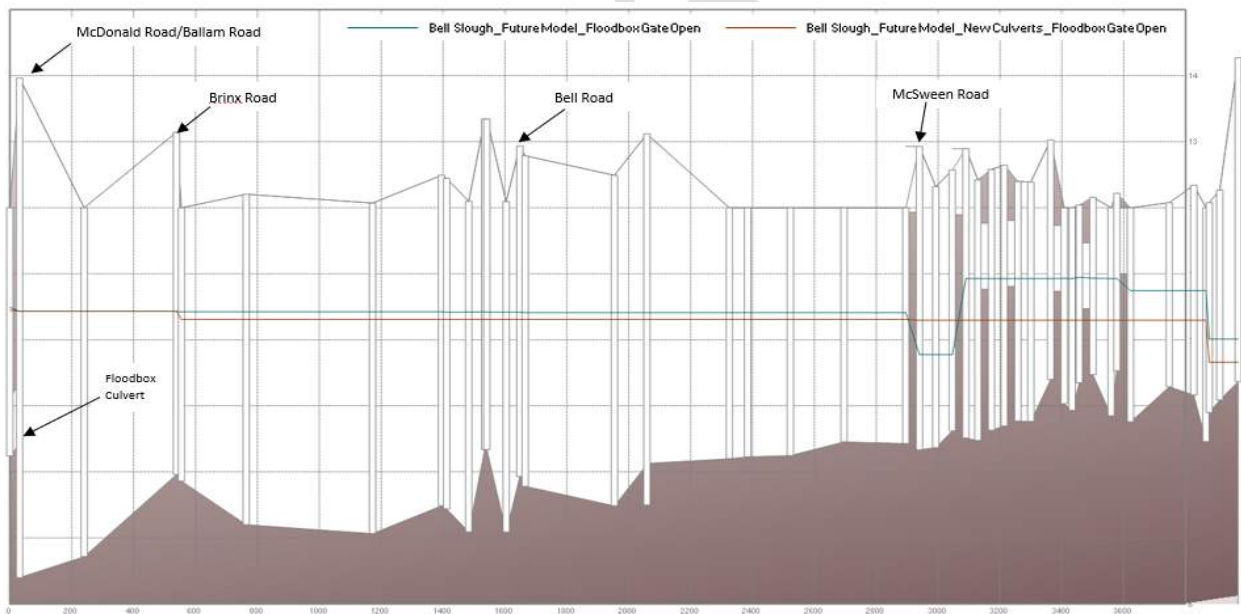
Figure 5-12: HGL Level Comparison for the 100-year Climate Change Design Storm Event for the Floodbox Remaining Open With (Brown HGL)/Without (Green HGL) the New Culvert Scenario

Figure 5-12 depicts the comparison of the modelling scenario in which the floodgates remain open during the major storm events. The red line depicting the water levels for the recommended new culverts option within the Bell Slough system and the green line depicts the HGL levels without the recommended culverts.

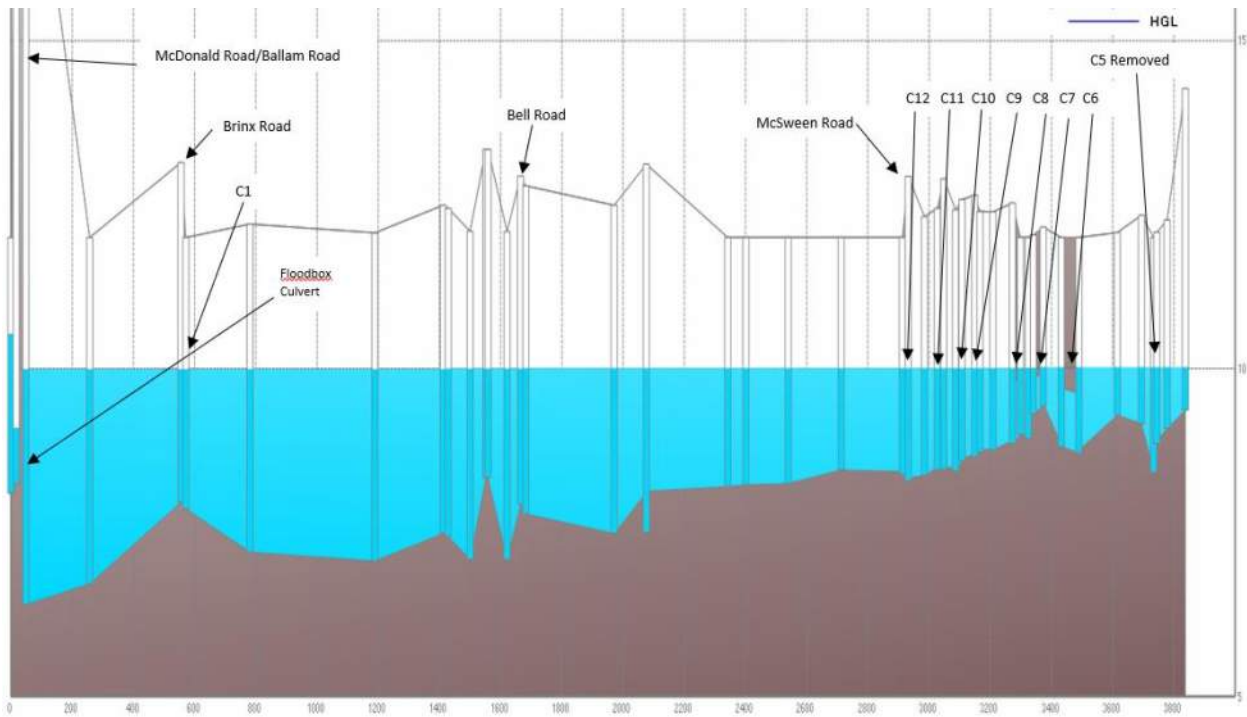
Figure 6-1: HGL levels of the Recommended Model for the 100-year Climate Change Design Storm Event

It is important to note that the aerial extent for flooding shown on the images in the report reflects flooding from surrounding channels and sloughs as well and not just the Bell Slough. The aerial figures represent illustration of the flooding level and in no case represent the modelled results. Therefore, caution needs to be taken in evaluating the flooding extent at different elevations from the imagery.

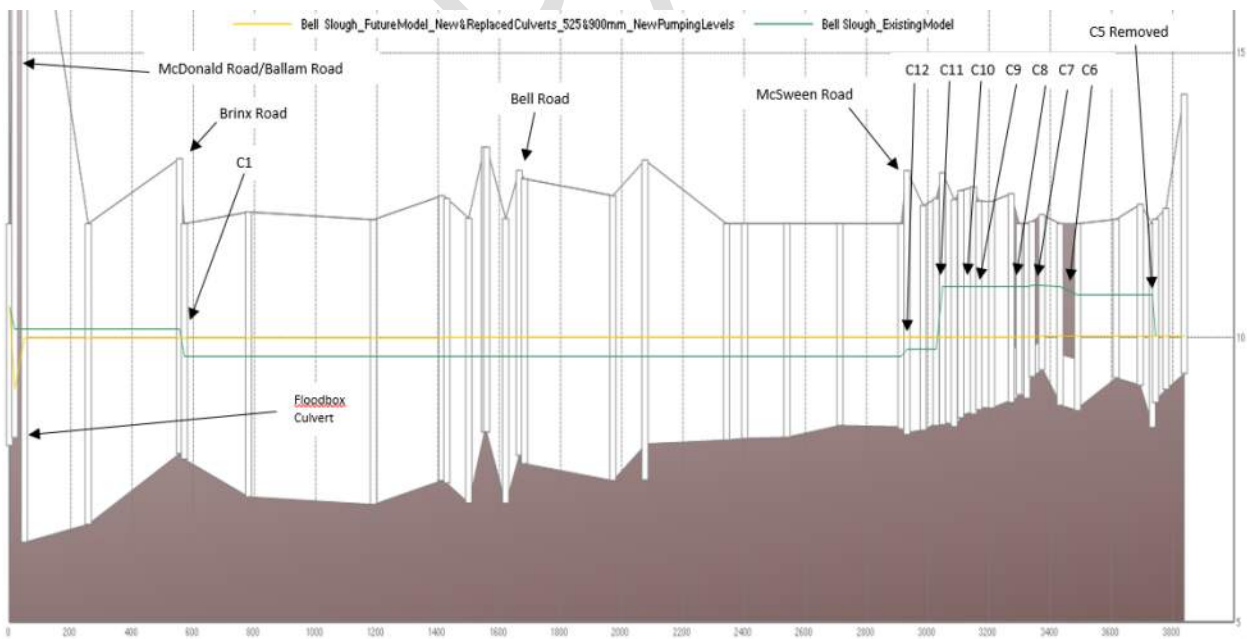
Figure 6-2: Water Level Comparison for the 100-year Climate Change Design Storm Event of the Recommended Conditions Model (Green HGL) with the Existing Conditions Model (Yellow HGL)

As per the 100-year hydraulic model scenario (inclusive of climate change), the model results indicates that the water level remain contained within the slough and the model does not show flooding of the surrounding properties assuming that all proposed culverts have been installed at the recommended elevations. **Figure 6-1** and **Figure 6-2** illustrates that the water levels within the slough on the downstream end have increased from the existing conditions with a maximum HGL level of 9.99m (**Figure 6-3**). Thus, leading to more water retained in the slough and promoting better habitat conditions. Furthermore, on the upstream end of the slough the connectivity is significantly improved with the insertion of culverts on existing roadways/ driveways with the maximum HGL level of 10.02m (See **Figure 6-3**). Overall, with these proposed operations, the HGL for the water levels is more consistent throughout the slough.

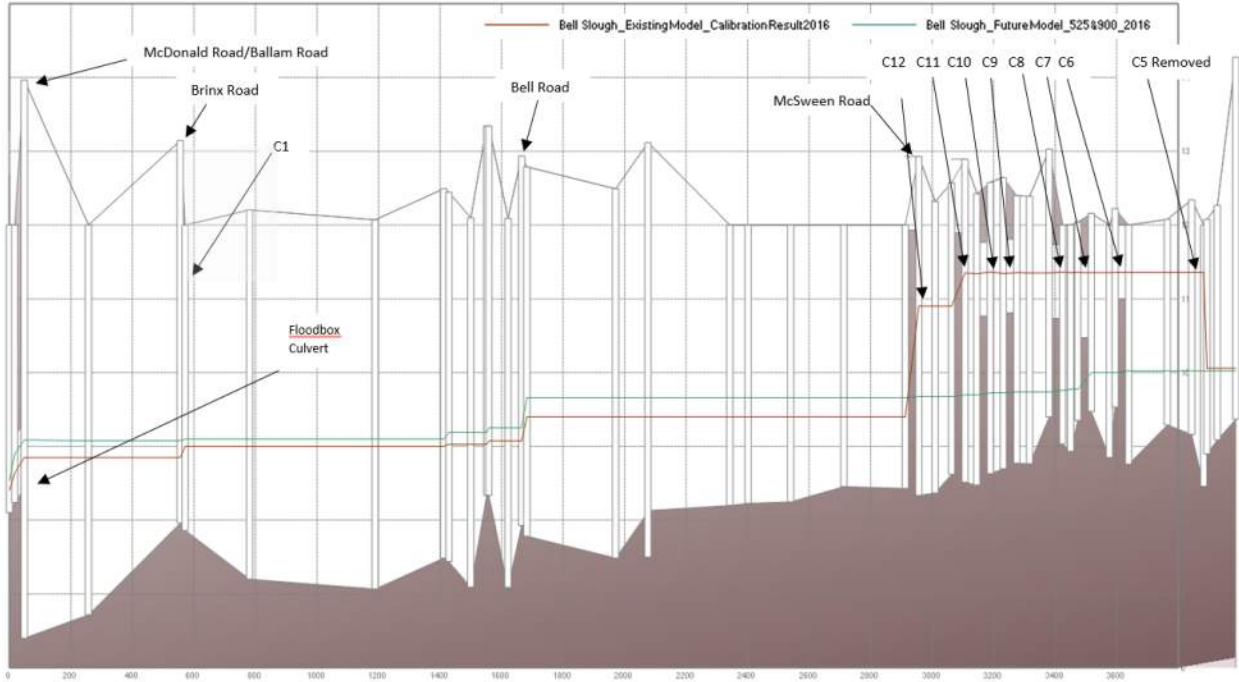
Figure 6-4: HGL Level Comparison for the Year 2016 Storm Event of the Calibrated Model (Brown HGL) with the Recommended Model (Green HGL)

Figures 6-4 to 6-9 provides comparison of the model simulation results for the existing and proposed upgraded Bell Slough system for year 2016 and 2020 rainfall. As can be seen in the **Figures 6-4** and **6-7**, for the existing system during the years 2016 & 2020 rainfall events, the HGLs are significantly higher at the upstream part of the Slough mainly due to the lack of connectivity resulting in instances of overtopping of the roadway/driveway crossings of the Slough. With the improved connectivity, i.e. recommended culvert upgrades, the upgraded system HGLs are lower in the upstream part of the system resulting in consistent level within Bell Slough. **Figures 6-5** and **6-8** illustrates the water levels upstream of the Floodbox Culvert for the year 2016 and 2020, respectively. As expected for the upgraded system, the HGLs are higher in the downstream end of system due to improved connectivity within the upstream part of the system.

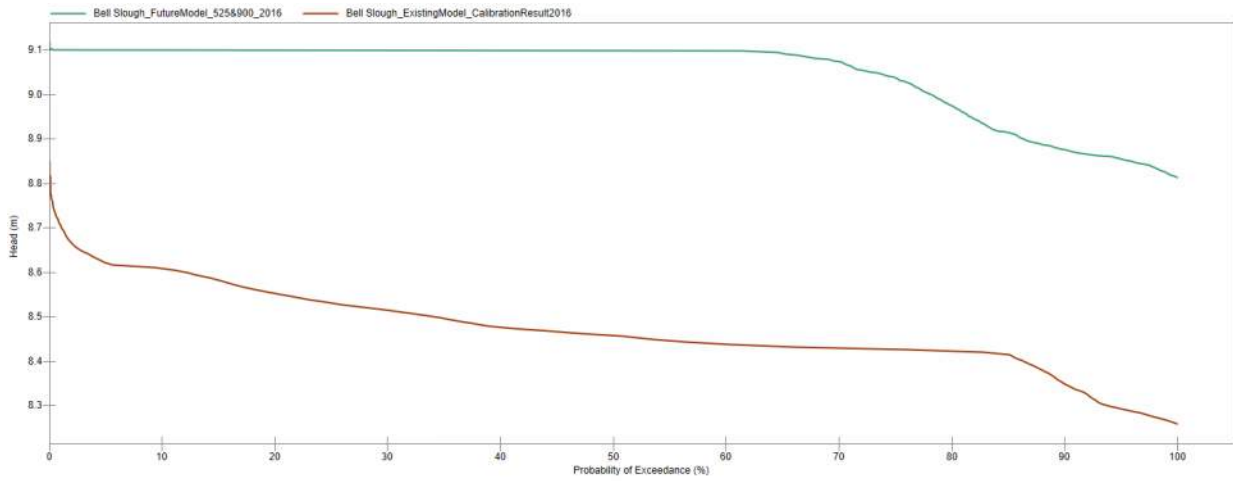
Figure 6-6: Duration-Exceedance (%) Comparison based on the Head Level for the Year 2016 Storm Event at the most downstream point of the Bell Slough (close to the Floodbox Culvert) of the Calibrated Model (Brown HGL) with the Recommended Model (Green HGL)

level was above 9.1m, 60% of the year it was around 9.1m, and 20% of the year the water level was below 9.1m.

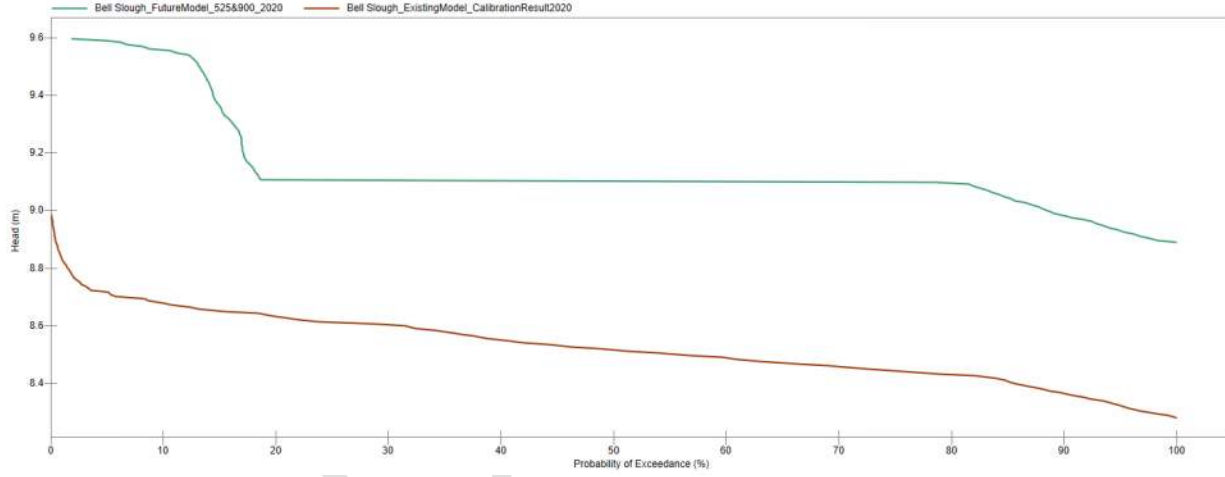
Figure 6-9: Duration-Exceedance (%) Comparison based on the Head Level for the Year 2020 Storm Event at the most downstream point of the Bell Slough (close to the Floodbox Culvert) of the Calibrated Model (Brown HGL) with the Recommended Model (Green HGL)

Figures 6-6 and 6-9 are duration-exceedance plots, representing the percentage of time that the water level at the downstream end of the Bell Slough is above any given level for the existing and the proposed upgraded systems under the 2016 and 2020 rainfall, respectively. It can be seen that the recommended upgrades scenario (green line) results in higher water levels than under the existing infrastructure scenario. During the dry year, 9.1m was the maximum water level and the Slough maintained this water level for about 65% of the year. During 2020 (the wet year), the peak water level was 9.6m. 20% of the time the

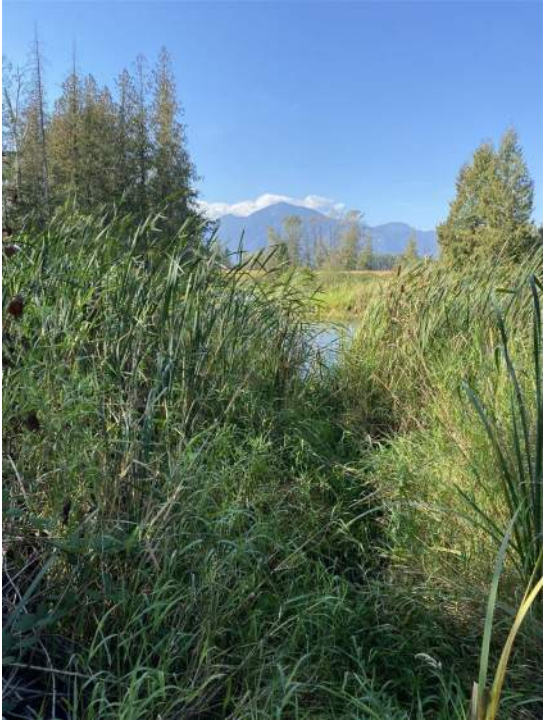
Client:	City of Chilliwack	Project:	Bell Slough Feasibility Study
Site Name:	Bell Slough	Site Location:	Chilliwack, British Columbia
Photograph ID: 1

Photo Location: Upstream extent of the Bell Slough			
Direction: Facing upstream			
Survey Date: 9/22/2022			
Comments: No connectivity observed between the Bell Slough and Camp-Nelson Slough.			
Photograph ID: 2

The farthest upstream portion of the Bell Slough was observed to be dry and largely overgrown with dense vegetation (**Appendix A:** Photos 1, 2). During the field visits, a caved-in 600 mm wooden culvert and flap gate (preventing flows from entering from the Camp-Nelson Slough) was discovered at the tie in between the Bell Slough and the Camp-Nelson Slough (**Appendix A:** Photo 3).

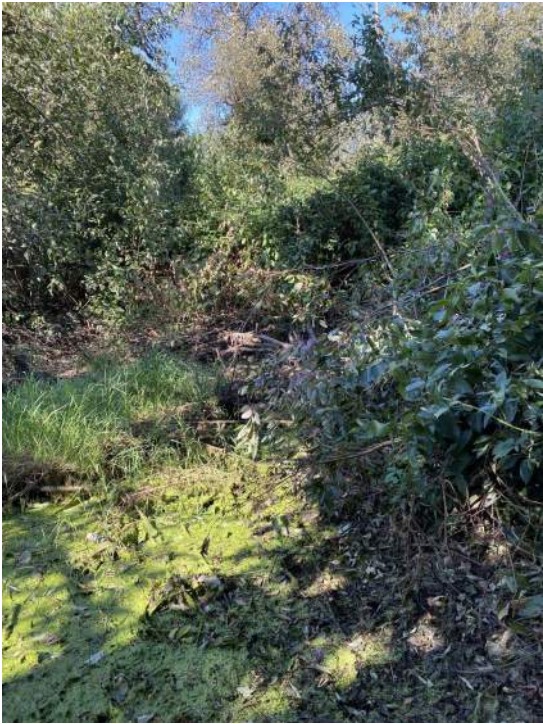
Photo Location: Upstream extent of the Bell Slough			
Direction: Facing downstream			
Survey Date: 9/22/2022			
Comments: Dense vegetation growing in and around the channel. Himalayan blackberry present.

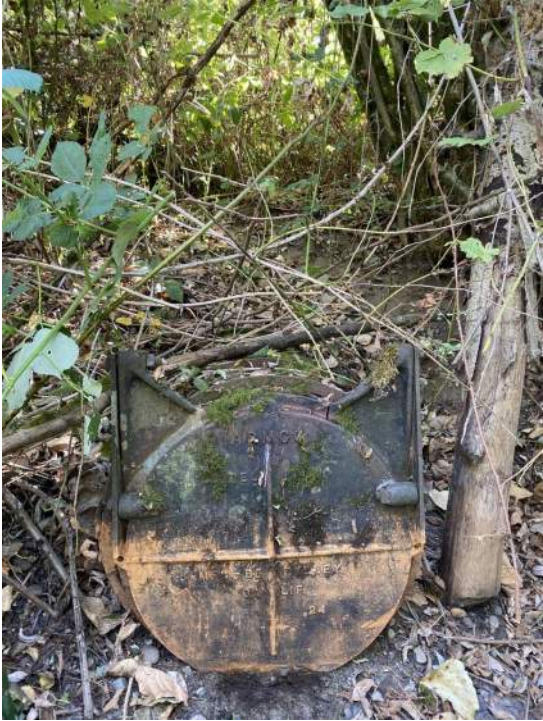
Photo Location: Upstream extent of the Bell Slough			
Direction: Facing downstream			
Survey Date: 9/22/2022			
Comments: Existing Damaged and Non-Functioning 600mm Wooden Culvert			
Photograph ID: 4

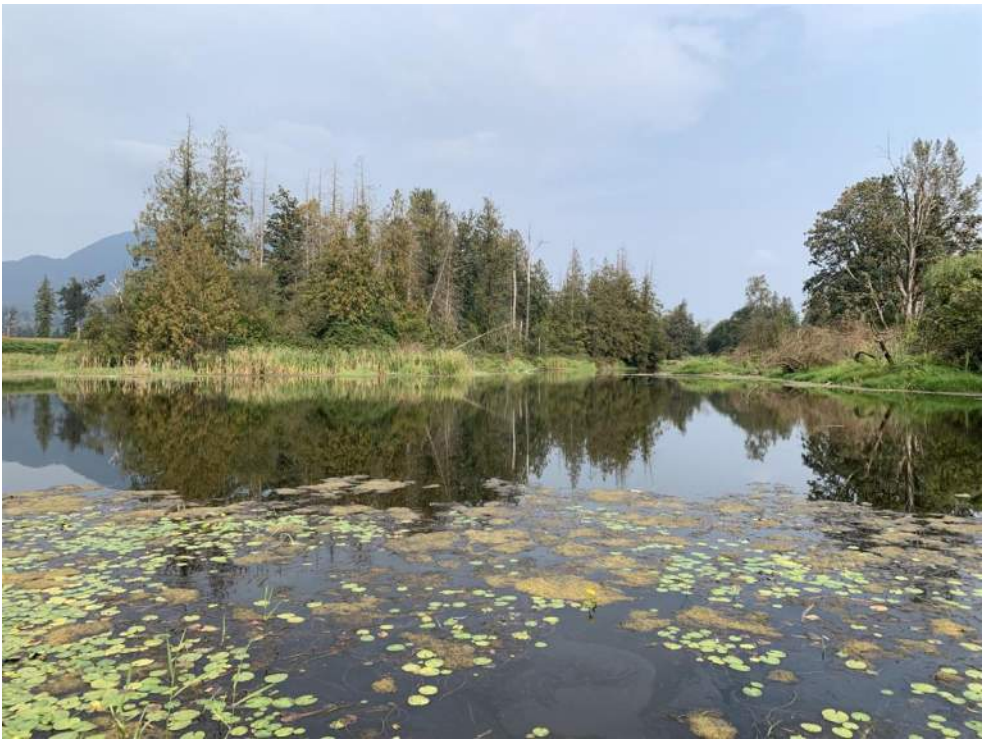
Client:	City of Chilliwack	Project:	Bell Slough Feasibility Study
Site Name:	Bell Slough	Site Location:	Chilliwack, British Columbia
Photograph ID: 5

Photo Location: Camp-Nelson Slough upstream of the McSween Road culvert			
Direction: Facing upstream			
Survey Date: 9/14/2022			
Comments: Riparian vegetation includes a mix of water tolerant species and canoping forming large trees.

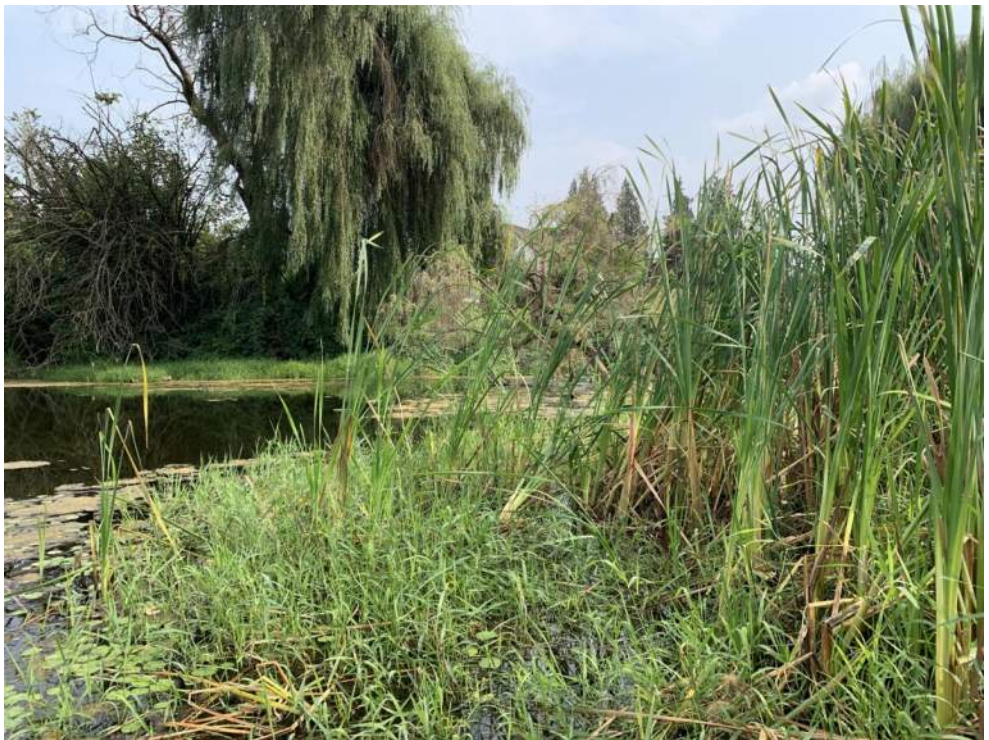
Photo Location: Camp-Nelson Slough upstream of the McSween Road culvert			
Direction: Facing upstream			
Survey Date: 9/14/2022			
Comments: Cattails and rushes surround the fringe of the slough.			
Photograph ID: 6

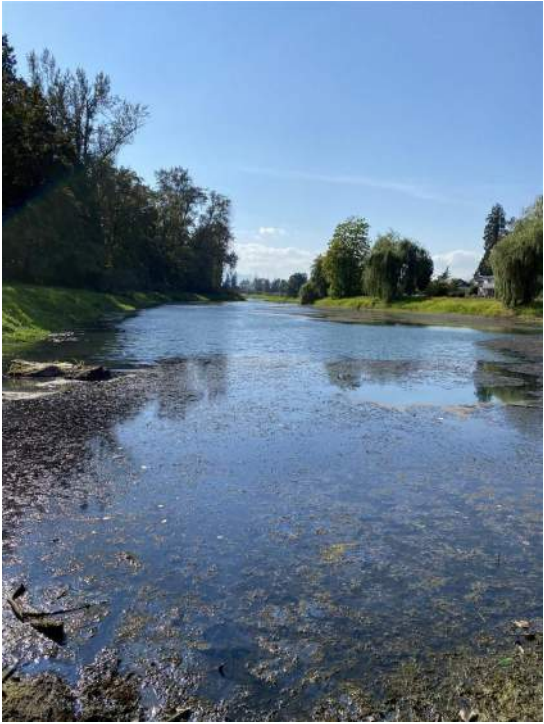
Photo Location: Camp-Nelson Slough downstream of the McSween Road culvert			
Direction: Facing downstream			
Survey Date: 9/14/2022			
Comments: Open water with patches of lilies. Tall trees present for crown closure.

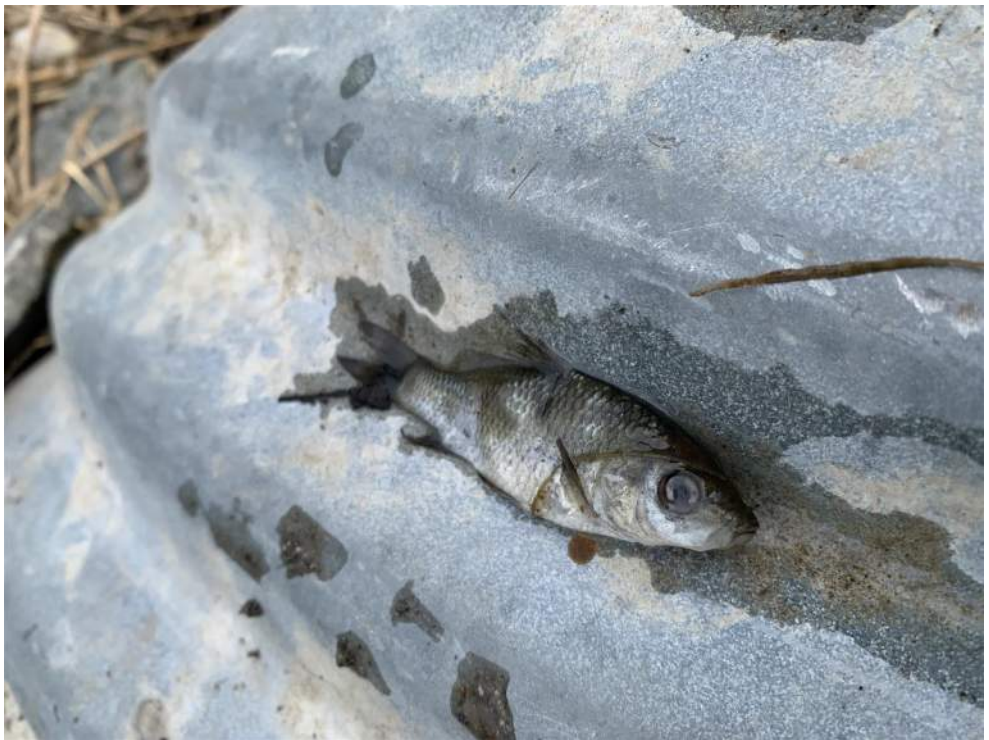
Photo Location: Camp-Nelson Slough downstream of the McSween Road culvert			
Direction: Facing down			
Survey Date: 9/14/2022			
Comments: Dead juvenile carp (exotic species) found at outflow of culvert.			
Photograph ID: 8

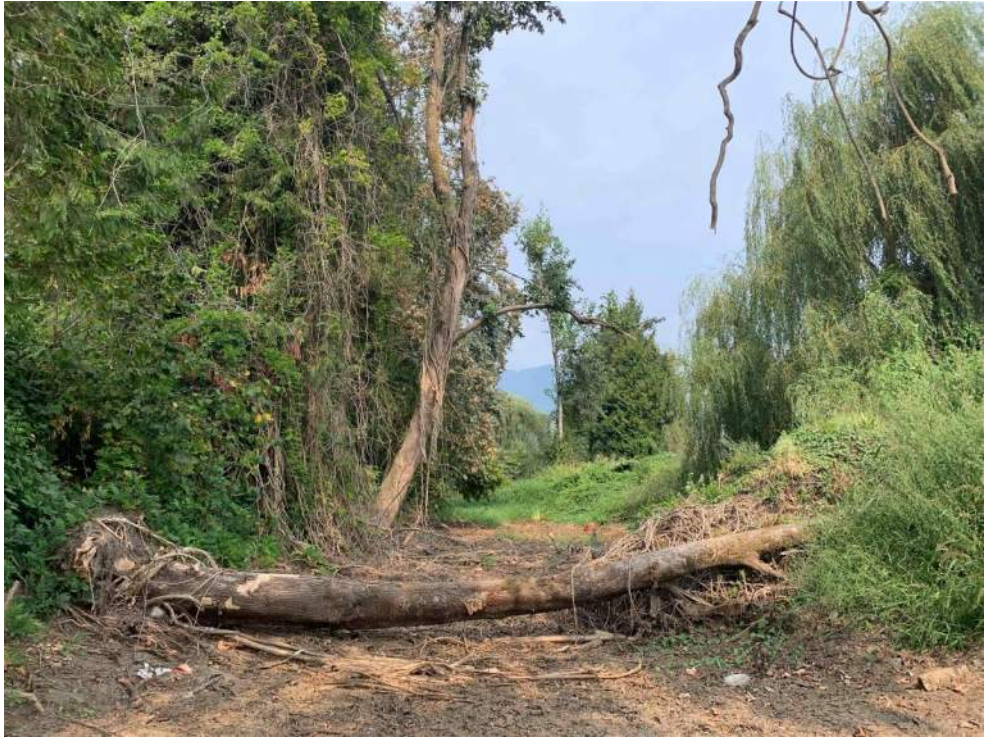
Photo Location: Midstream Bell Slough at McSween Road			
Direction: Facing upstream			
Survey Date: 9/14/2022			
Comments: Dry with large woody debris and crown closure.

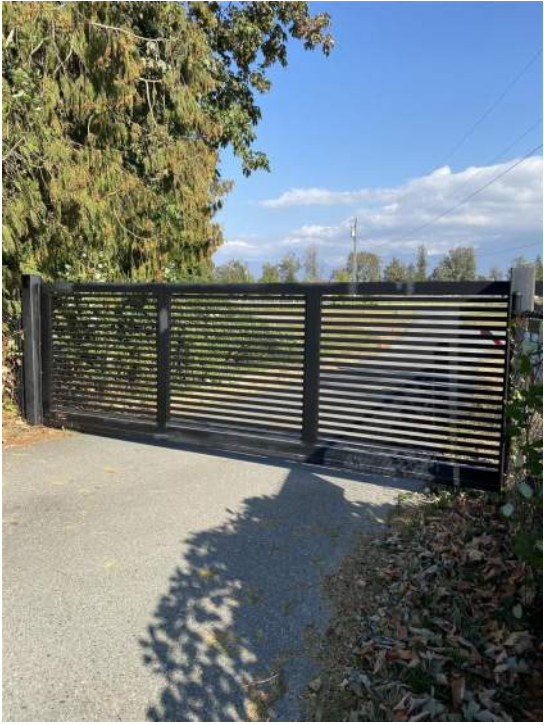
Photo Location: Midstream Bell Slough at McSween Road	
Direction: Facing cross-stream	
Survey Date: 9/22/2022	
Comments: Private driveway is without culvert.

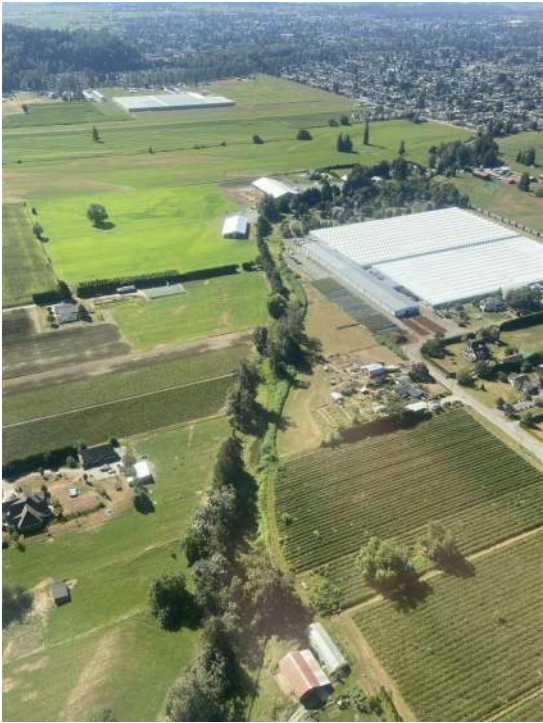
Photo Location: Midstream Bell Slough between McSween Road and Bell Road crossing			
Direction: Facing downstream from aerial perspective			
Survey Date: 9/7/2022			
Comments: Dry channel bed with tall canopy coverage in riparian habitat.			
Photograph ID: 14

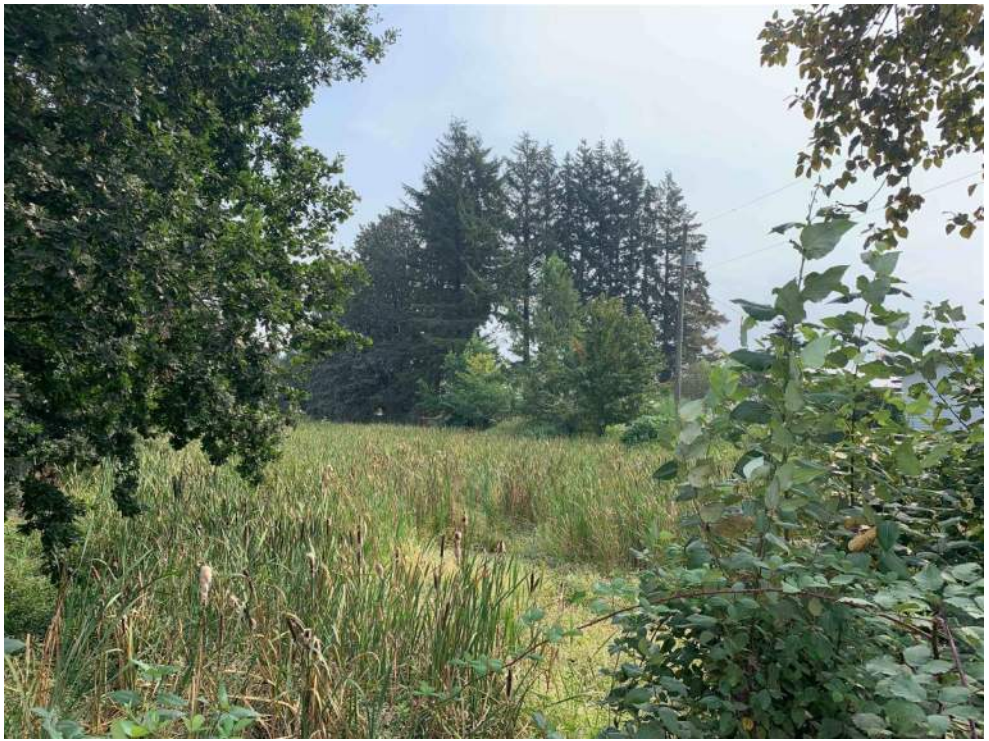
Photo Location: Midstream Bell slough upstream of Bell Road crossing			
Direction: Facing upstream from Bell Road access			
Survey Date: 9/14/2022			
Comments: Cattails present in wetland area and tall trees in riparian habitat.

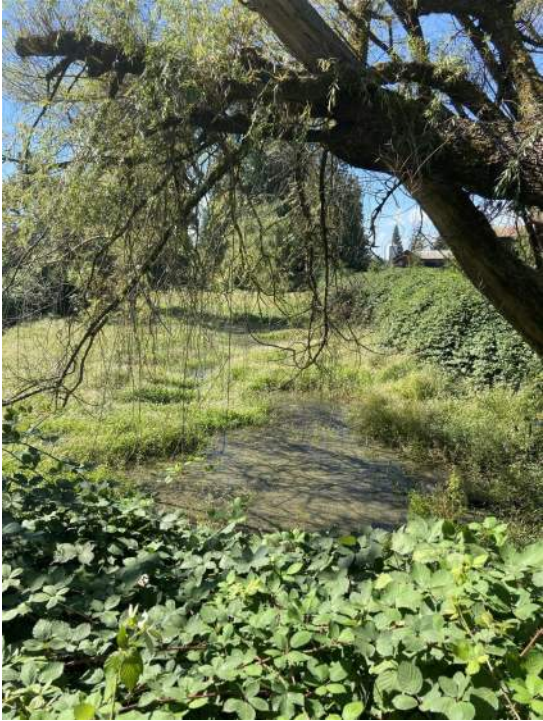
Photo Location: Midstream Bell Slough at Bell Road crossing			
Direction: Facing downstream from Bell Road			
Survey Date: 9/7/2022			
Comments: Himalayan blackberry bushes and large trees line the banks of the slough. Smartweed mats float on slough surface.			
Photograph ID: 16

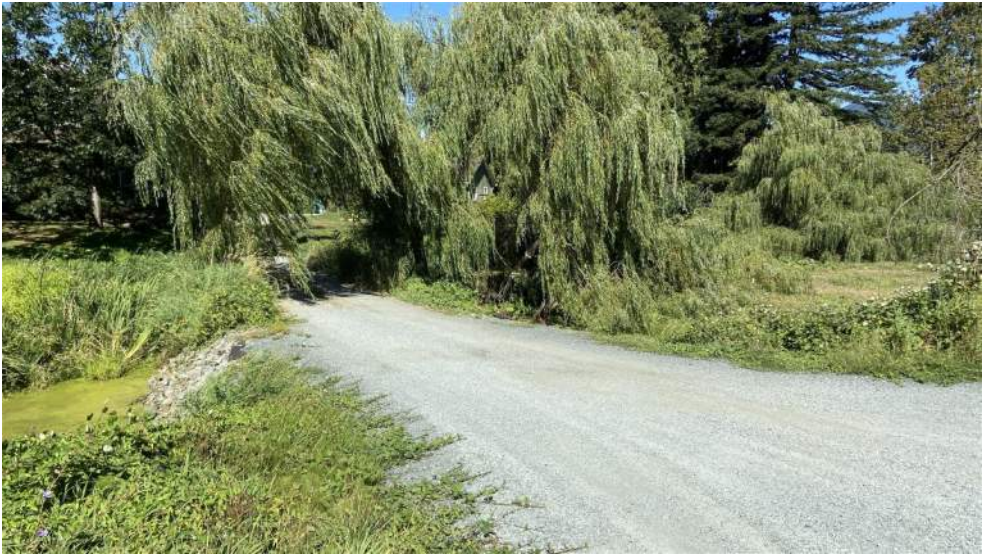
Photo Location: Midstream Bell Slough at Bell Road			
Direction: Facing cross-stream			
Survey Date: 9/7/2022			
Comments: Culverted driveway across slough. Dense riparian vegetation with crown closure on right bank. Himalayan blackberry on road side bank.

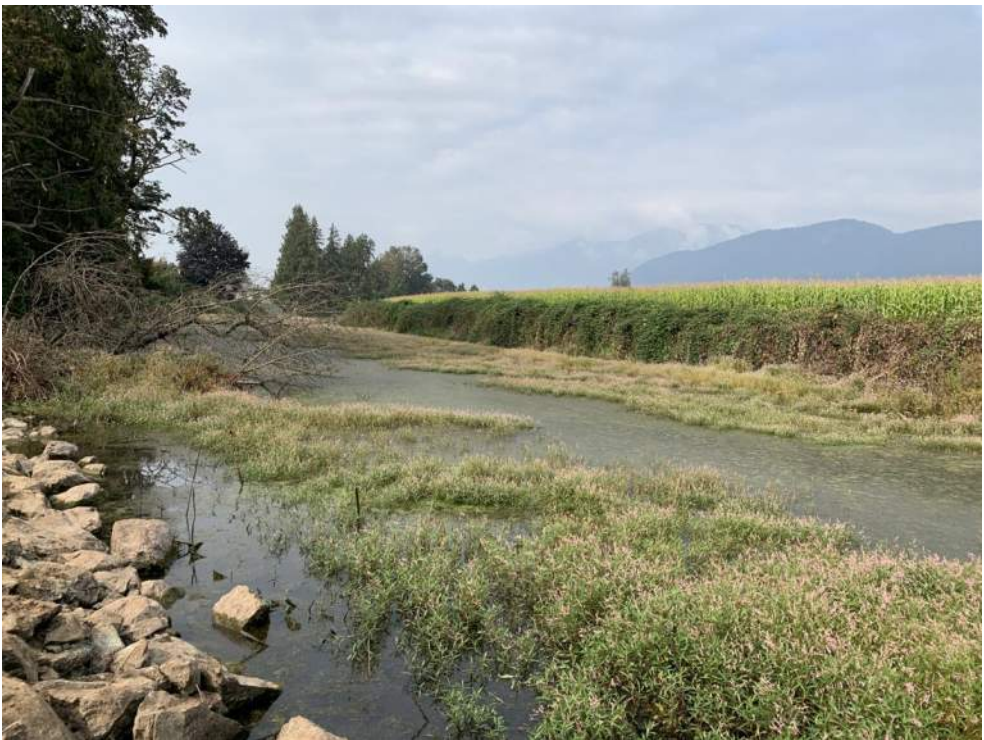
Photo Location: Midstream Bell Slough at Bell Road			
Direction: Facing downstream			
Survey Date: 9/14/2022			
Comments: Smart weed patches with some open water.			
Photograph ID: 18

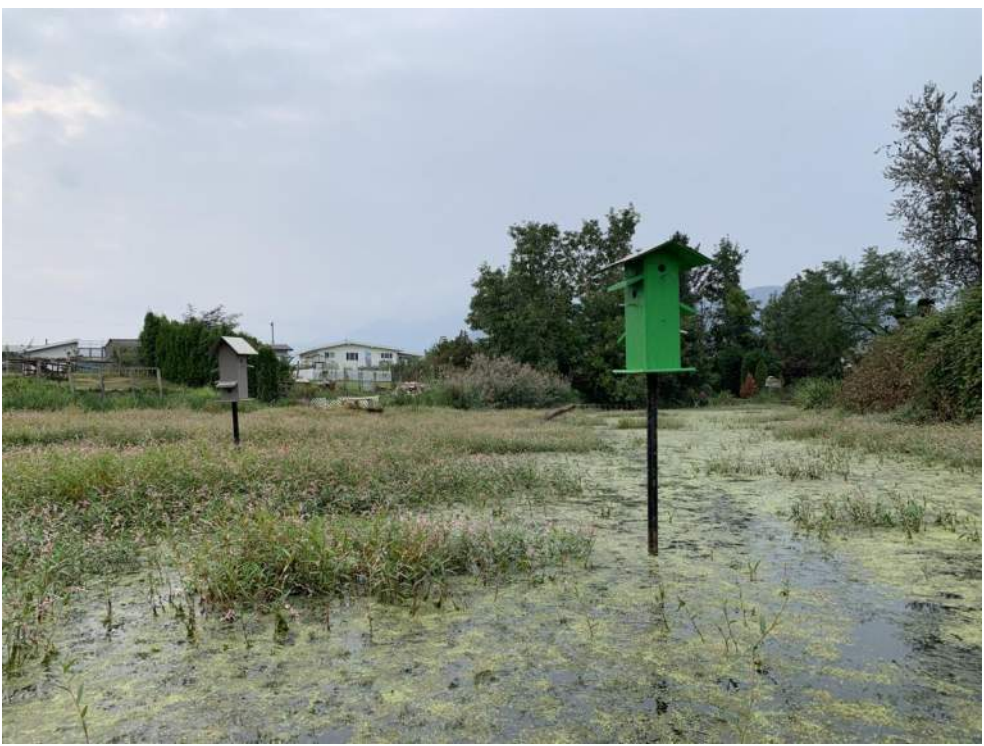
Photo Location: Midstream Bell Slough behind residences of Montana Drive			
Direction: Facing downstream			
Survey Date: 9/14/2022			
Comments: Dense aquatic vegetation mats, floating grass stands, and Himalayan blackberry along right bank. Large trees seen along left bank downstream from photo.

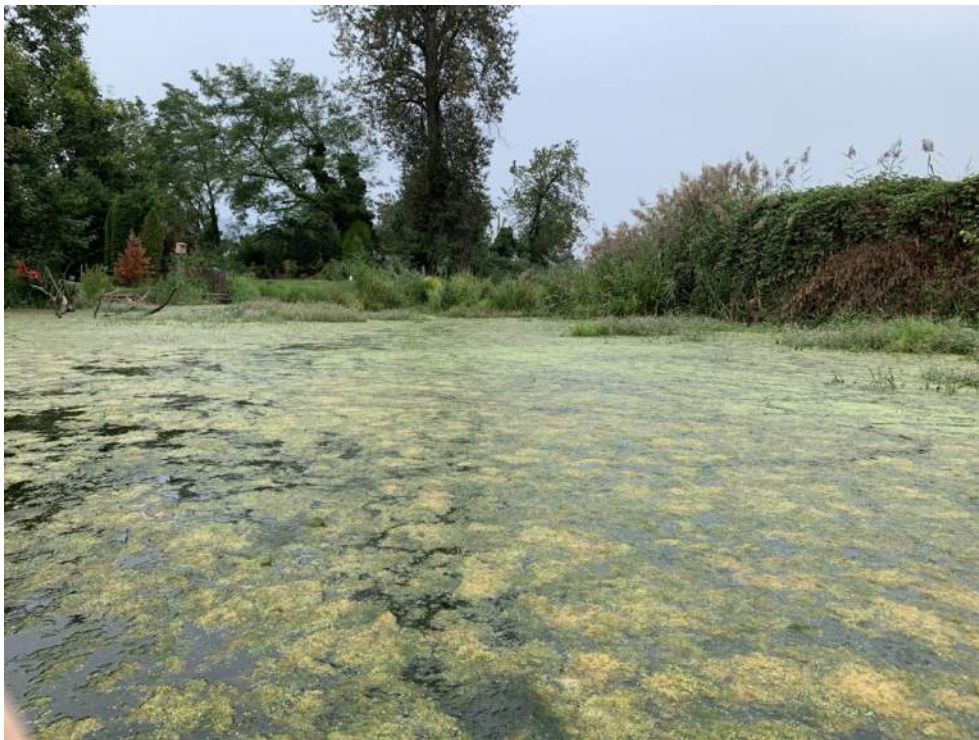
Photo Location: Midstream Bell Slough behind residences of McDonald Road			
Direction: Facing downstream			
Survey Date: 9/14/2022			
Comments: Dense aquatic vegetation mats, floating grass stands and Himalyan blackberry lining right bank. Native riparian vegetation and shade producing trees on left bank.			
Photograph ID: 20

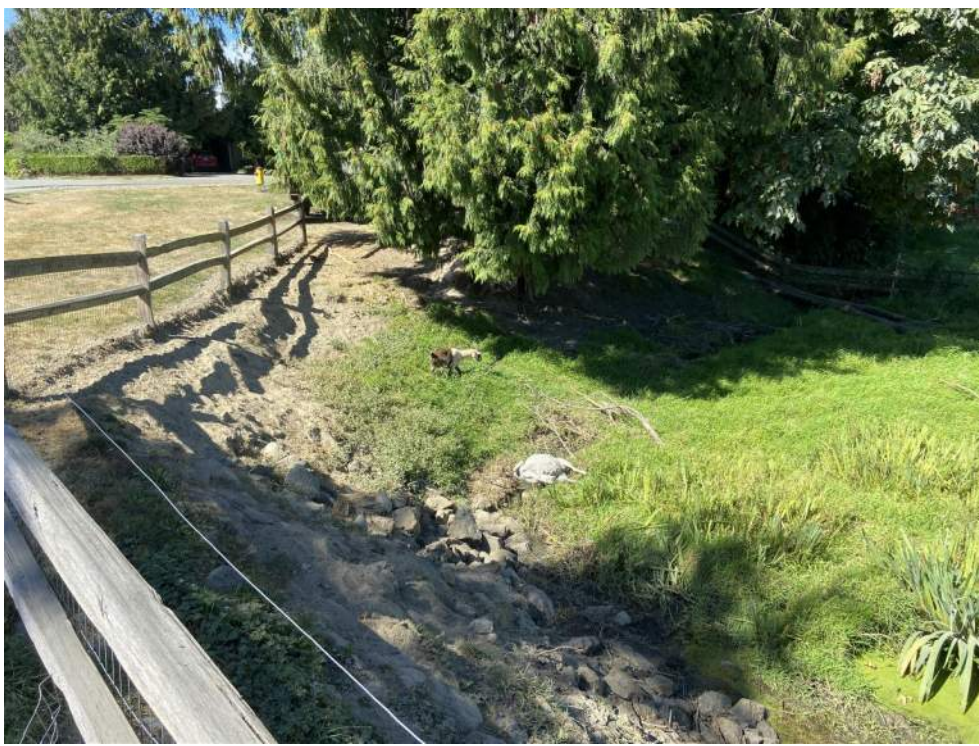
Photo Location: Midstream Bell Slough driveway from McDonald Road			
Direction: Facing down/cross-stream to left bank			
Survey Date: 9/7/2022			
Comments: Goats fenced into riparian habitat surrounding slough.

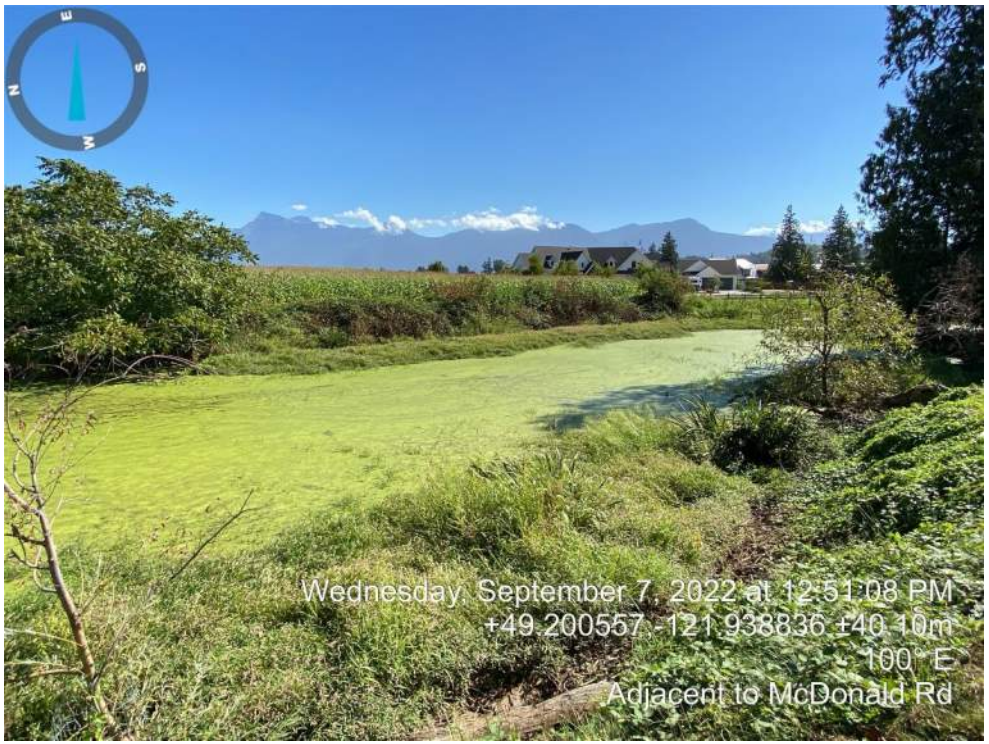
Photo Location: Midstream Bell Slough at McDonald Road	
Direction: Facing up/cross-stream towards right bank	
Survey Date: 9/7/2022	
Comments: Dense aquatic vegetation mat across slough surface.
