**Chilliwack Bell Slough
Improvements Feasibility
Study [Draft]**

Feasibility Study

Prepared for:
City of Chilliwack

Prepared by:
Stantec Consulting Ltd.
500 – 4515 Central Boulevard
Burnaby, BC, V5H 0C6

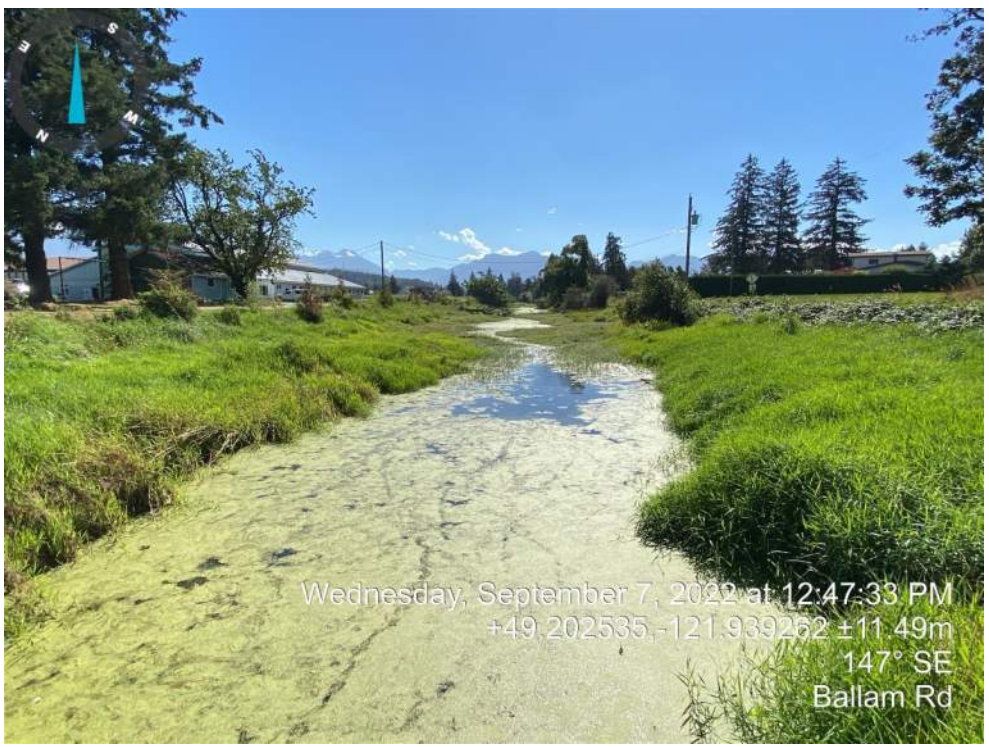
Photo Location: Downstream Bell Slough at Ballam Road crossing	
Direction: Facing upstream	
Survey Date: 9/7/2022	
Comments: Green algal mats across water surface. Reed canary grass on both banks. Efforts on right (facing downstream) bank to plant native vegetation.

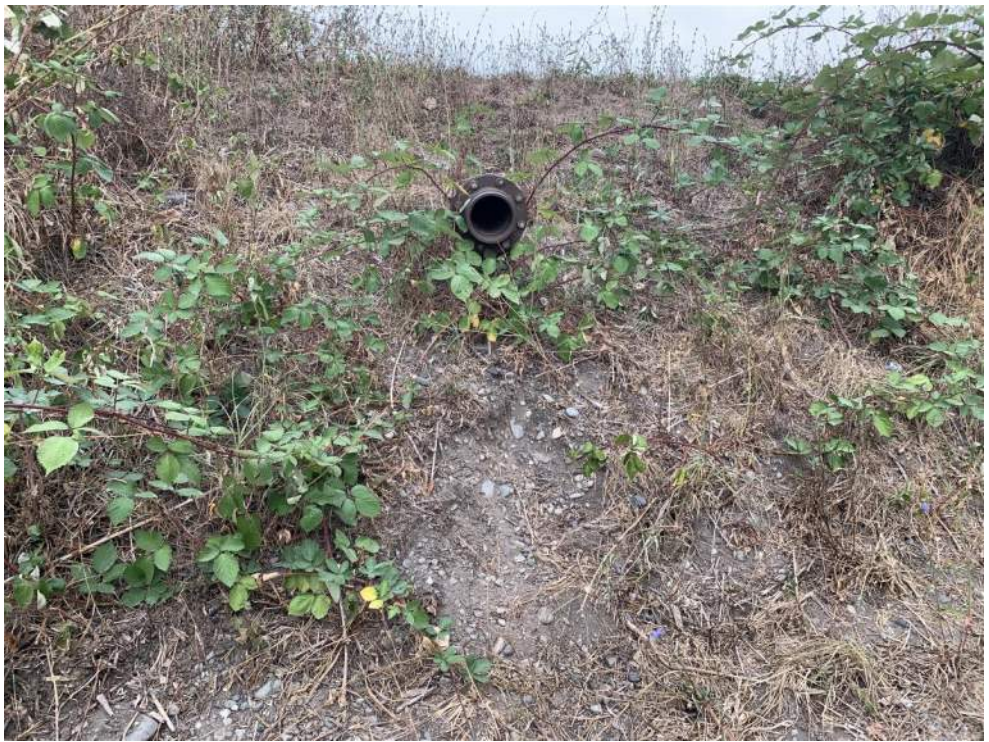
Photo Location: Downstream Bell Slough at Ballam Road crossing			
Direction: Facing downstream			
Survey Date: 9/14/2022			
Comments: Overflow pumpout pipe used under flooding scenarios in slough.			
Photograph ID: 26

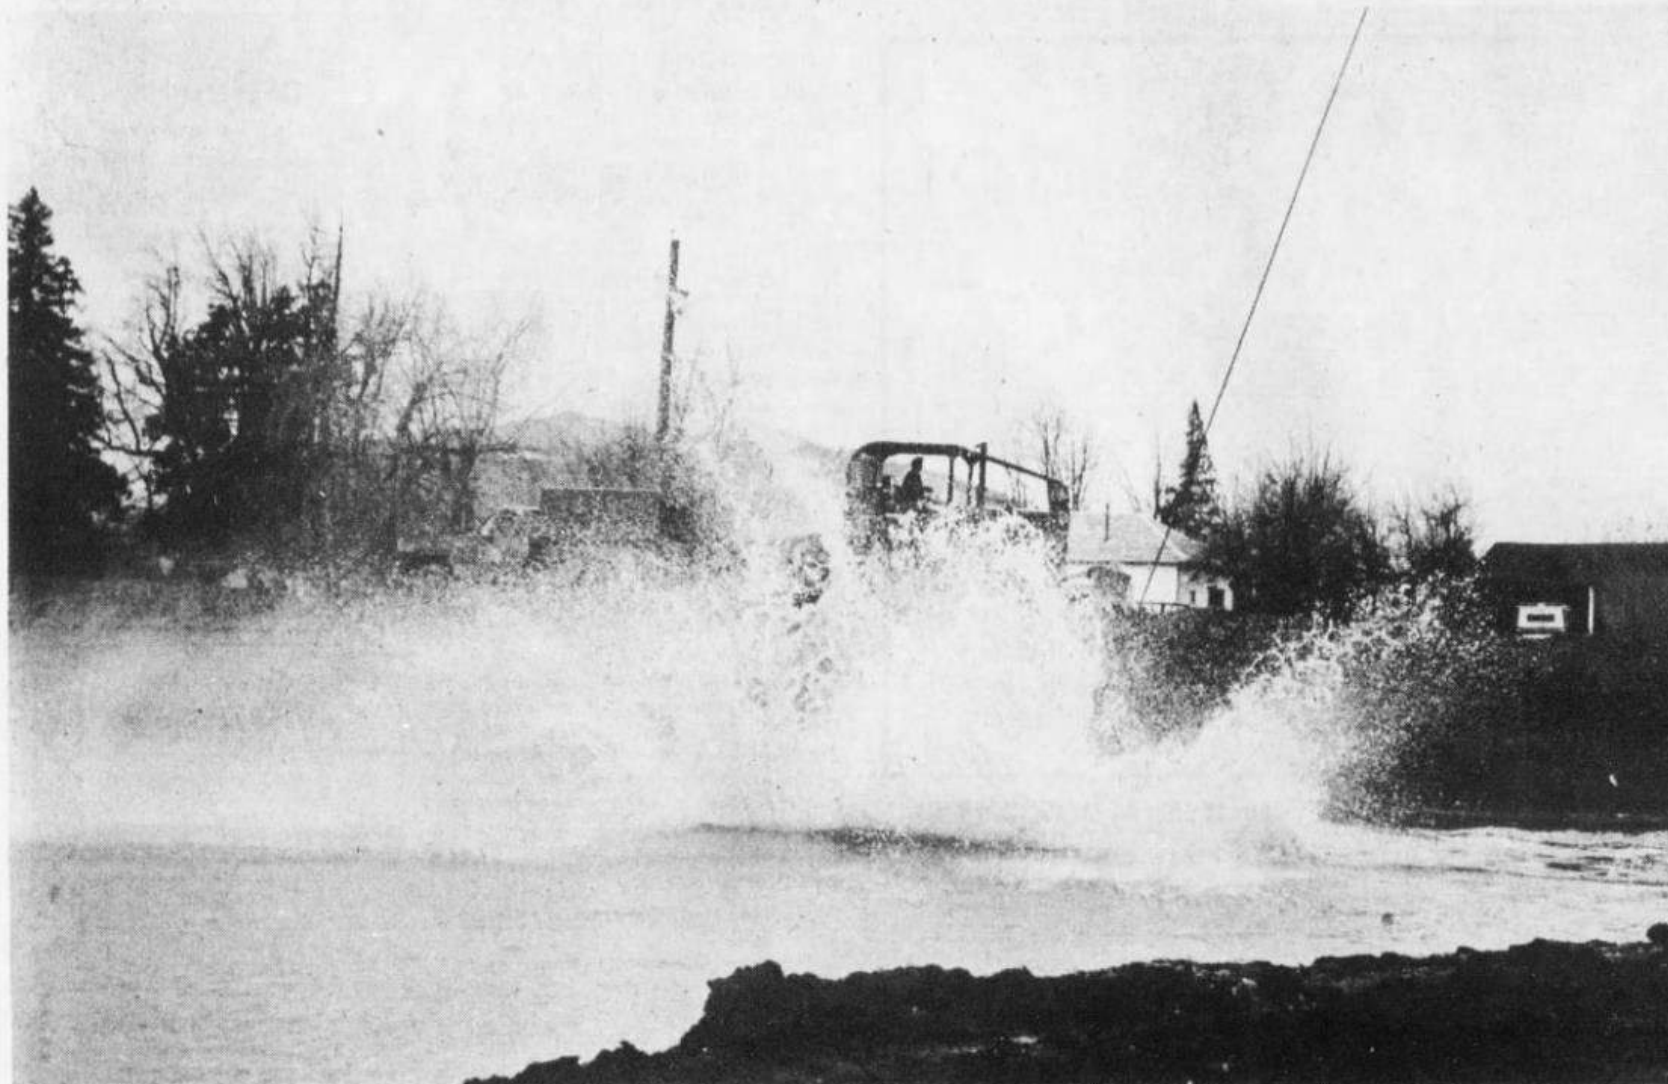
THE DRAG LINE — Canadian Forces Base Chilliwack has supplied the drag line and operators for the Rotary Club's **Bell Slough** project. Work is well under way now and officials are hopeful that the major part of the work will be finished this spring.

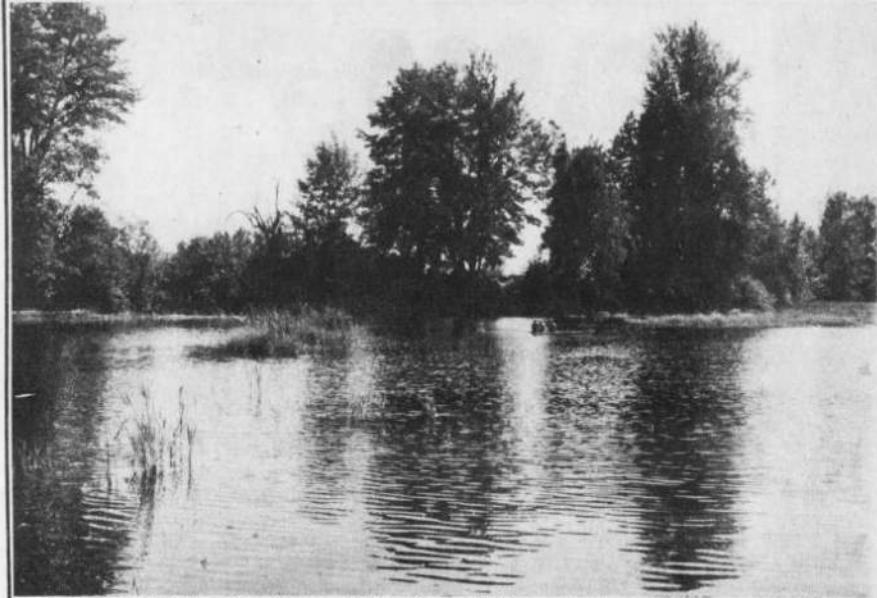
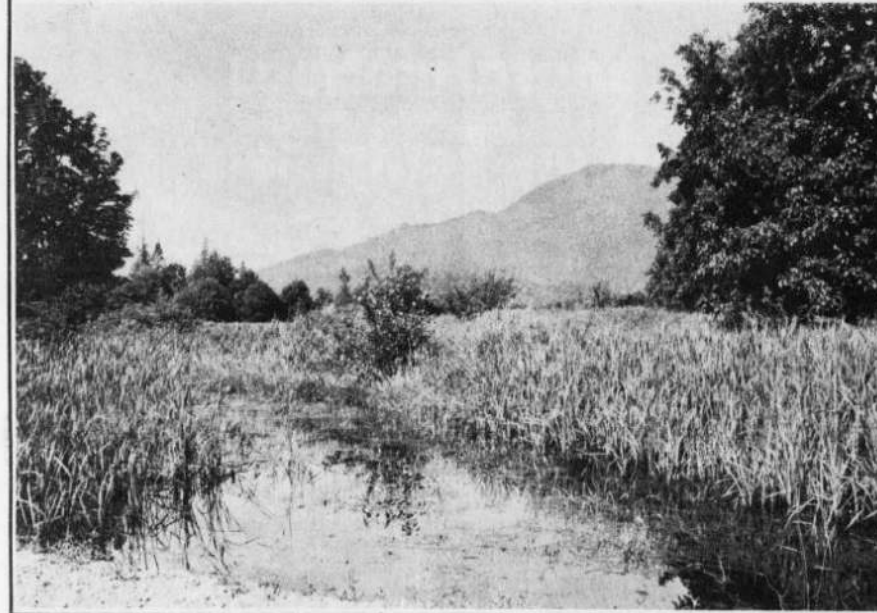
Bell Slough — after and before

BEFORE AND AFTER? — Chilliwack Rotary Club's Bell Slough project is transforming a section of the waterway into a new park and fishing spot. Dredging is complete and the bank work is scheduled to begin soon. Top photo shows part of the recently cleared section. In the bottom photo is the section of the slough immediately across the road from the new park area, giving some indication of the progress made on the slough during the past few months. This site is being considered as the next step in the Rotary project.

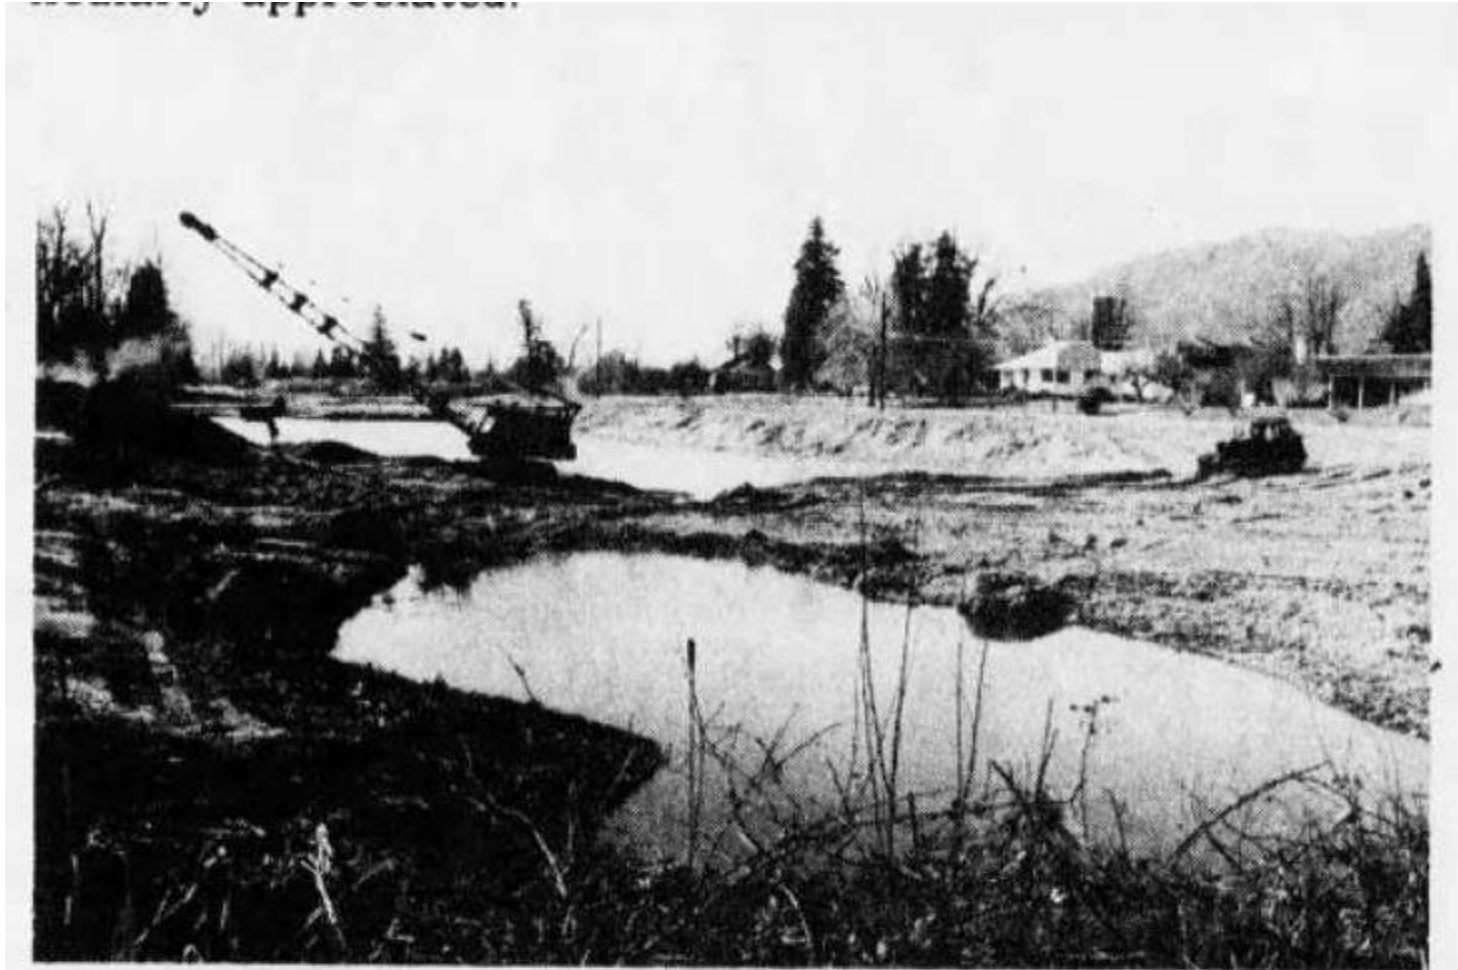
Heavy equipment section of Base Transport shown near completion of the **Bell Slough** project on Fairfield Island. In this project approximately 20,000 cubic yards of material were moved to make way for a senior citizens park.

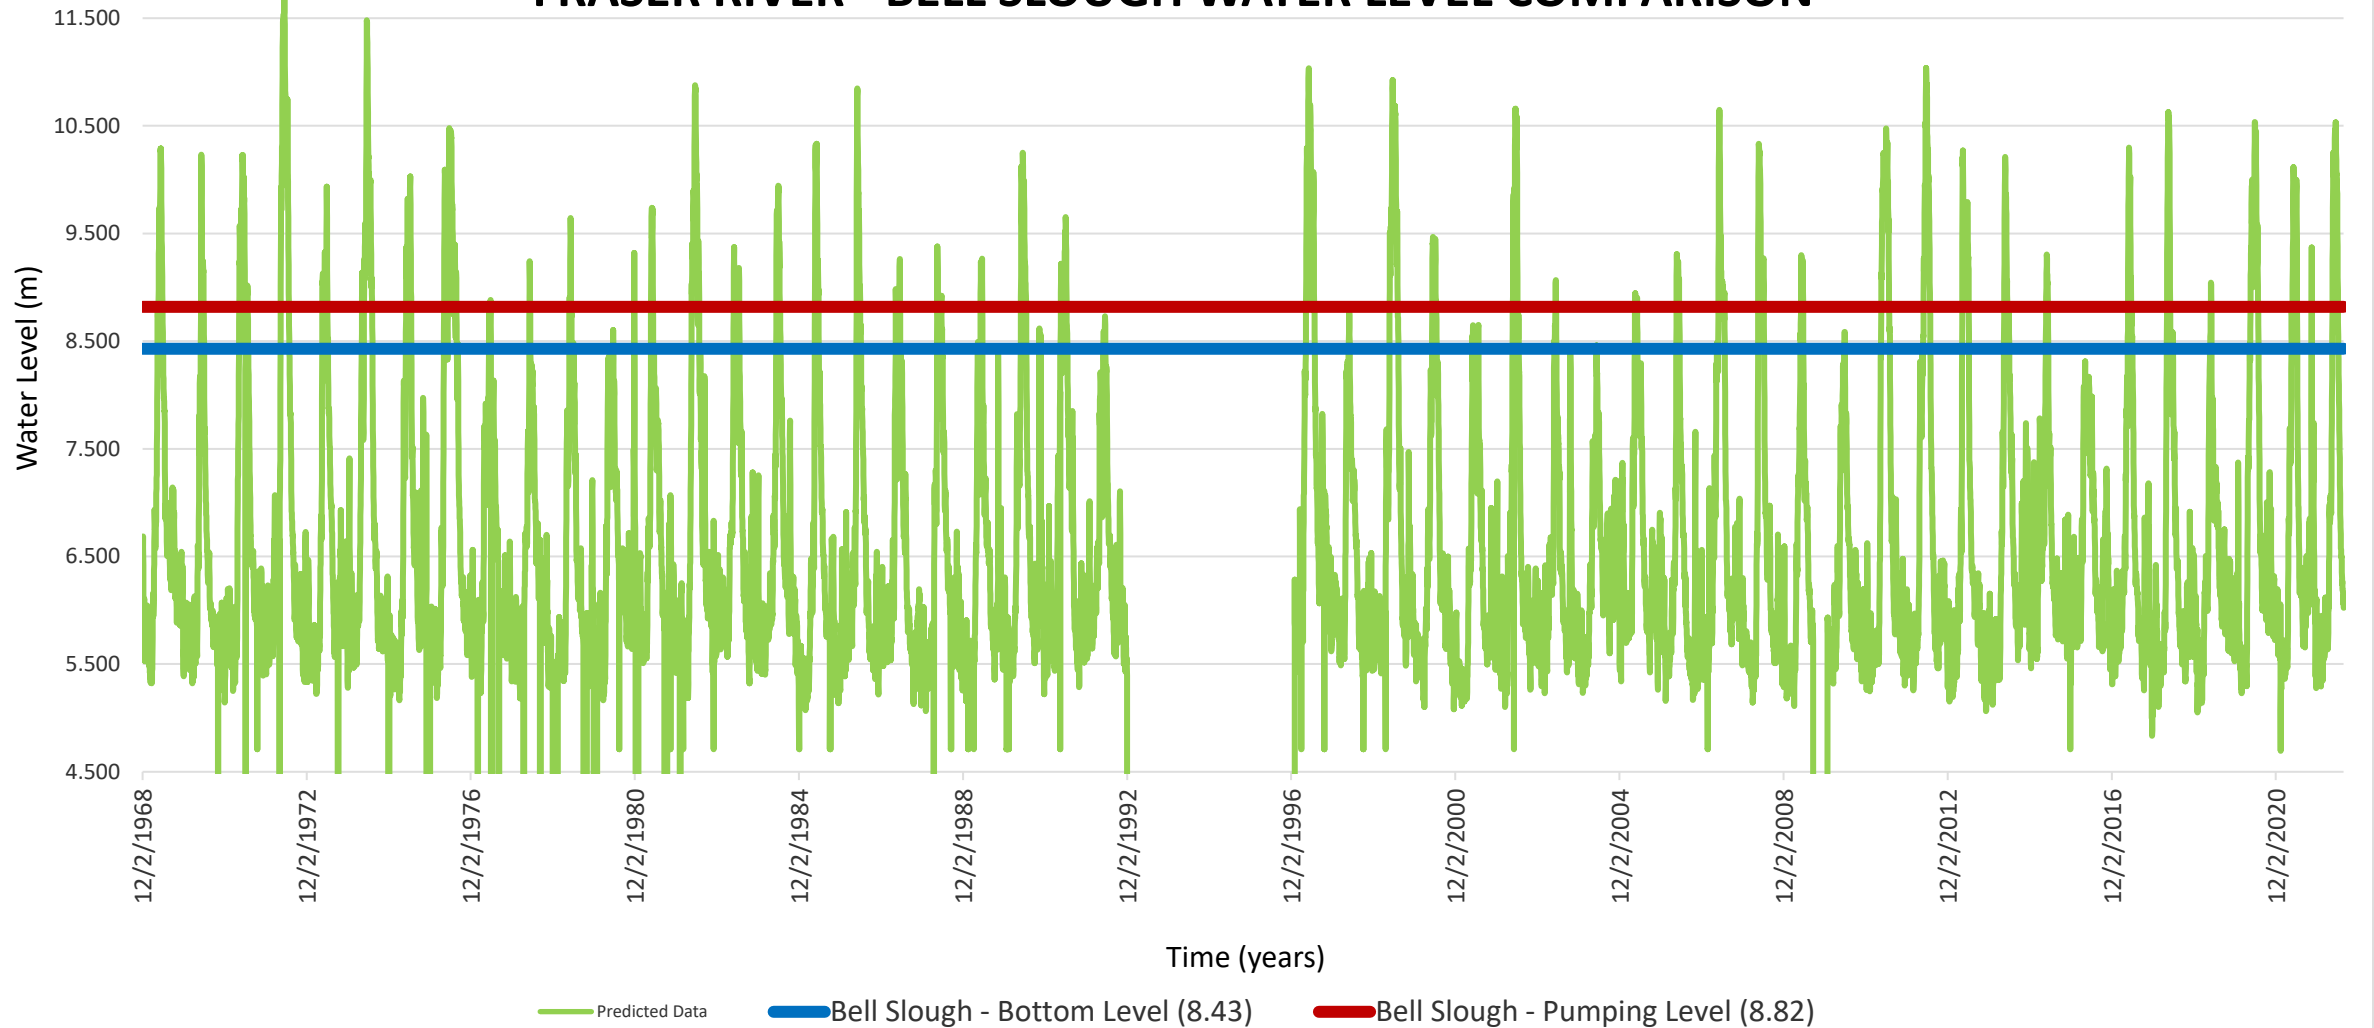
FRASER RIVER - BELL SLOUGH WATER LEVEL COMPARISON

Summary of Water Levels In Fraser River

- Data referenced from 2014-2022 water levels for Bell Slough and Fraser River.
- The chart illustrates the number of days there has been a backflow on a yearly basis from Fraser River to Bell Slough.
- Over the last few years, there has been an increase in backflow frequencies from the Fraser River.
- The maximum water level attained in the Fraser River over the last few decades - 11.787m
- In 2020, the maximum recurrence in backflow events occurred.

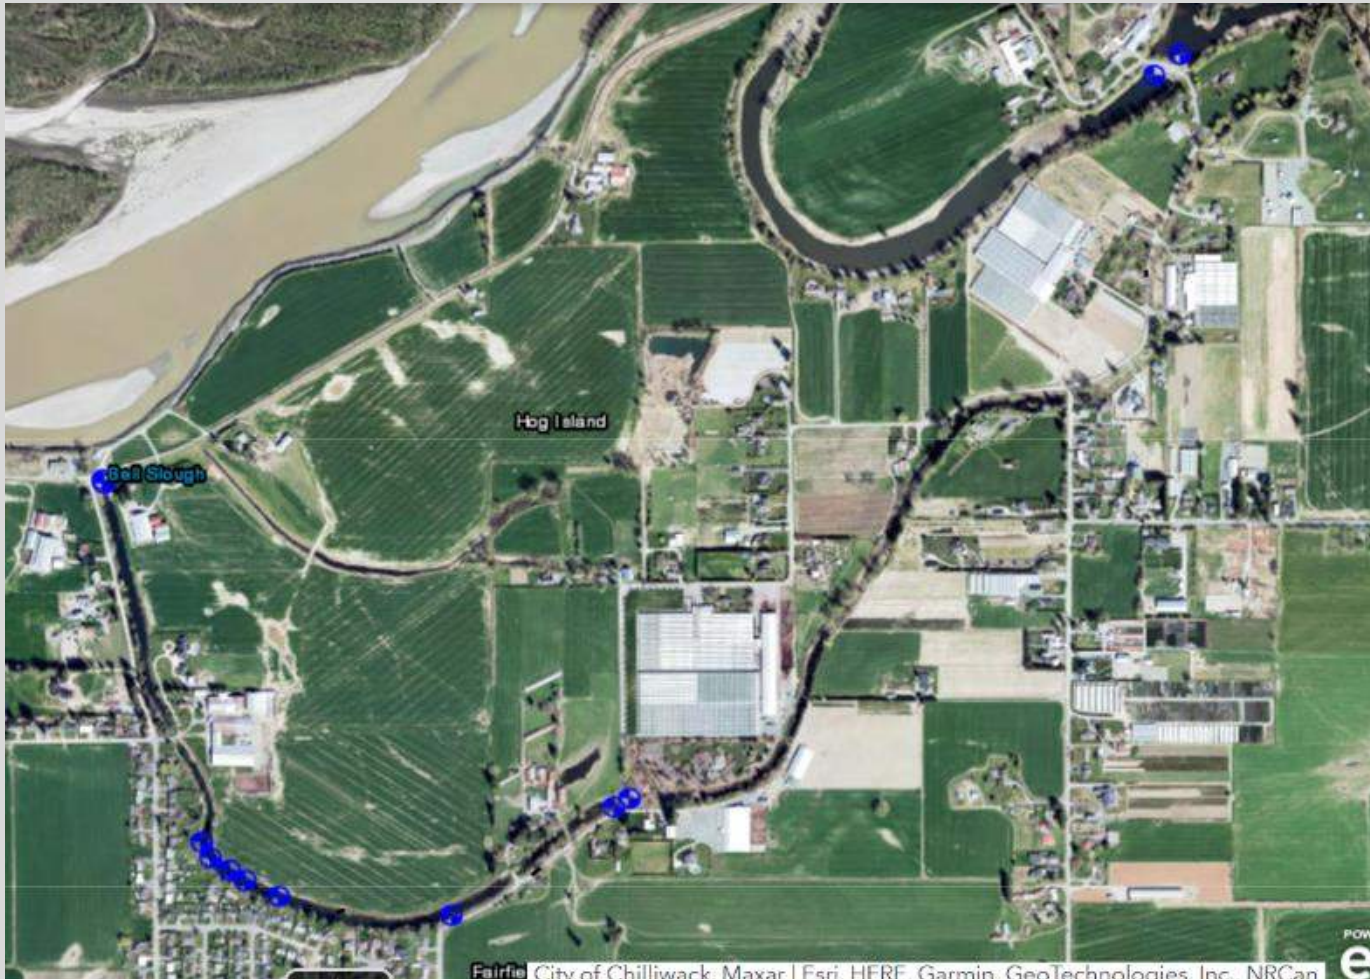
Water Quality Samplings

(What it should be)

BC Ambient Water Quality Guidelines for Aquatic Life

Temperature	Lower Dissolved Oxygen	pH
Long term	18 C	8 mg/L	6.5-9
Short term	19 C	5 mg/L

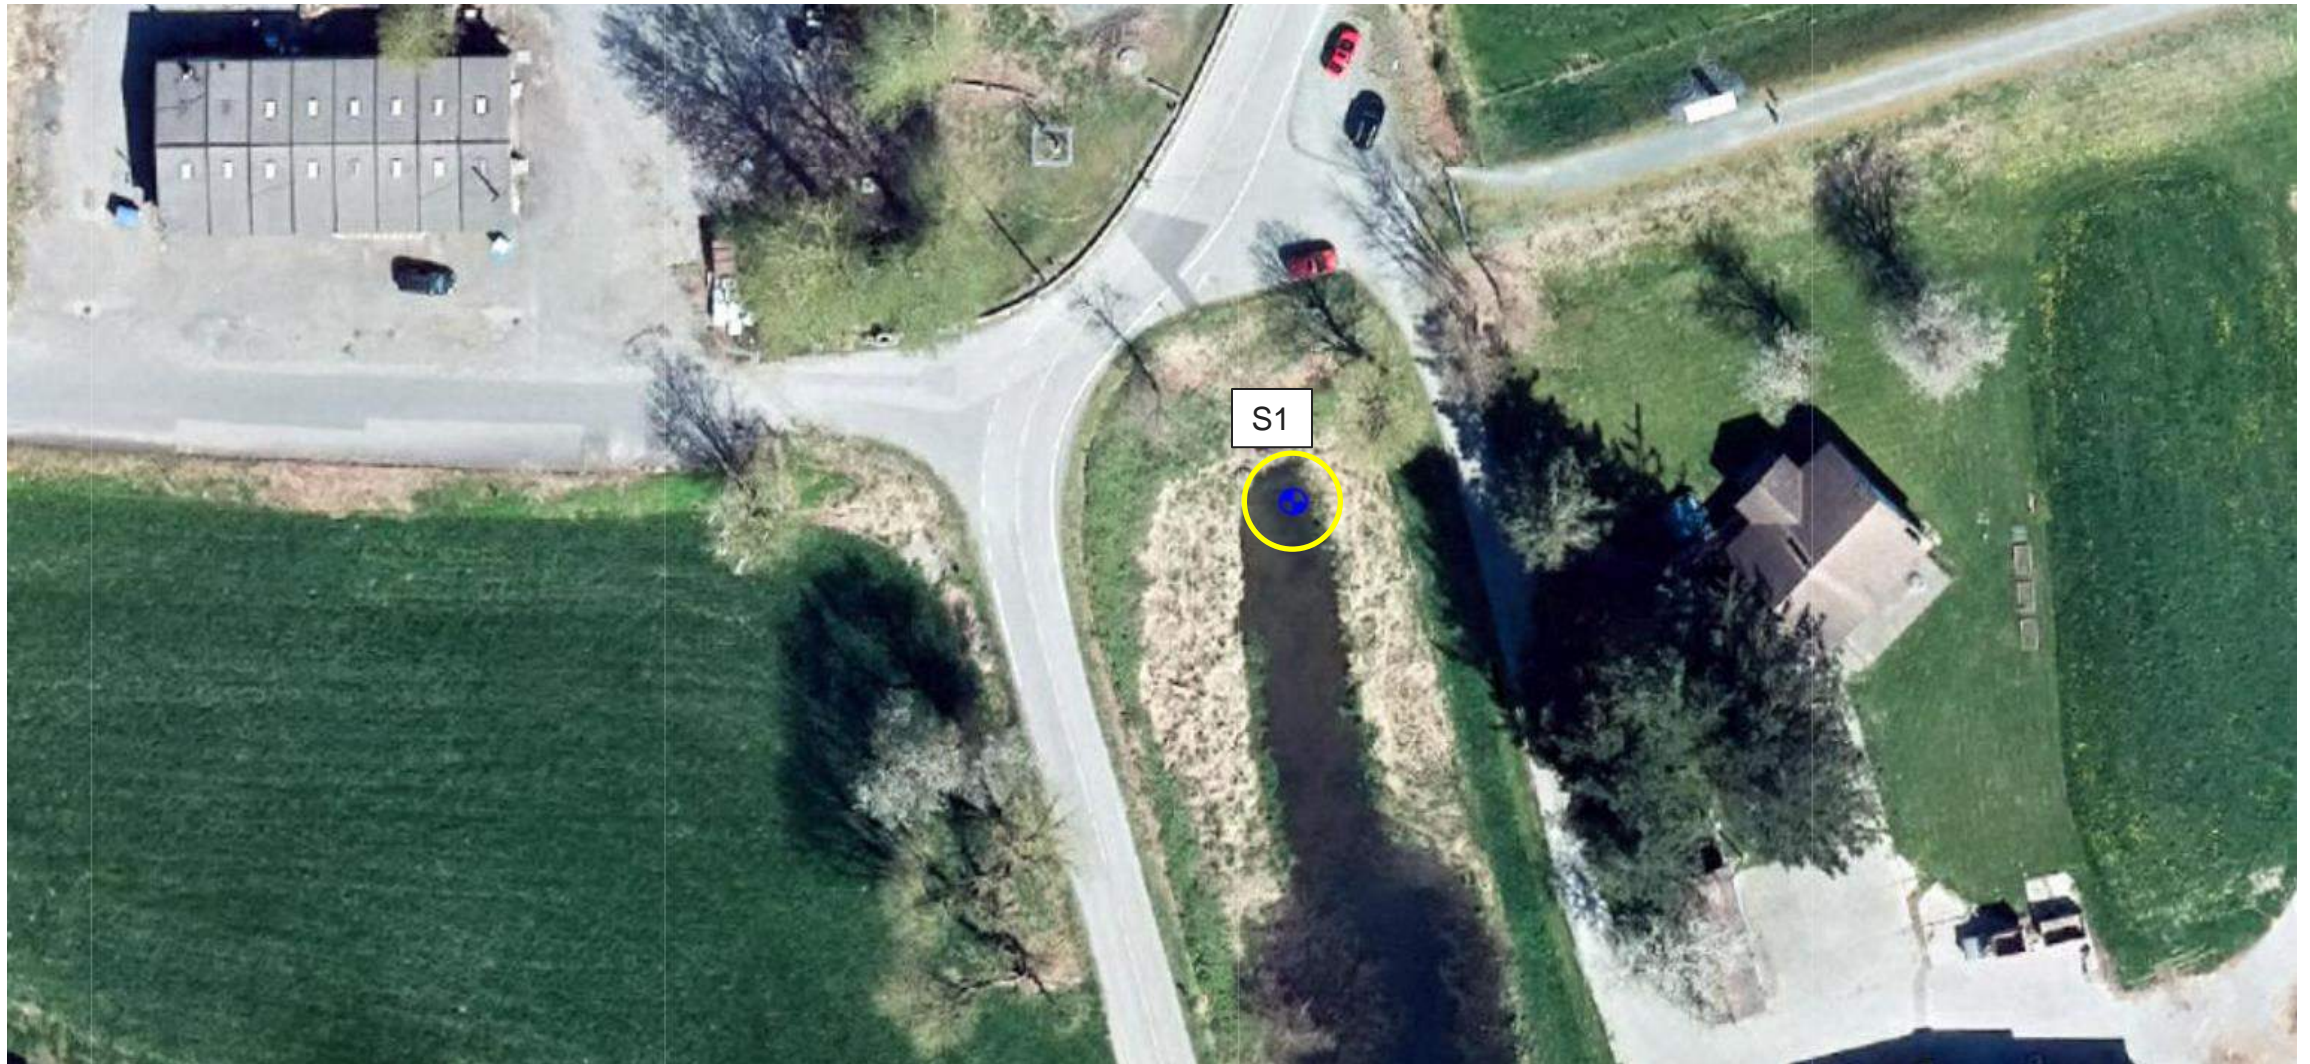
Station 1 (Fraser River Extent of the Slough)

Station 1 Water Quality Data

Temperature	Dissolved Oxygen	pH
17 C	2 mg/L	6.82
Green algae with visible open water

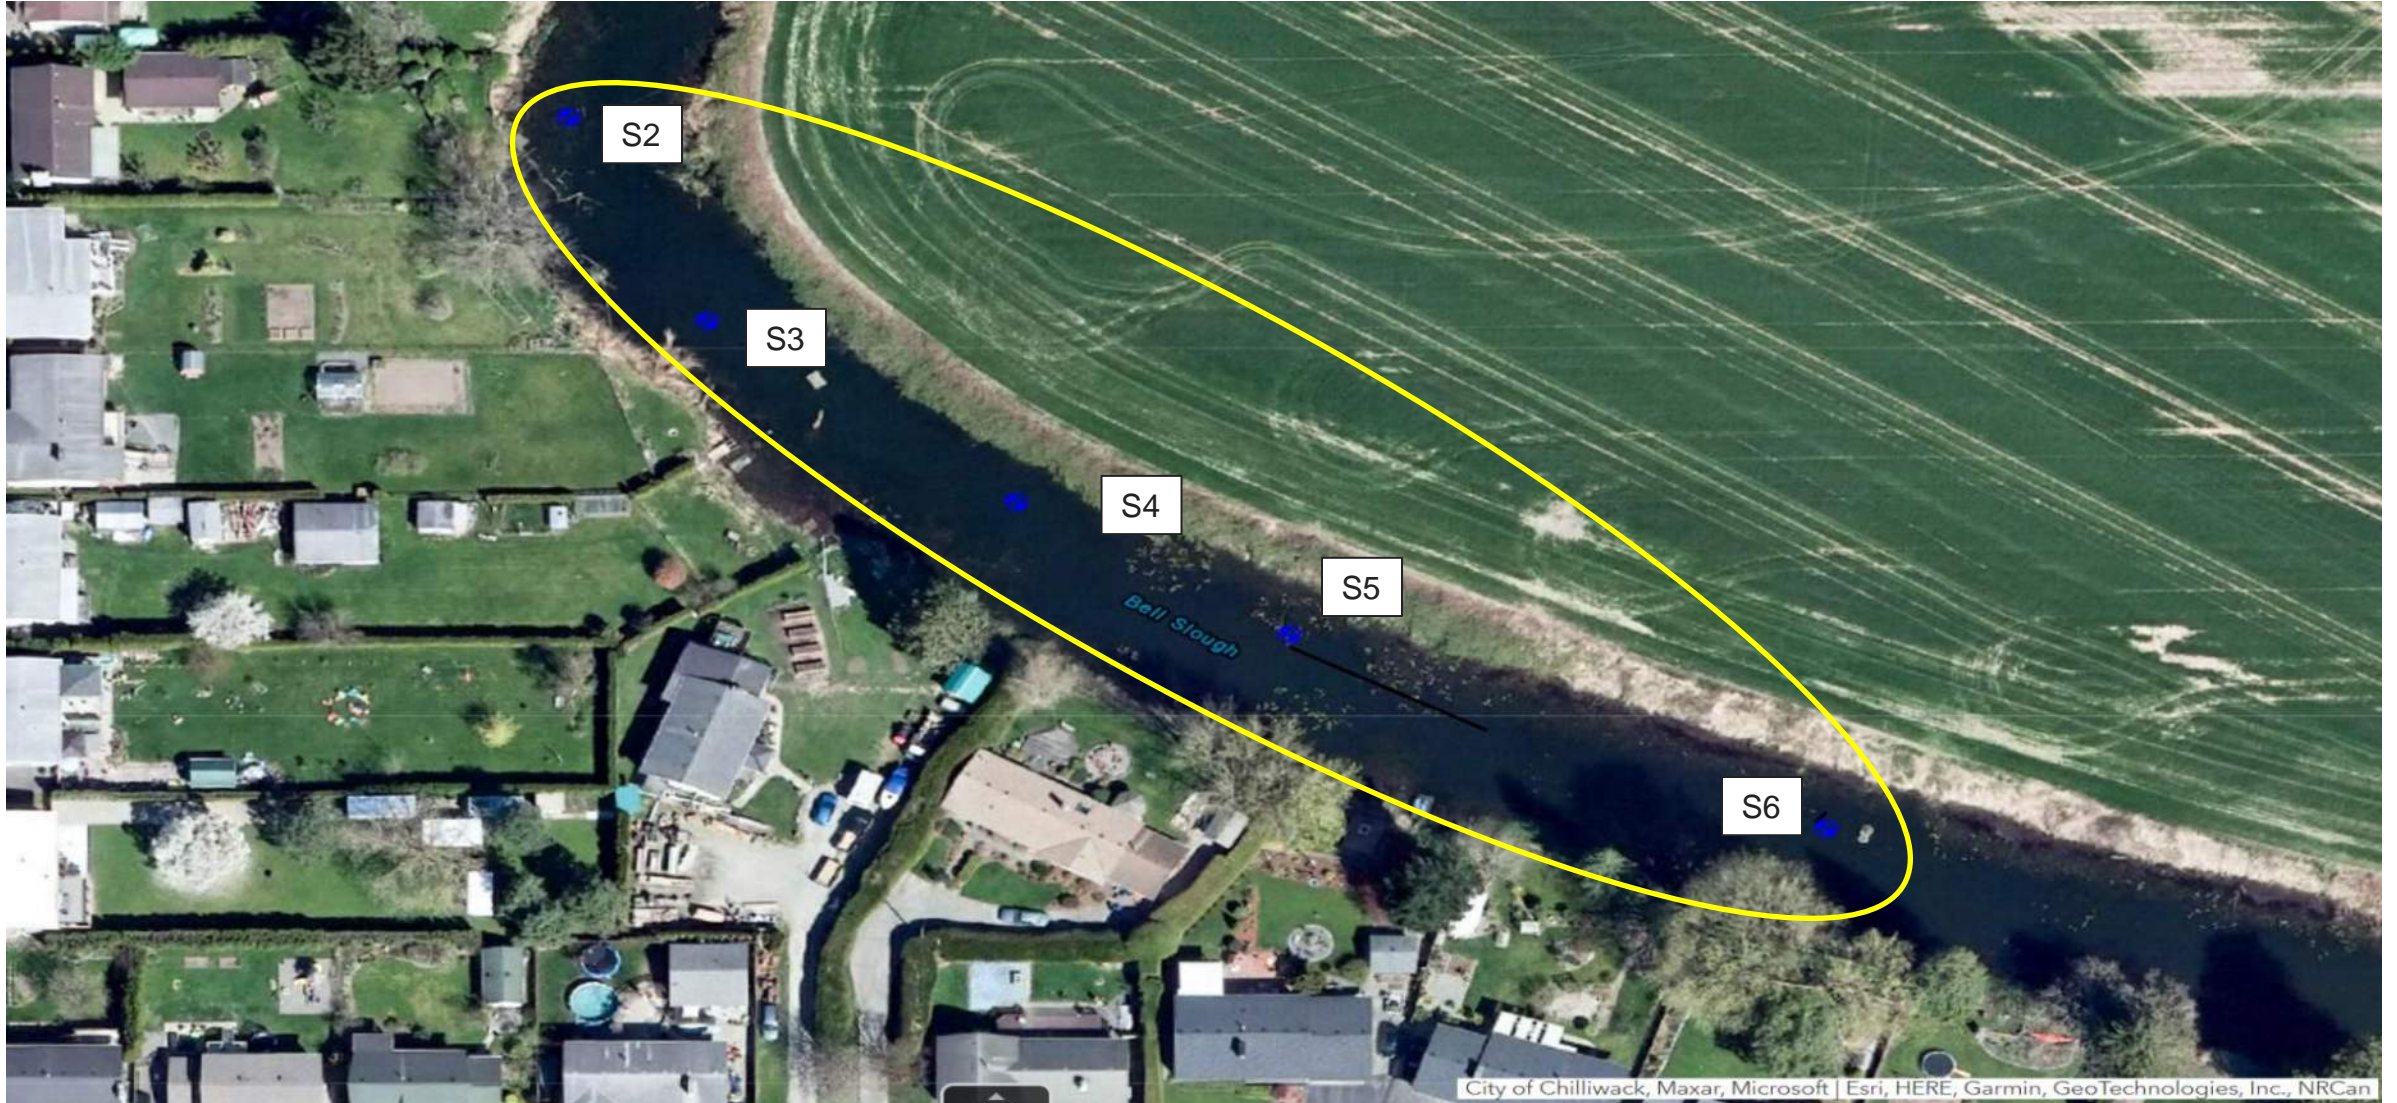
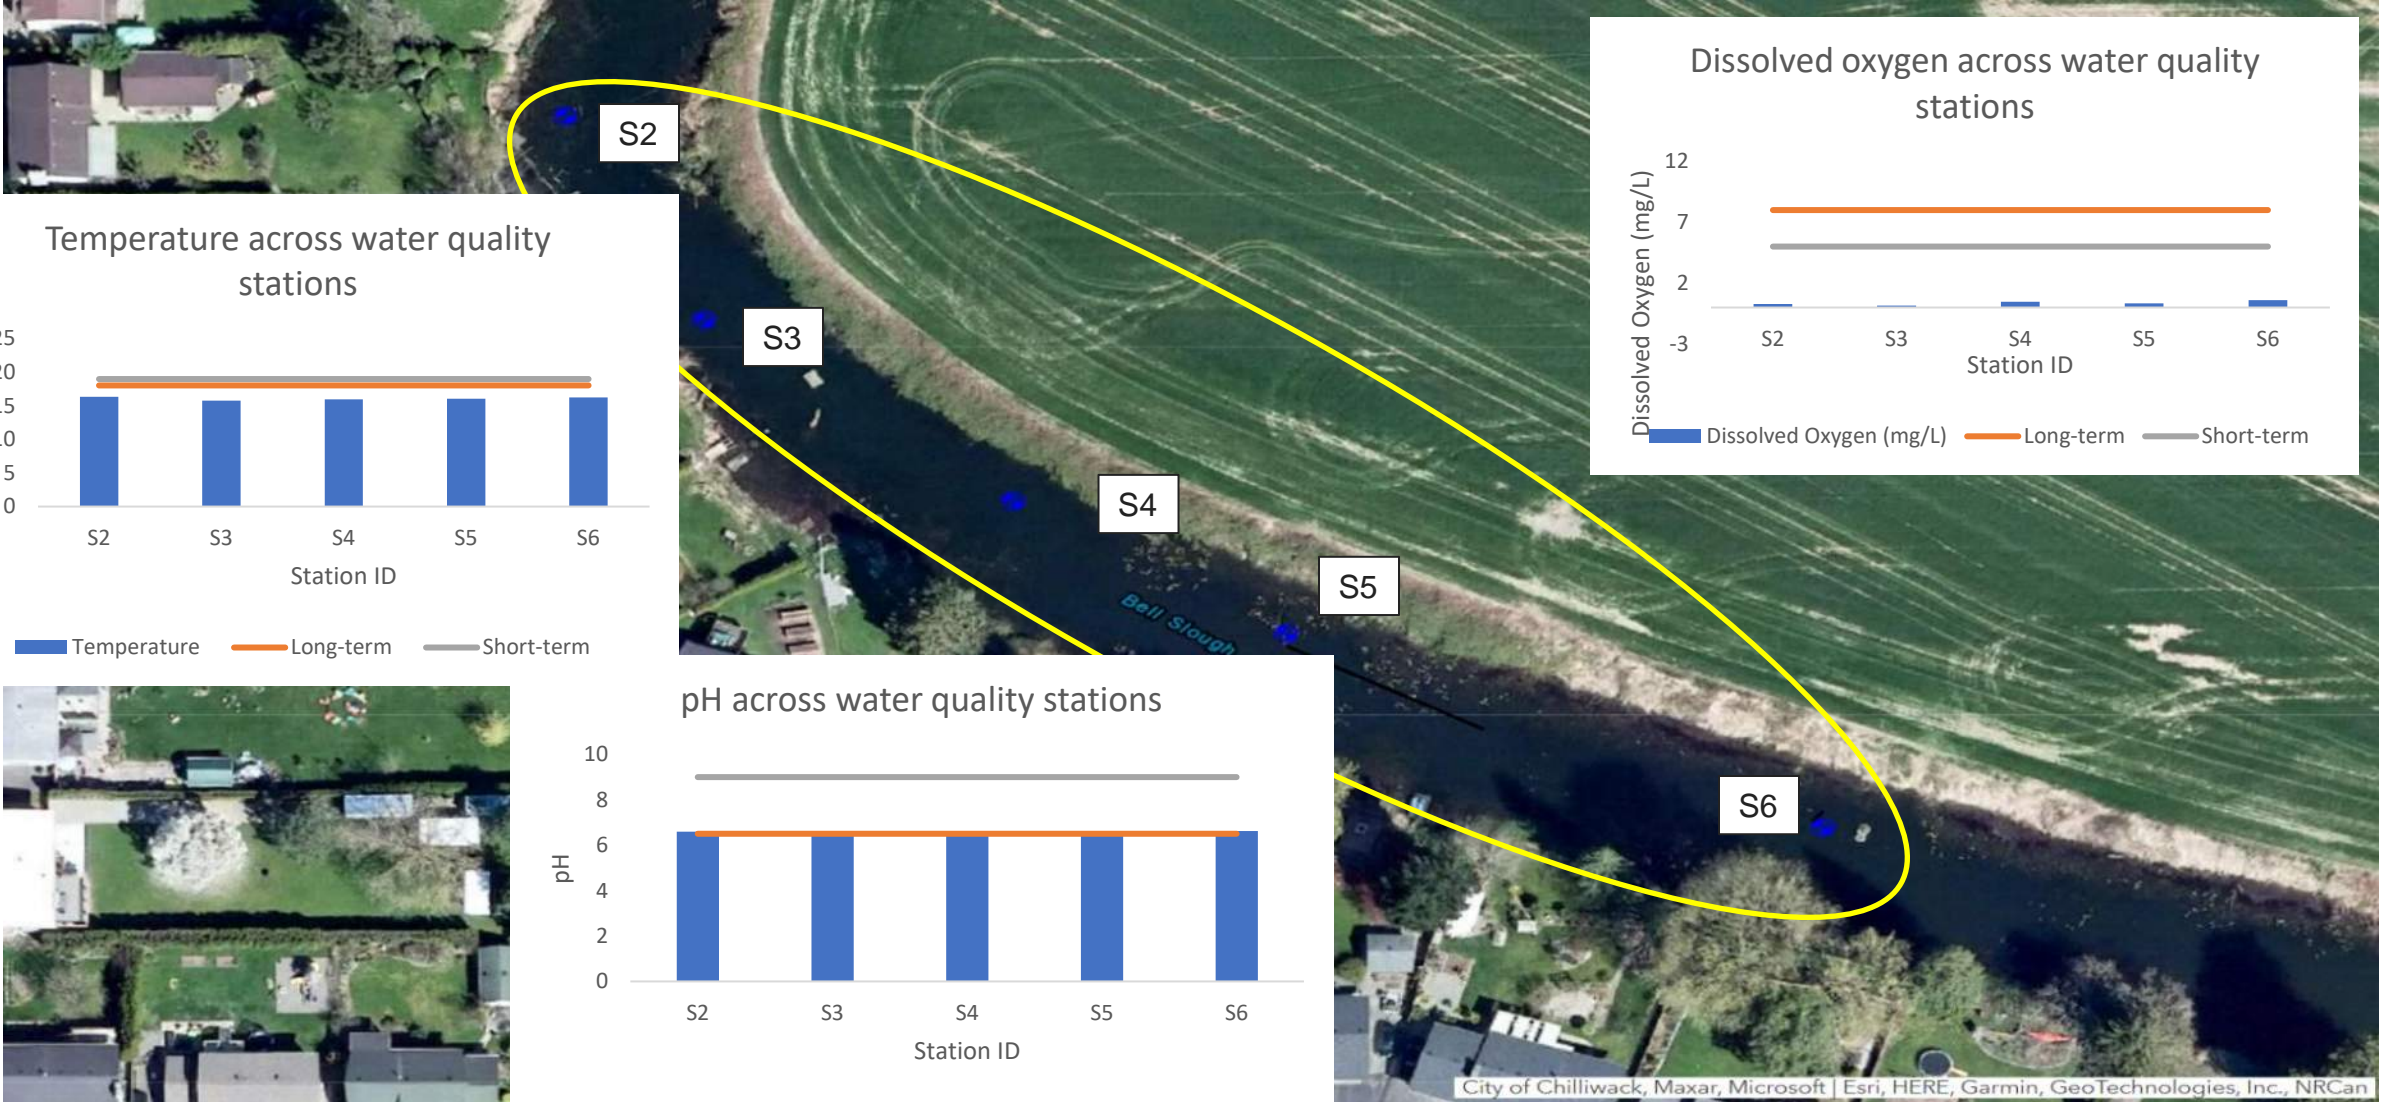
Stations 2-6 (Montana Drive Area)

Stations 2–6 Water Quality Data (avg.)

Temperature	Dissolved Oxygen	pH
Long term	16 C	3.5 mg/L	6.56
Thick aquatic plant mats covering entire surface of slough
