**Chilliwack Bell Slough
Improvements Feasibility
Study [Draft]**

Feasibility Study

Prepared for:
City of Chilliwack

Prepared by:
Stantec Consulting Ltd.
500 – 4515 Central Boulevard
Burnaby, BC, V5H 0C6

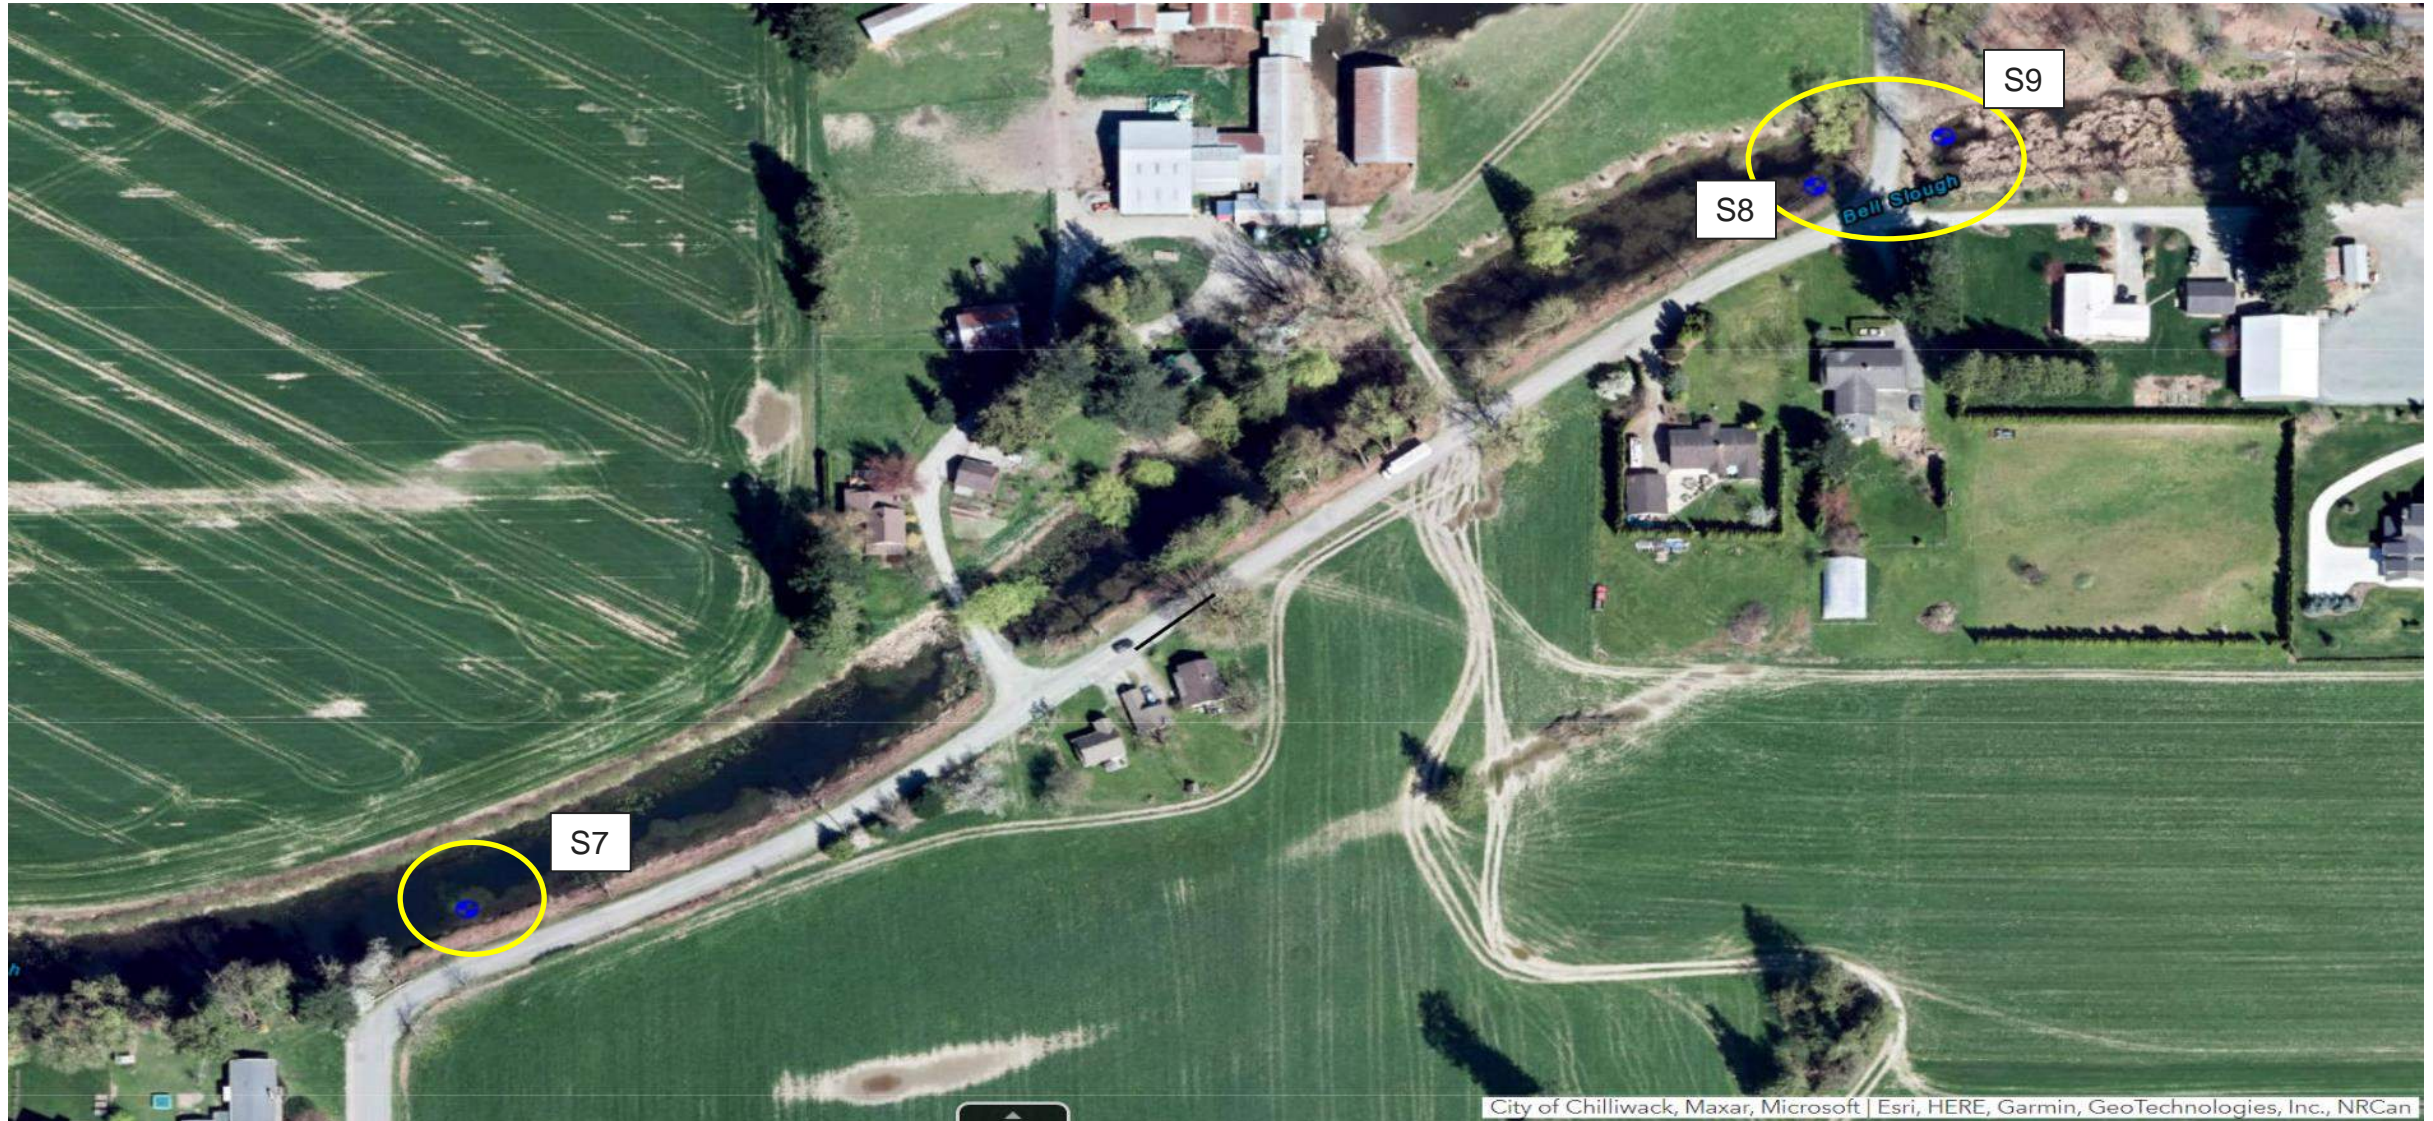
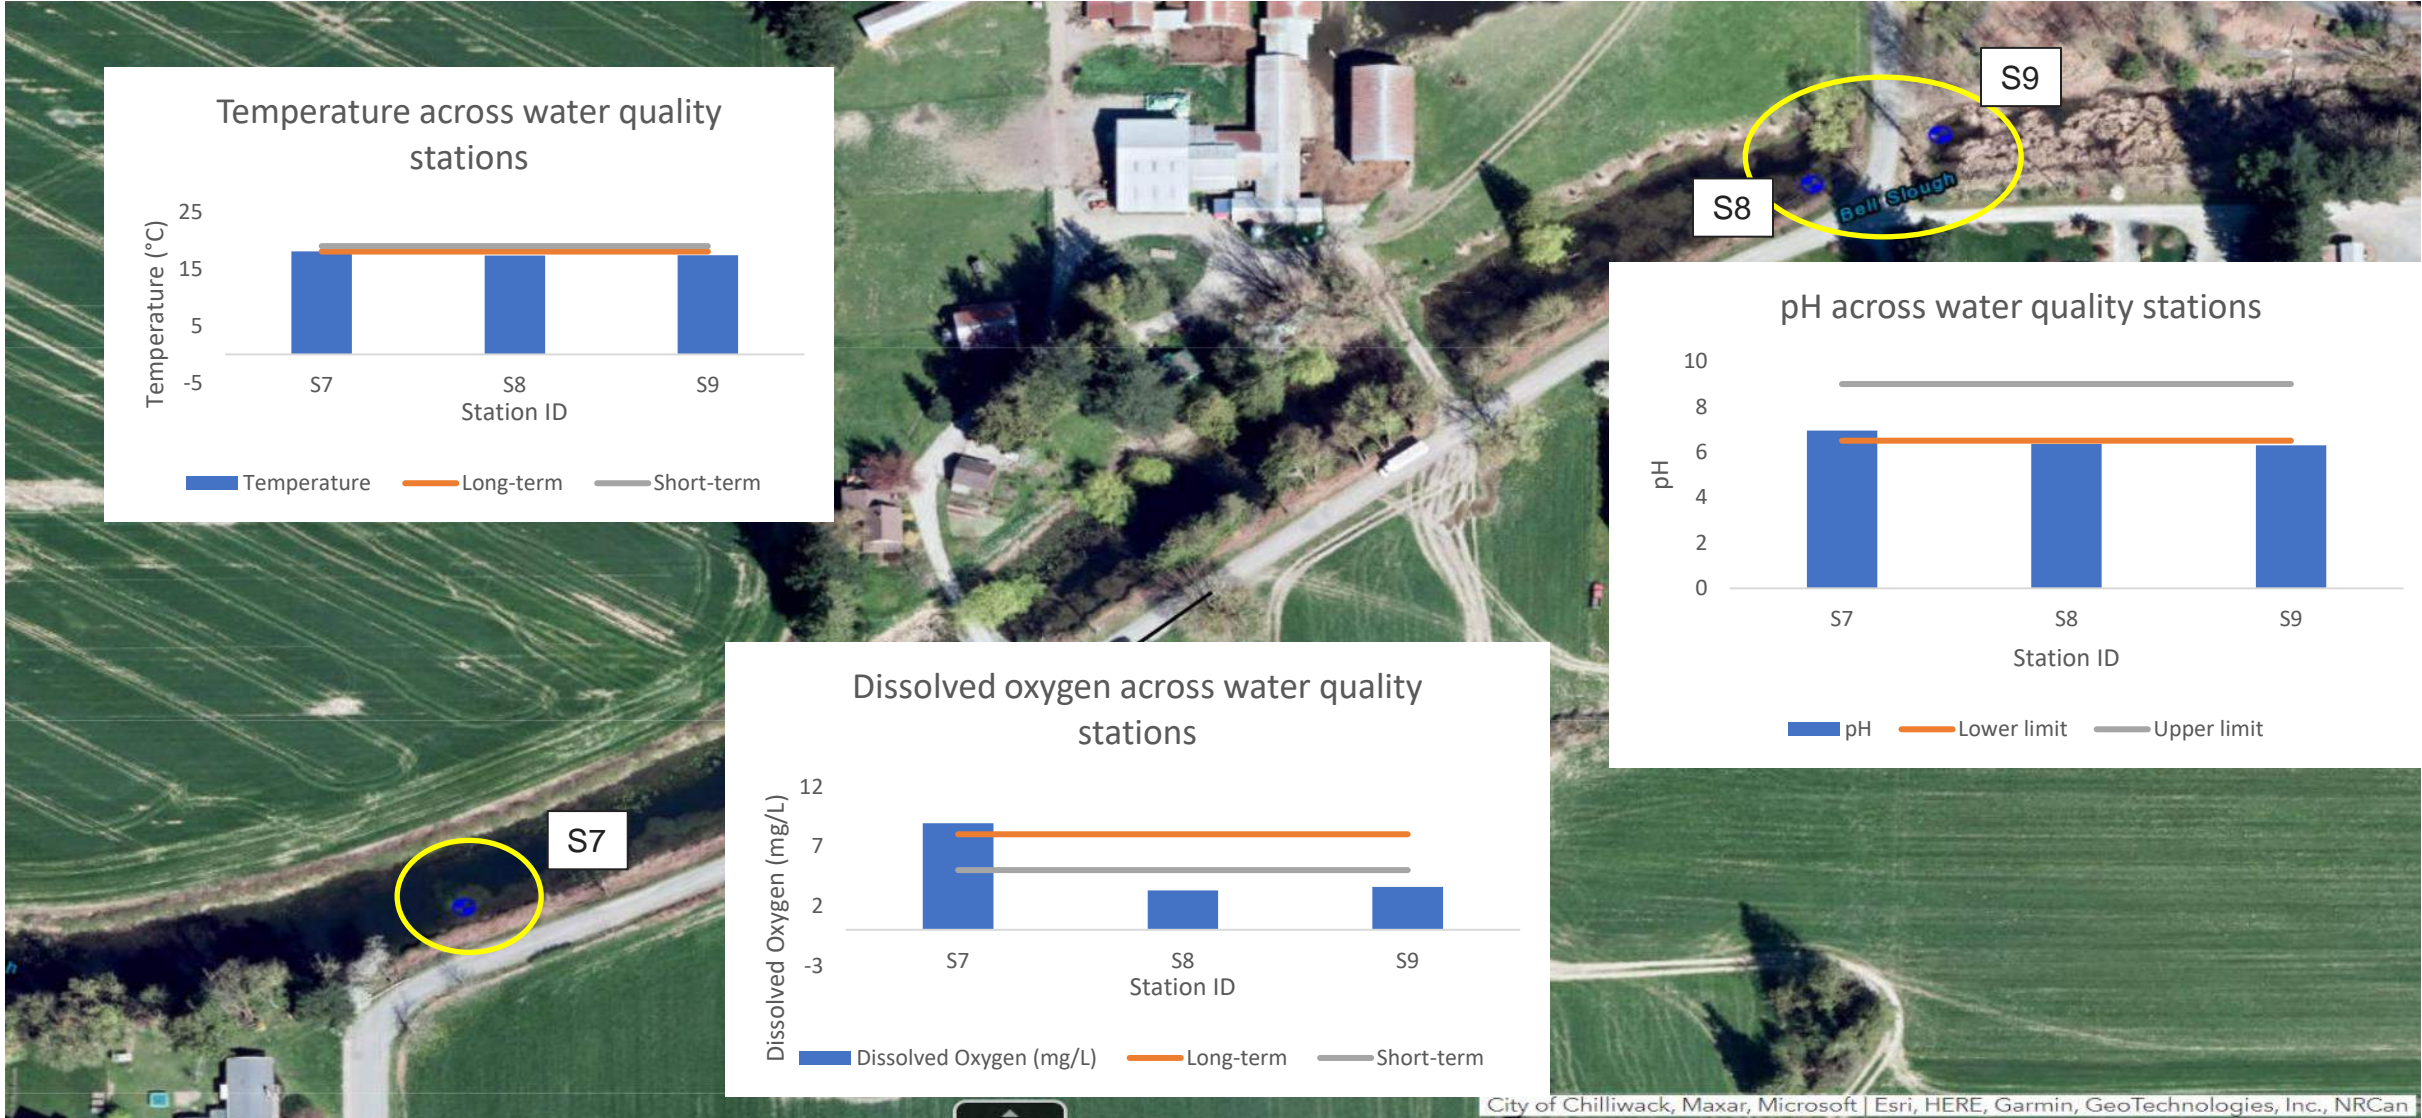
Stations 7-9 (Bell Road)

Stations 7–9 Water Quality Data (avg.)

Temperature	Dissolved Oxygen	pH
Long term	18 C	55.8 mg/L	6.53
Patches of smart weed, but also open water. Transitions between continuous wetted to pools.

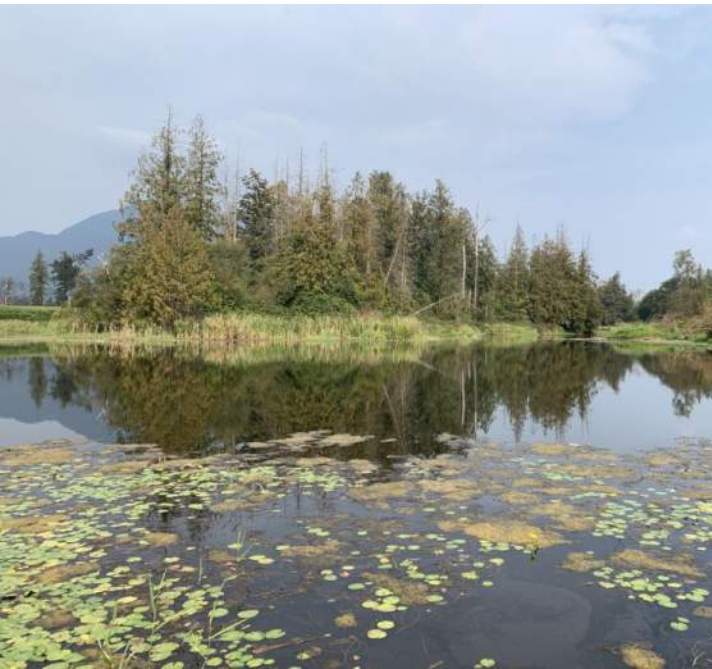
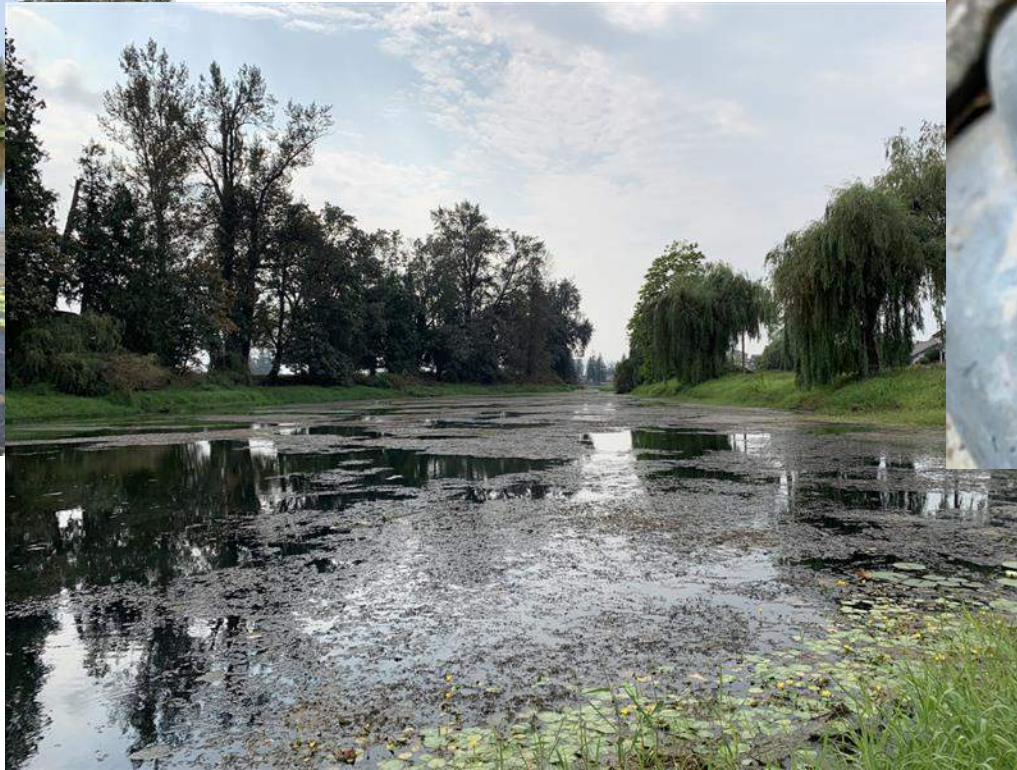
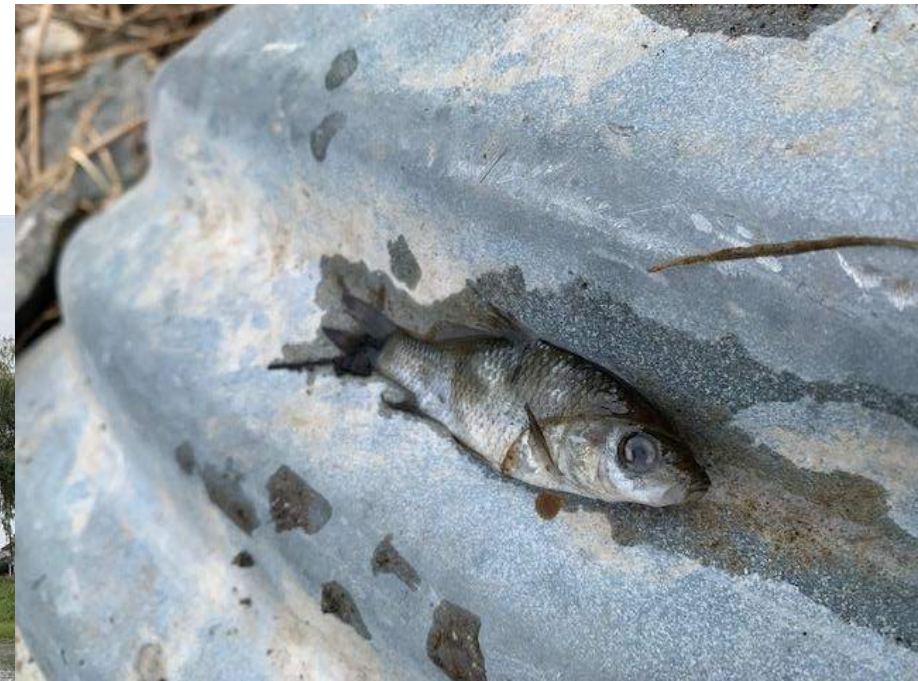
Stations 10 and 11 Water Quality Data (avg.)

Temperature	Dissolved Oxygen	pH
Long term	20 C	92.9 mg/L	7.7
Open water with some lily pads around edges. Dead juvenile carp at culvert outfall.

Photo Location: Camp-Nelson Slough downstream of the McSween Road culvert			
Direction: Facing down			
Survey Date: 9/14/2022			
Comments: Dead juvenile carp (exotic species) found at outflow of culvert.			
Photograph ID: 8

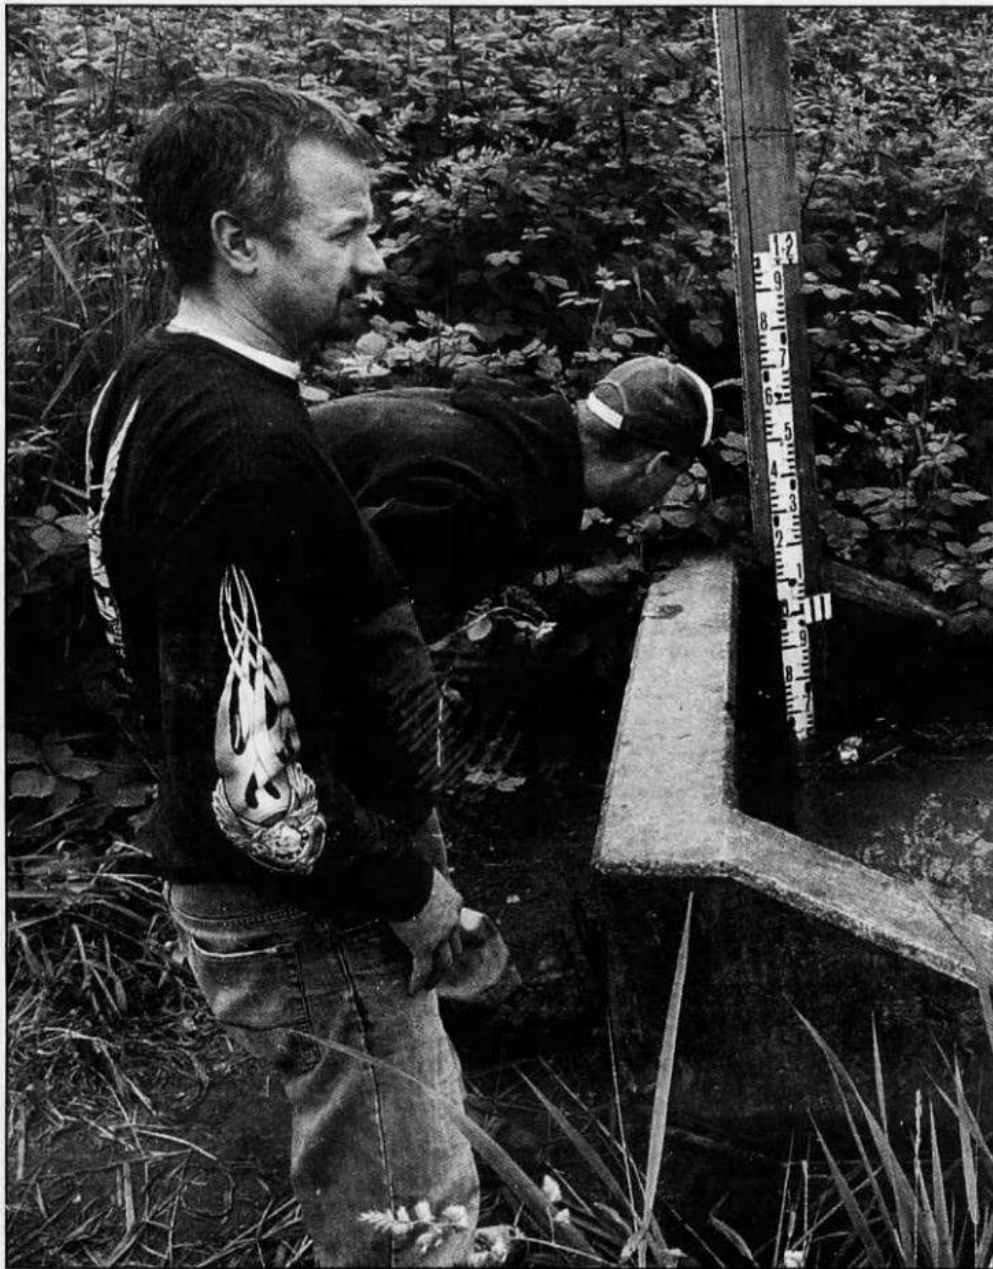
Kurt Buhl gets a close look at the Bell Slough gauge as Perry Dueck looks out over the Fraser River at Ballam and McDonald roads. JENNA HAUCK/ PROGRESS

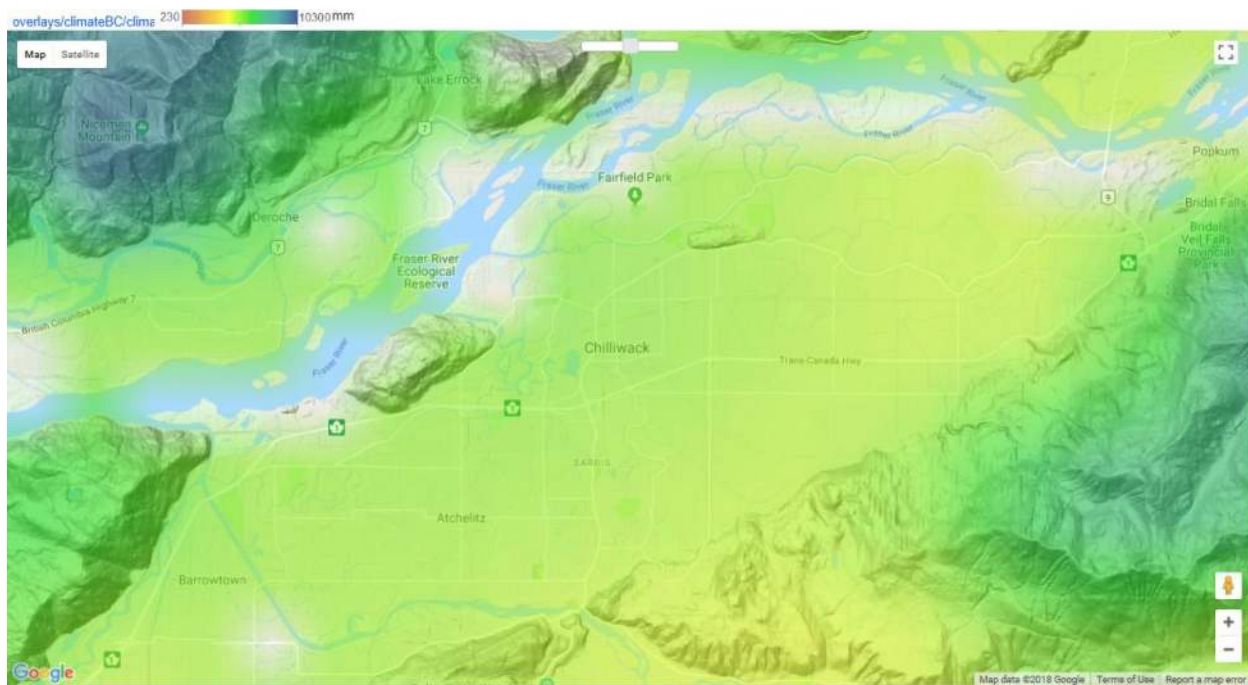
Additionally, climate maps available from Climate BC show that precipitation within the valley surrounding Chilliwack is relatively uniform compared to variations observed between the precipitation gauges (see following figure). The more significant differences are between the valley and the mountainous areas. Therefore, instead of creating IDF curves for each station, the rainfall data from all the stations was combined to create a single, more regional set of IDF curves. We feel that creating a regional set of curves produces more reliable estimates applicable to the City as a whole, and is easier to apply in City criteria documents.

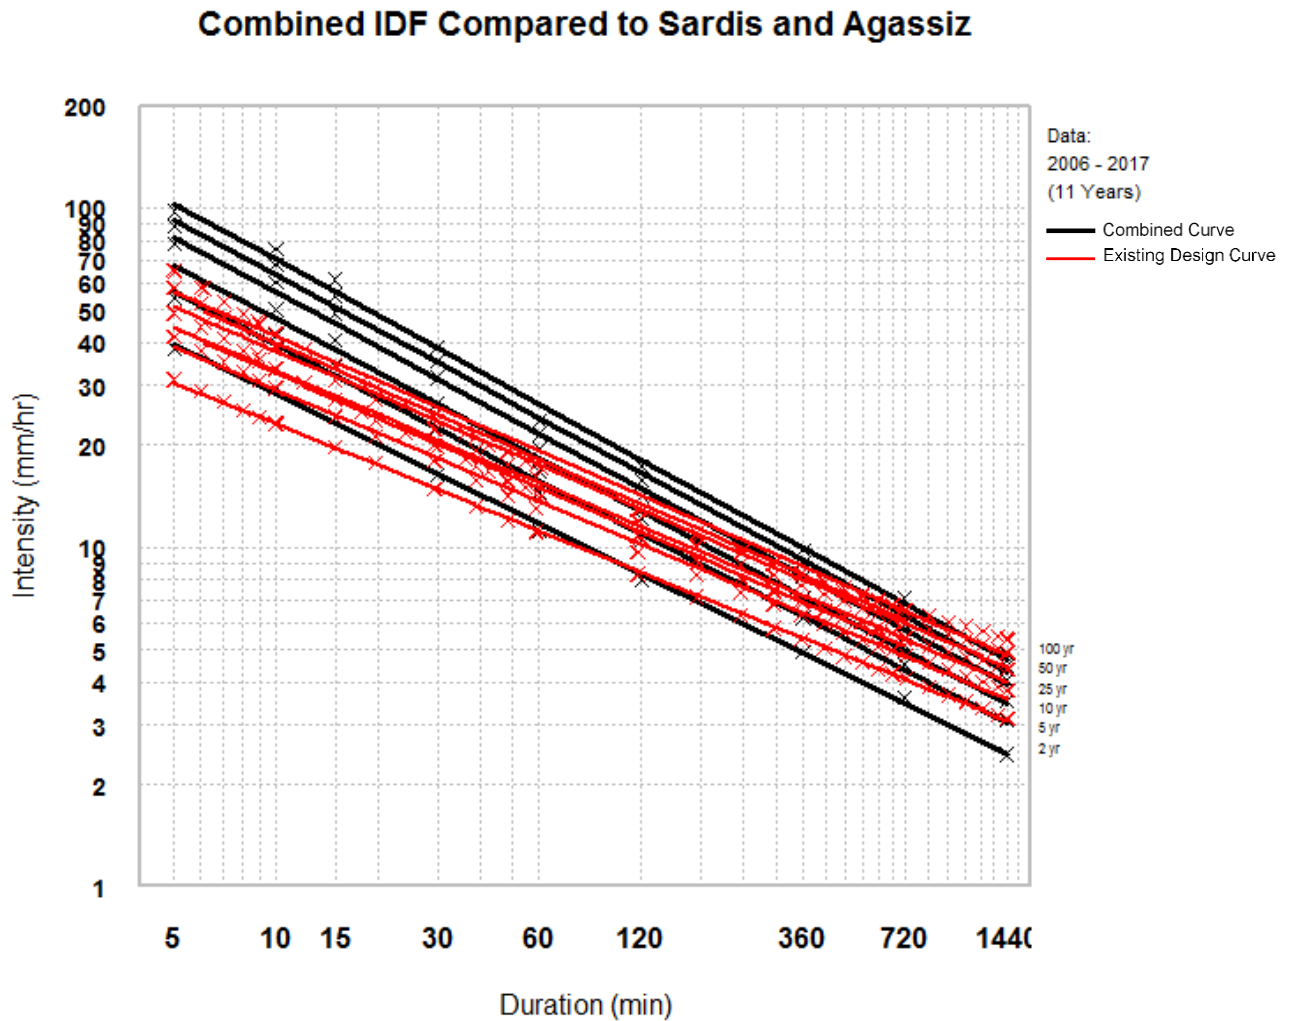
The new combined curves (in black) are compared to the existing City design curves (Agassiz and Sardis-Vedder in red) in the figure below:

Compared to the original City IDF Curves, the updated curves show higher intensities for durations less than 12 hours, but similar intensities for durations greater than 12 hours. This steepening of the curves is consistent with IDF curves updated for other locations in the Fraser Valley.

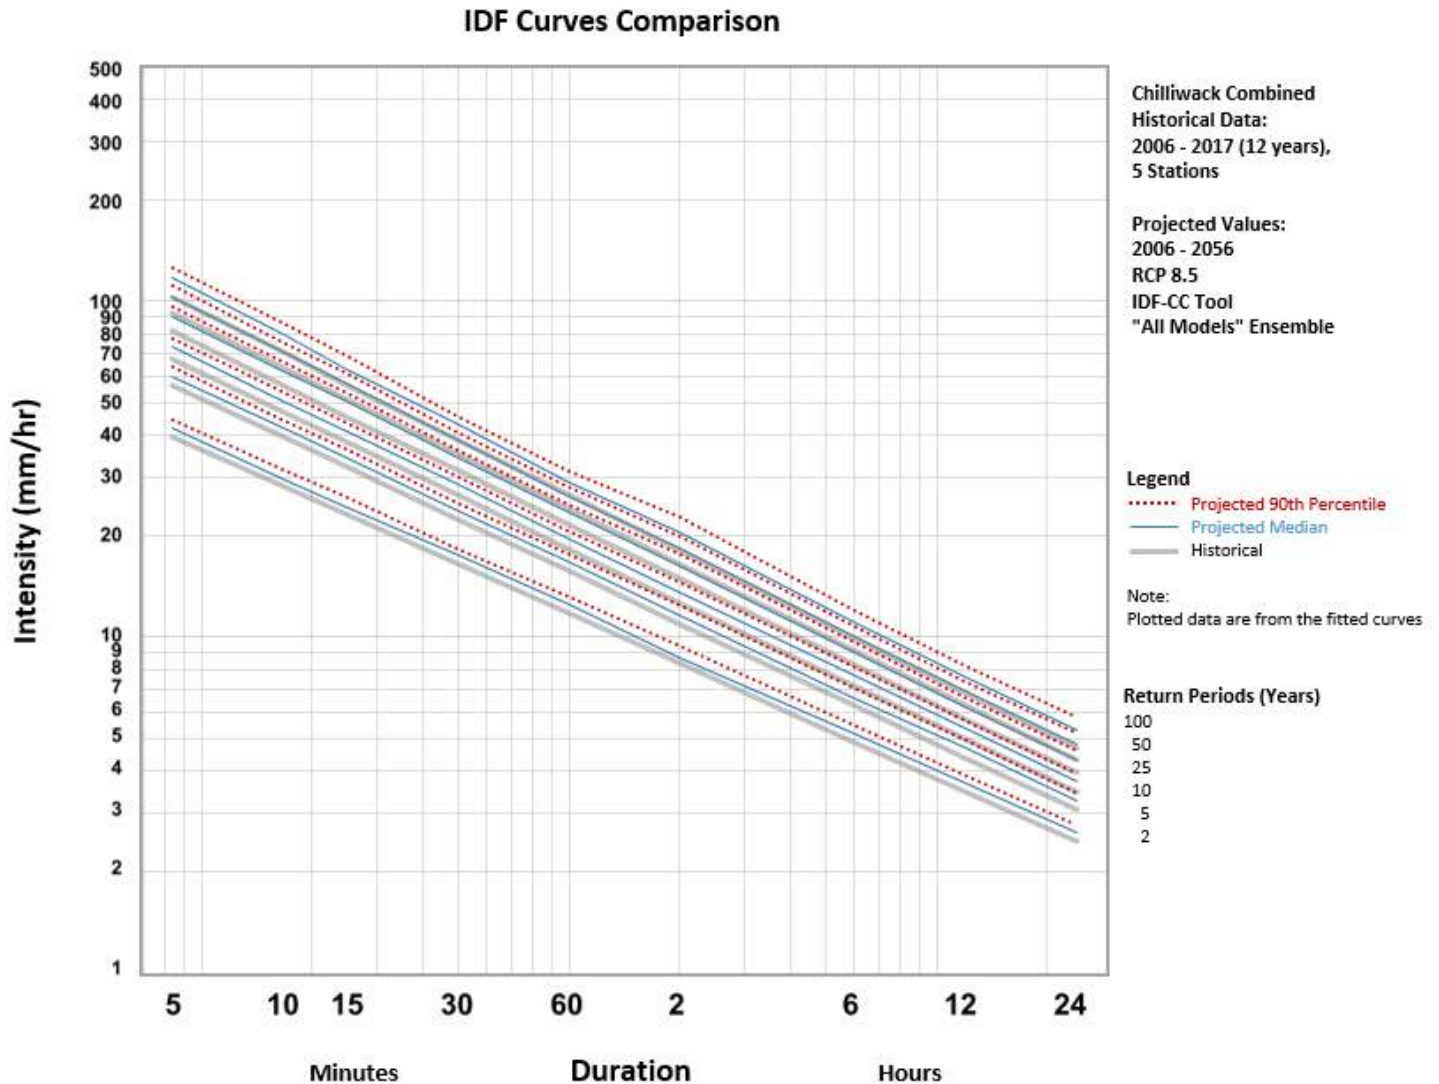
The updated combined IDF curves were then used to generate climate change projections using the IDF-CC tool from Western University (Simonovic 2018). This tool estimates precipitation increases using 24 General Circulation Models (GCM's) that simulate long-term climate values. The resulting IDF curves based on the median and 90th percentile output from the GCM's are compared to the current combined curve in the figure below:

Values have been projected to the year 2056. The results show an increase for the 1:2 year return period curve of 6% for the median and 13% for the 90th percentile. The 1:100 year return period curve increases 14% for the median and 23% for the 90th percentile.

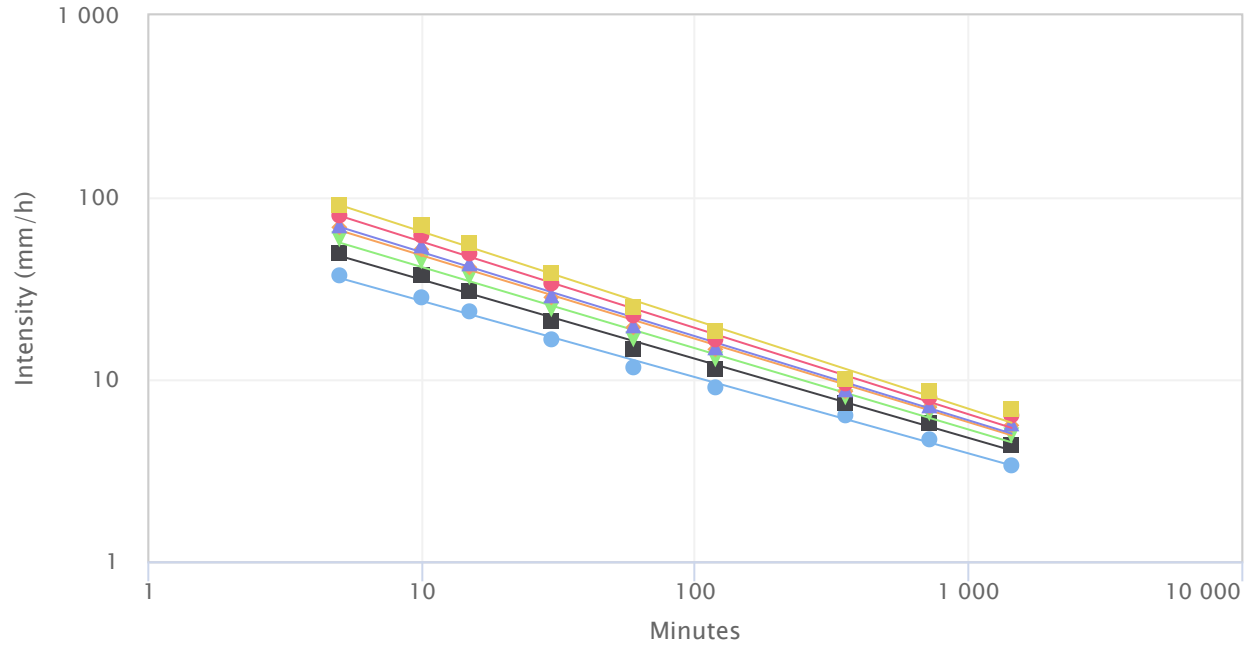
Station: Ungauged IDF for: Lat: 49.16667 °, Lon: -121.93537 °, Historical data

The table below provides coefficients for the interpolation equations fitted to the IDF curve using the GEV distribution.

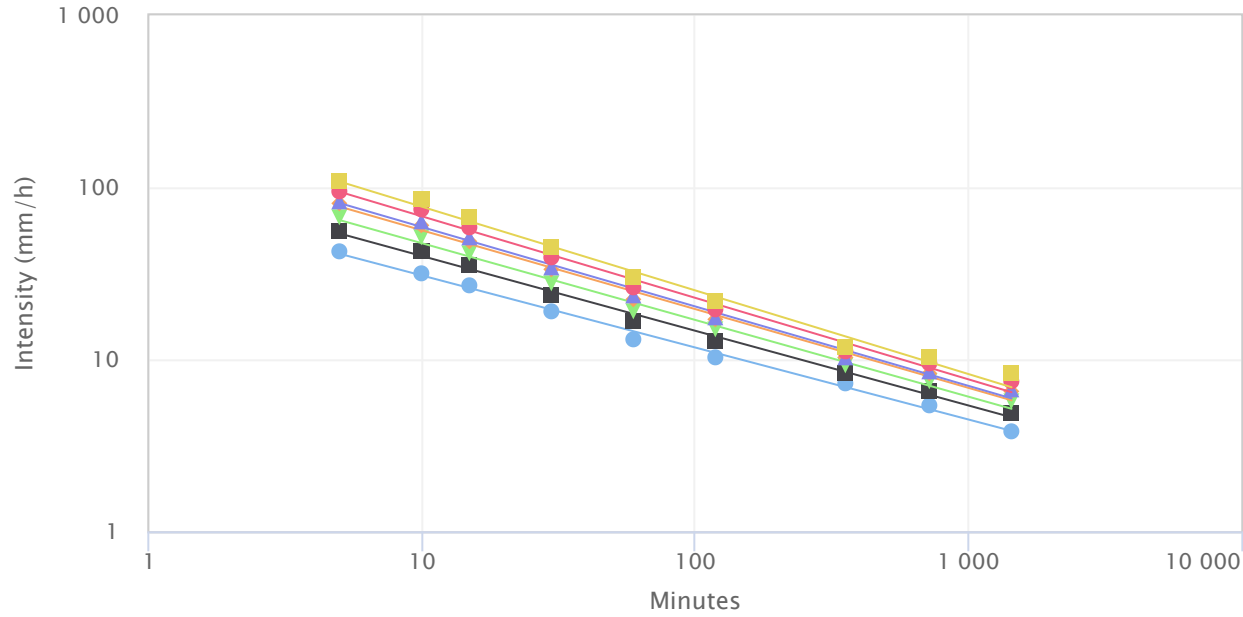
Station: Ungauged IDF for: Lat: 49.16667 °, Lon: -121.93537 °, Model: , projection period: 2015 to 2100

The table below provides the coefficients for the interpolated equations fitted to the average IDF for future scenario RCP 8.5

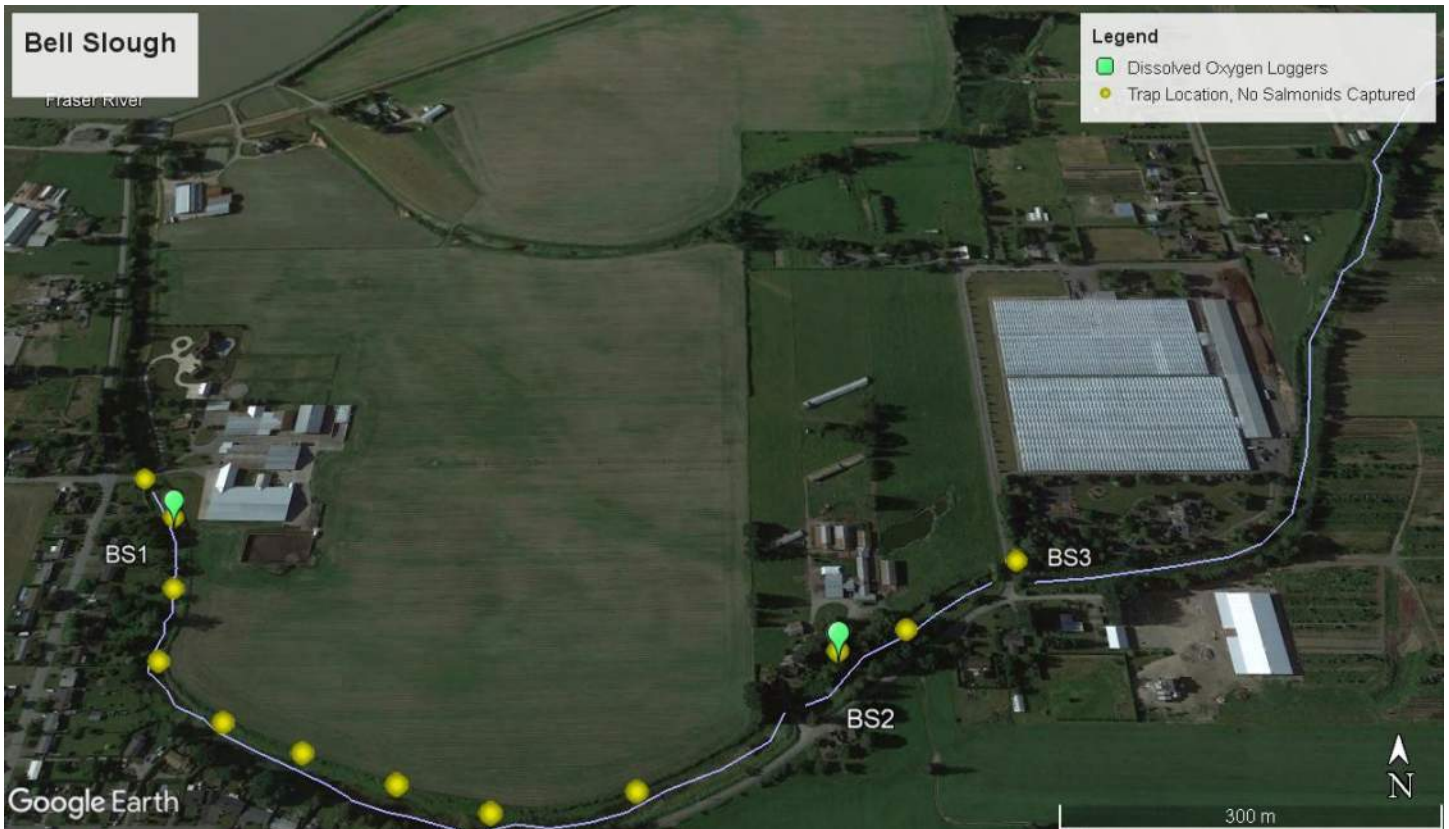
Fish Sampling and Salmonid Capture Locations

- No native fish species were caught in Bell Slough.
- Two introduced fish species, Pumpkinseed and Brown Catfish, were found. These species are commonly found throughout the Lower Fraser watershed.

- Two native and two introduced amphibians were observed in Bell Slough.
- Specific conductivity was fairly low, but slightly elevated in Reach BS1
- Water temperatures were well within the tolerance range for salmonids as expected for spring sampling.

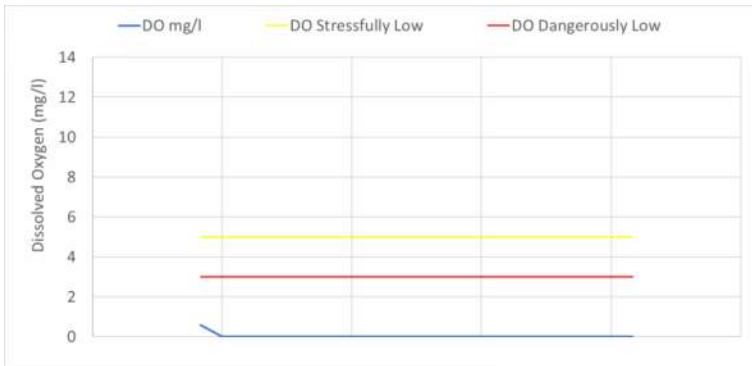
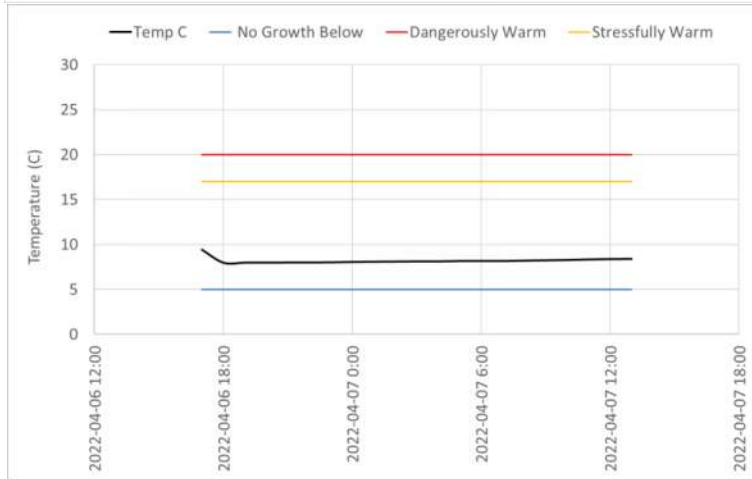
Dissolved Oxygen Logger BS1

Start Date	6-Apr-22
End Date	7-Apr-22
Sampling Interval (h)	1
Number of Days	0.9
Number Measurements	21
Max DO	0.6
Min DO	0.0
Max. Temperature	9.4
Min. Temperature	8.0

DO	Days	Hours	% Time
Below 5 mg/l	0.9	21	100.0
Below 4 mg/l	0.9	21	100.0
Below 3 mg/l	0.9	21	100.0
Below 2 mg/l	0.9	21	100.0
Below 1 mg/l	0.9	21	100.0

- Dissolved oxygen in BS3 was not sufficient to support fish. In reaches BS2 and BS1 dissolved oxygen levels varied from well within tolerance ranges of salmonids to stressfully low, suggesting deteriorating oxygen levels throughout the summer is likely.

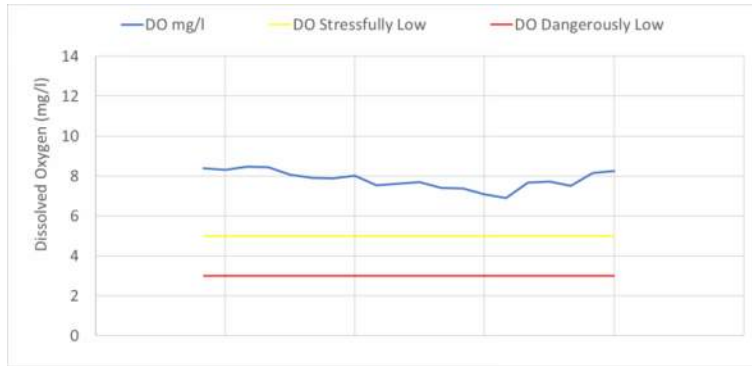
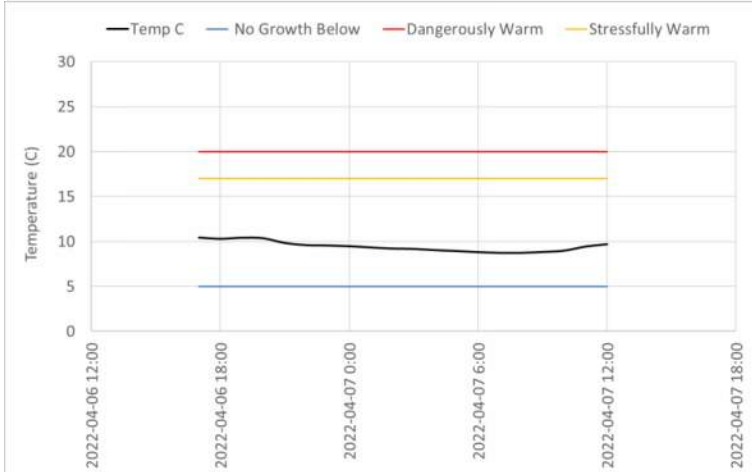
Dissolved Oxygen Logger BS2

Start Date	6-Apr-22
End Date	7-Apr-22
Sampling Interval (h)	1
Number of Days	0.8
Number Measurements	20
Max DO	8.5
Min DO	6.9
Max. Temperature	10.4
Min. Temperature	8.7

DO	Days	Hours	% Time
Below 5 mg/l	0.0	0	0.0
Below 4 mg/l	0.0	0	0.0
Below 3 mg/l	0.0	0	0.0
Below 2 mg/l	0.0	0	0.0
Below 1 mg/l	0.0	0	0.0

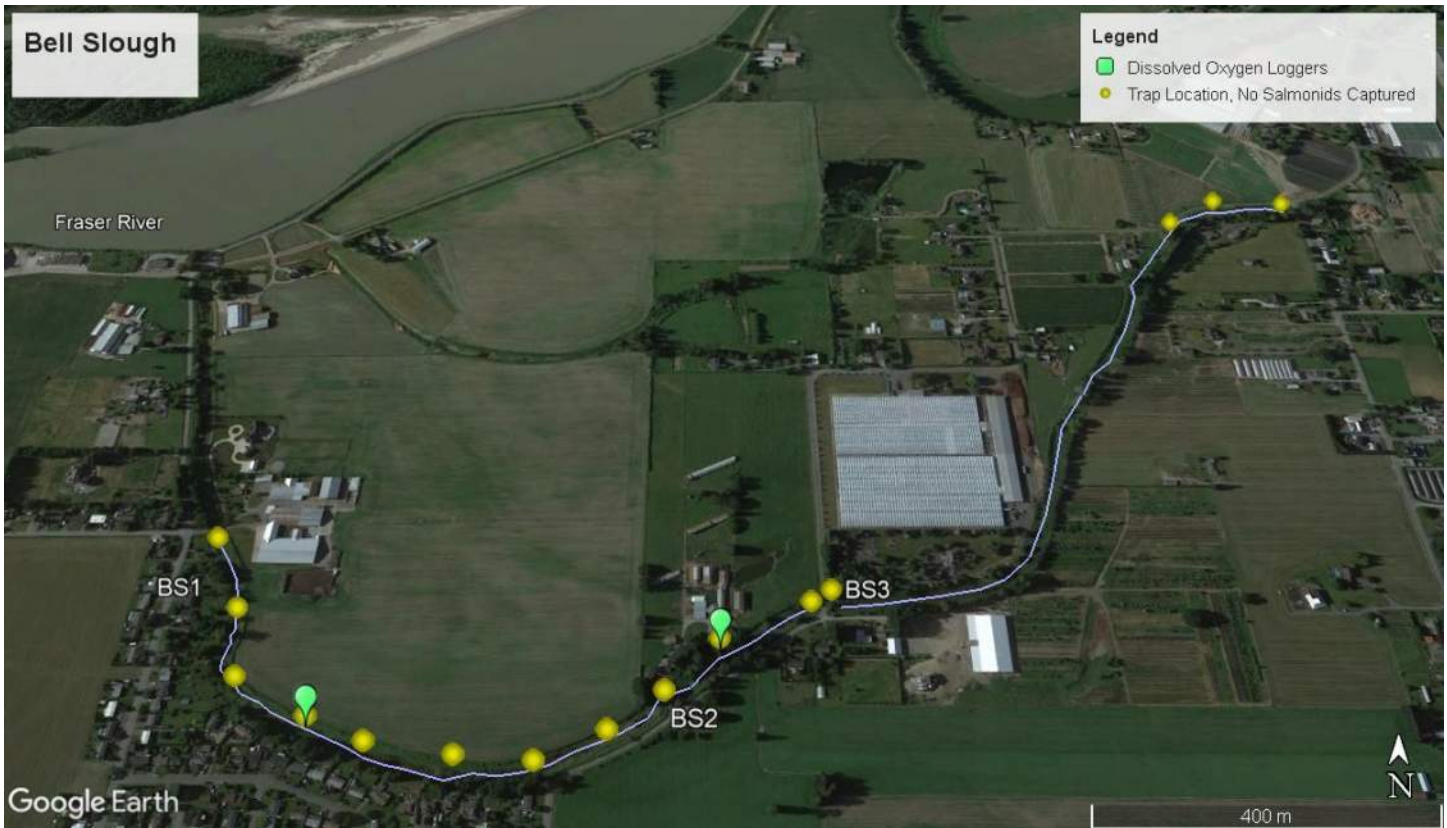
Fish Sampling and Salmonid Capture Locations

- Only 2 indigenous fish species were captured, although one was a species at risk (Brassy Minnow)
- No salmonids were caught.
- The majority of the catch consisted of introduced species and a high proportion of traps were empty.
- Water temperature was ideal for salmonids, but dissolved oxygen levels were too low to support them
- Specific conductivity was significantly elevated in reach BS1 relative to BS2 and BS3, suggesting a local source of pollution there..

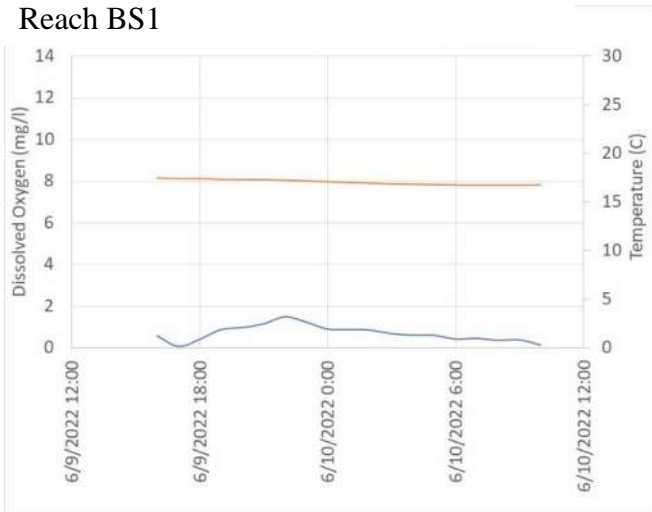
Reach BS1

Start Date	9-Jun-22
End Date	10-Jun-22
Sampling Interval (h)	1
Number of Days	0.8
Measurements	19
Max DO	1.5
Min DO	0.1
Max. Temperature	17.5
Min. Temperature	16.7

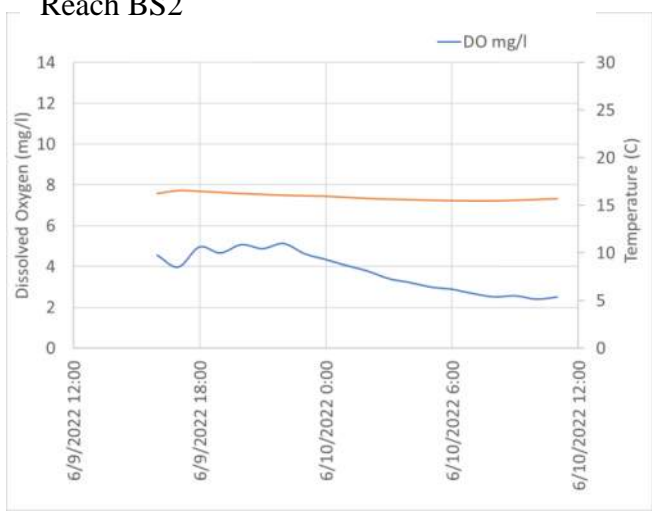
Reach BS2

Start Date	9-Jun-22
End Date	10-Jun-22
Sampling Interval (h)	1
Number of Days	0.8
Measurements	20
Max DO	5.1
Min DO	2.4
Max. Temperature	16.5
Min. Temperature	15.5

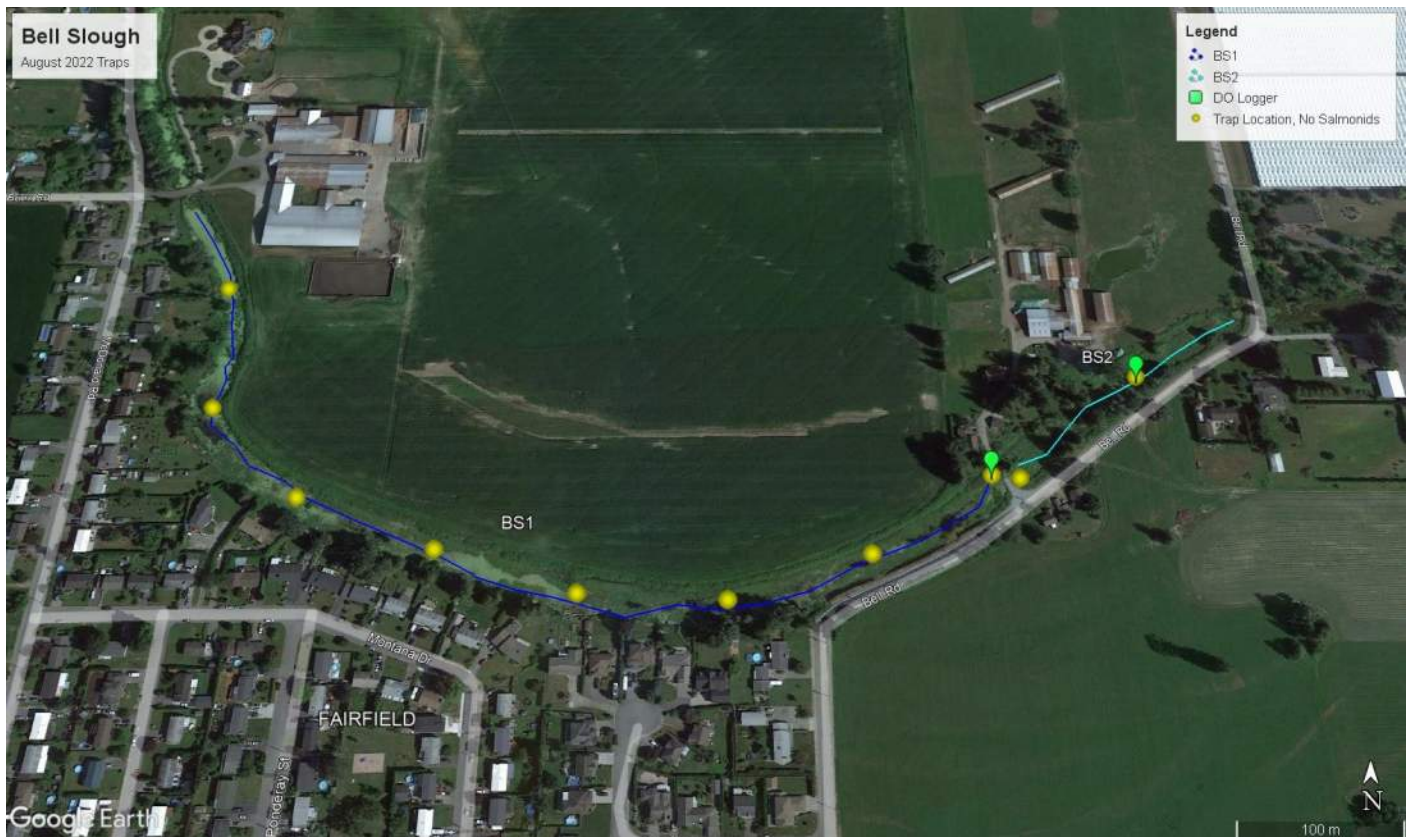
Fish Sampling and Salmonid Capture Locations

- Threespine stickleback was the only indigenous fish species captured
- No salmonids were caught.
- The majority of the catch consisted of introduced species and a the majority of traps were empty.
- Water temperature was adequate for salmonids, but dissolved oxygen levels were too low to support them
- Specific conductivity was significantly elevated in reach BS1 relative to BS2 and BS3, suggesting a local source of pollution there..
